# **Final Report No 2417**

## **by the Swiss Transportation Safety Investigation Board STSB**

concerning the accident of the helicopter  
Guimbal Cabri G2, HB-ZVK,

on 30 September 2021

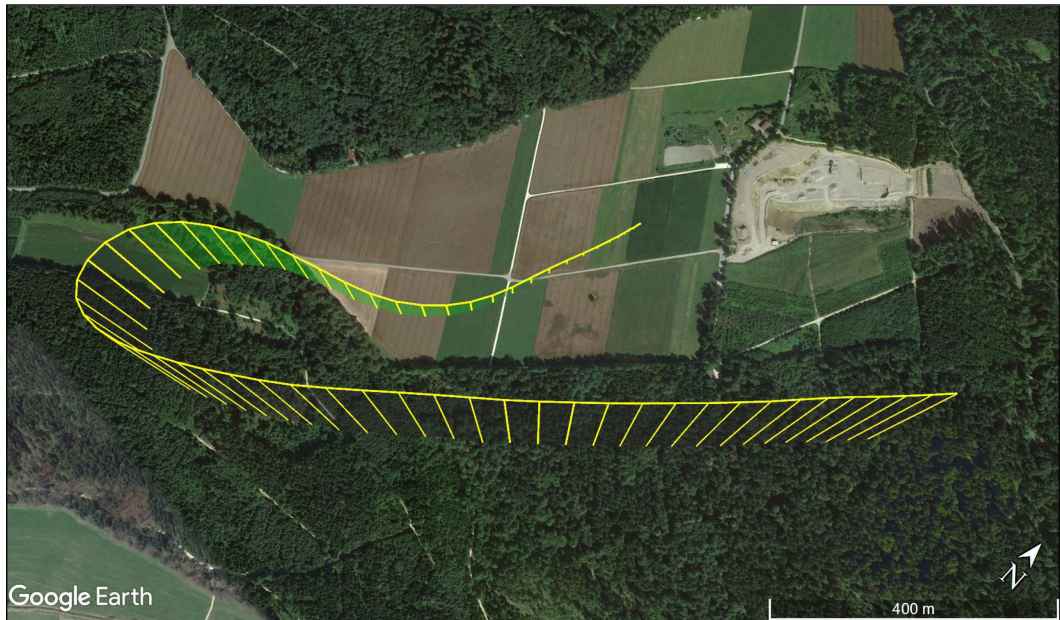
During the eighth autorotation exercise, the trainee pilot approached the landing site on the right-hand side of a road (cf. Figure 1). The final approach was too high and, as a result, was extended on the left-hand side of the road. Consequently, the trainee pilot changed course by about 45 degrees to the left on final approach. He performed a flare manoeuvre close to the ground, reducing the vertical and horizontal speed. He then used the collective pitch control (subsequently referred to as the 'collective') to reduce the vertical speed and to stabilise the helicopter in a horizontal position in hover flight. At the same time, the trainee pilot pressed the right foot pedal to counteract the increasing yawing moment to the left during this flight phase due to the anticipated engine power. The helicopter turned slightly to the right around its vertical axis. During this phase the engine and main rotor speeds had sharply fallen and the corresponding acoustic warning message had been activated. The indicator needles of the main rotor and engine speed had been synchronised on the electronic pilot monitor.

**Figure 1:** The final landing approach before the accident according to the GPS data recording device, shown in Google Earth.

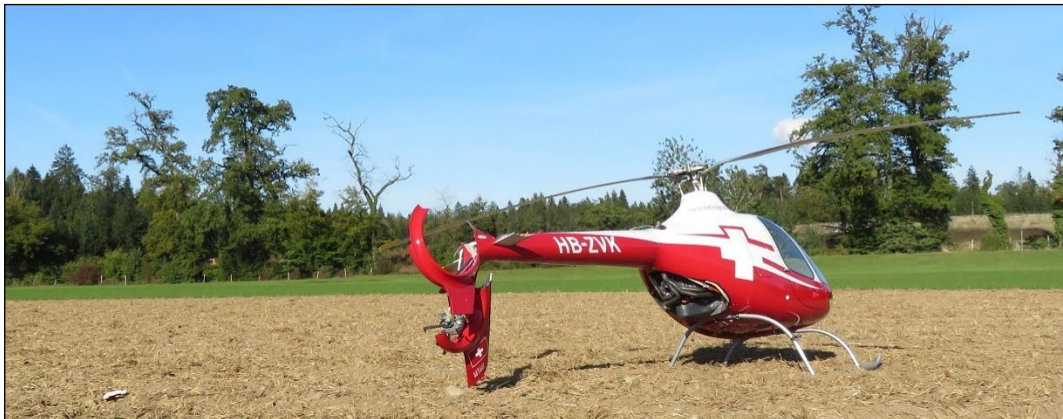
The flight instructor attempted to turn the helicopter nose back to the flight direction by pressing the left foot pedal, but did not succeed. The helicopter hit the ground hard, causing a main rotor blade to hit and destroy the tail boom (cf. Figure 2). The

**Figure 2:** Final position of the HB-ZVK helicopter looking north-east with a detached enclosed tail rotor.

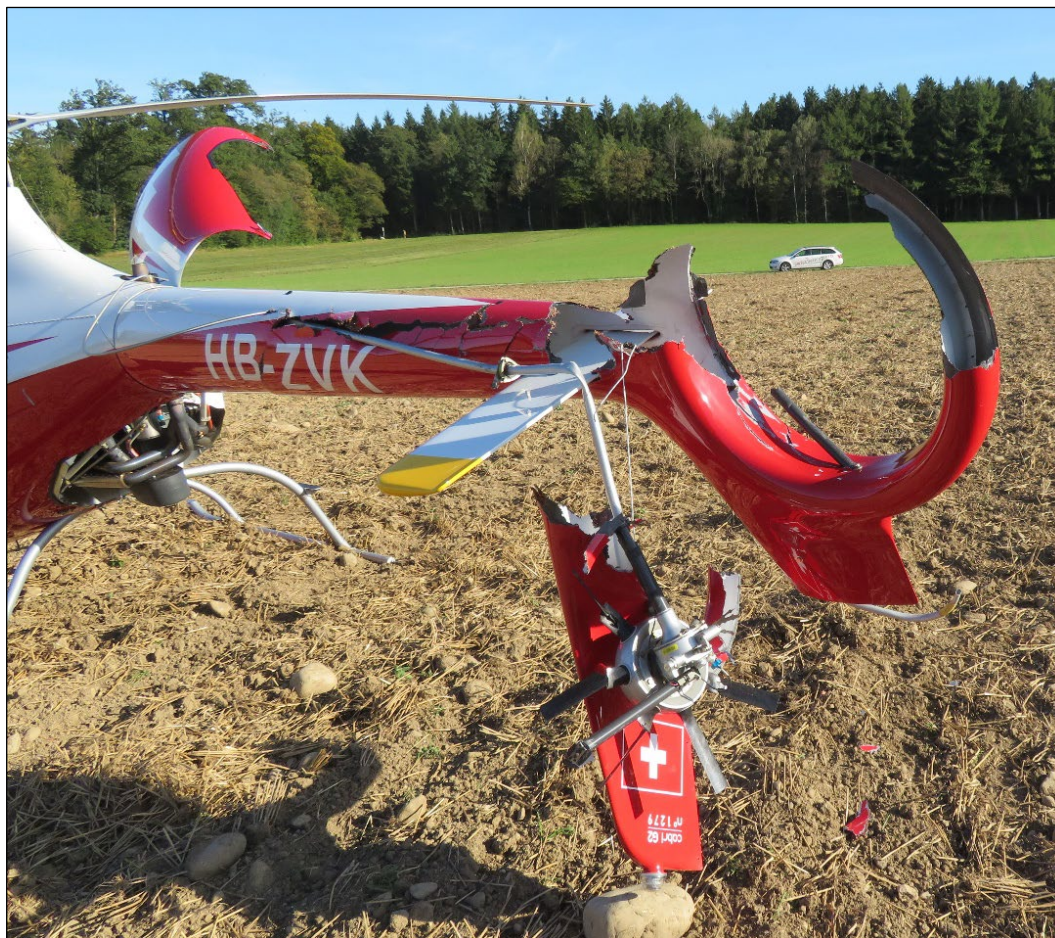
The collision with the ground pushed the helicopter airframe to the left side of the landing skids' cross bars. A main rotor blade hit and destroyed the tail boom. The tail rotor transmission shaft and the flexible tail rotor push-pull control were torn out of the tail boom. The control cable was detached in the area of the tail rotor unit (cf. Figure 5).

**Figure 5:** The HB-ZVK's destroyed tail boom with the tail rotor torn out

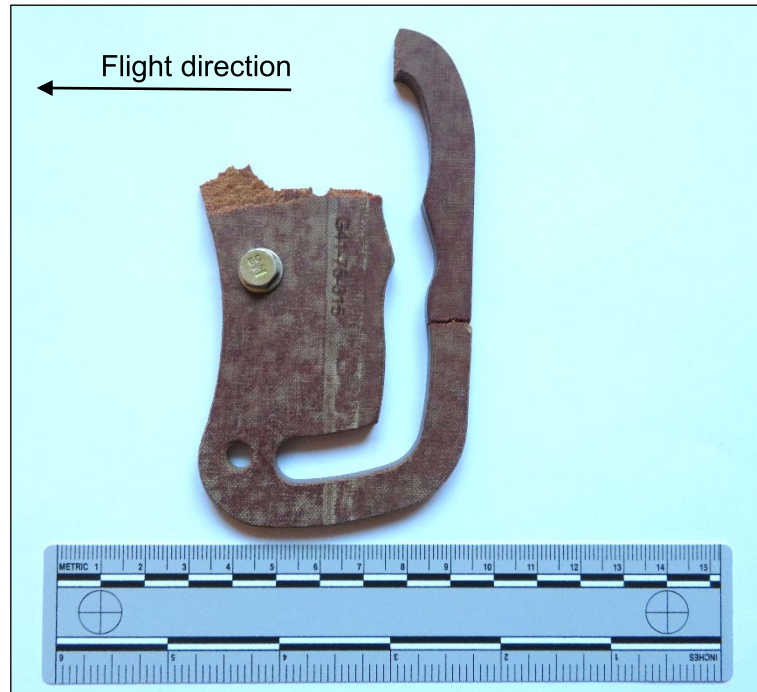
The technical investigation of the helicopter found that the throttle correlation cam (TCC) had broken off (cf. Figure 6). The flexible tail rotor push-pull control could be pulled out of the drill hole on the engine fire bulkhead by a few centimetres. The fixing bracket of the tail rotor push-pull control (cf. Figure 7) was bent and the cable

**Figure 6:** Broken off parts of the throttle correlation cam (TCC)

When the helicopter crashed, a main rotor blade hit and destroyed the tail boom. High tractive forces were exerted on the flexible tail rotor push-pull control, pulling it backwards from the engine bulkhead firewall and tearing it out of the fixing bracket near the throttle correlation cam inside the fuselage. As a result, the flexible tail rotor push-pull control cable exerted a large lateral force on the throttle correlation cam, causing it to break (cf. section 1.9, Figure 8). No other plausible explanations for the fracture of the throttle correlation cam were found.

Testing showed that such a fracture is only possible when the throttle correlation cam is in certain positions, or more specifically when the position of the throttle correlation cam and that of the flexible tail rotor push-pull control overlap. This occurs either when the throttle twist grip is fully closed – regardless of the position of the collective – or when the throttle twist grip is in idle position and the collective is fully closed or pulled to the half-way position (cf. section 1.9, Figure 9, positions with area colored in red). In summary, it can be stated that, according to the test arrangement, such a fracture of the throttle correlation cam is only possible with the throttle twist grip closed or the throttle twist grip in the idle position according to the test arrangement.

- This breakage was most probably caused by the tail rotor control cable being pulled out, which can only happen if the throttle twist grip is closed or in idle position.

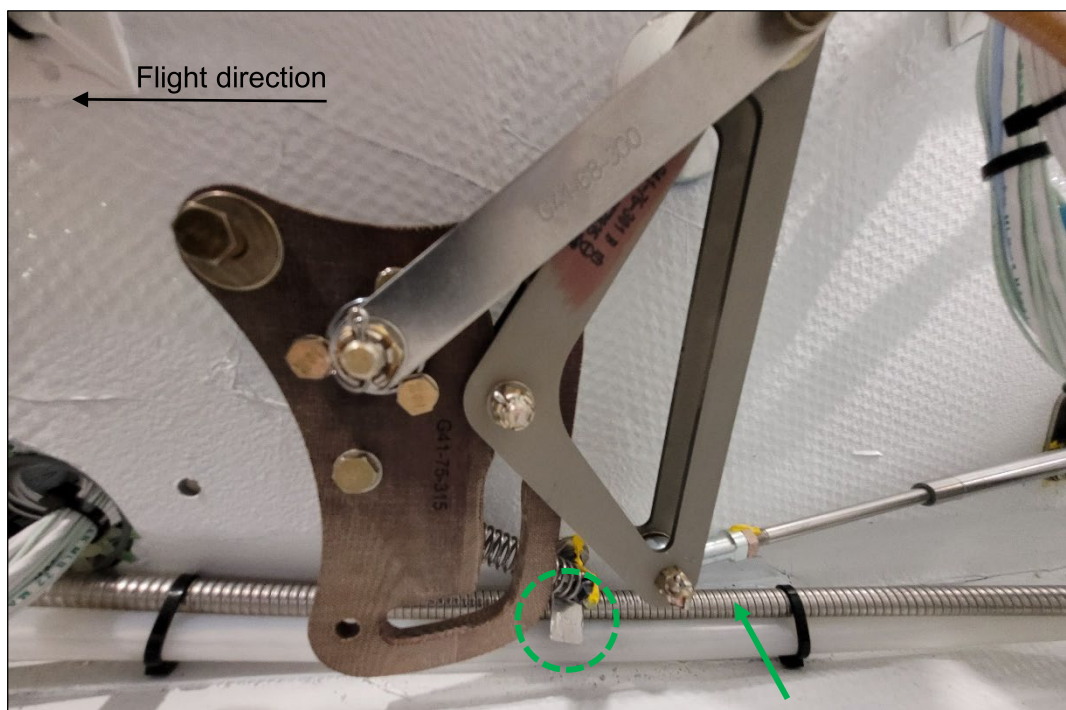
**Figure 7:** Example of the installation of the throttle correlation cam (TCC) and the guidance of the flexible tail rotor push-pull control cable (green arrow) and the fixing bracket (dashed green circle). Source: Hélicoptères Guimbal.

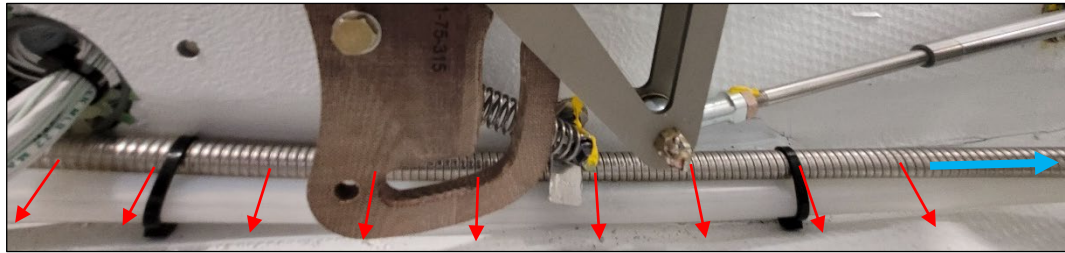
When tractive force was applied to the torn-out flexible tail rotor push-pull control, the cable became taut, causing it to move sideways from the bent fixing bracket towards the broken-off throttle correlation cam (TCC), as illustrated in Figure 8.

**Figure 8:** Direction of movement of the flexible tail rotor push-pull control cable (red arrows) upon application of tractive force to the right (blue arrow). Close-up of Figure 7.
