# **Schlussbericht der Eidgenössischen Flugunfall-Untersuchungskommission**

des Helikopters Bell 206L-1 HB-XMV

vom 31. Juli 1984

in Furt (2 km W Wangs)/SG

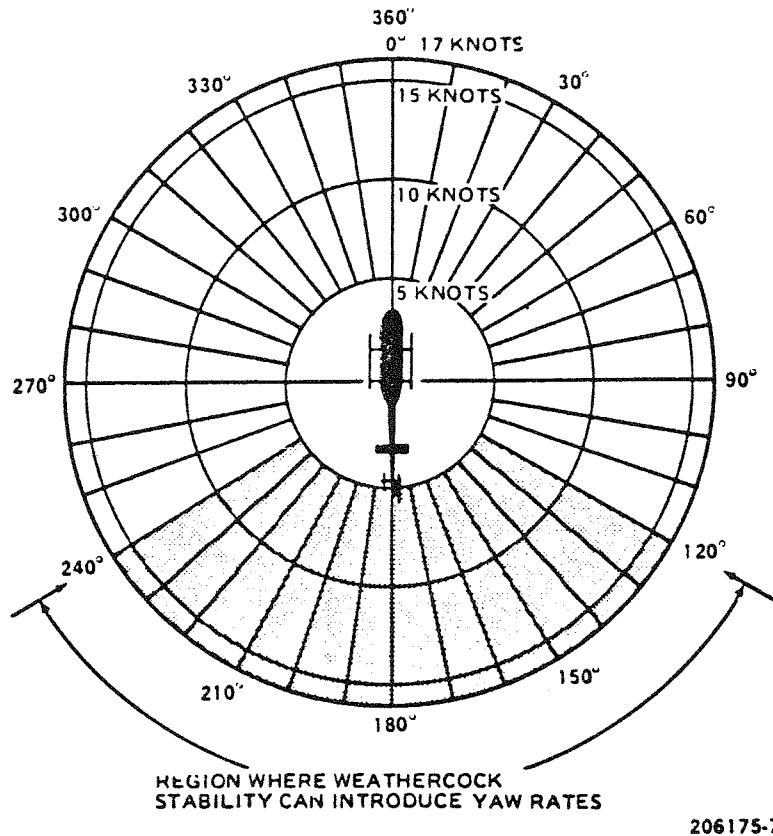
FIGURE 1. WEATHERCOCK STABILITY

#### Weathercock Stability (120 to 240 degrees)

Winds within this region will attempt to weathervane the nose of the aircraft into the relative wind. This characteristic comes from the fuselage and vertical fin. The helicopter will make an uncommanded turn either to the right or left depending upon the exact wind direction unless a resisting pedal input is made. If a yaw rate has been established in either direction, it will be accelerated in the same direction when the relative winds enter the 120 to 240 degree shaded area of Figure 1 unless corrective pedal action is made. The importance of timely corrective action by the pilot to prevent high yaw rates from occurring cannot be overstressed.

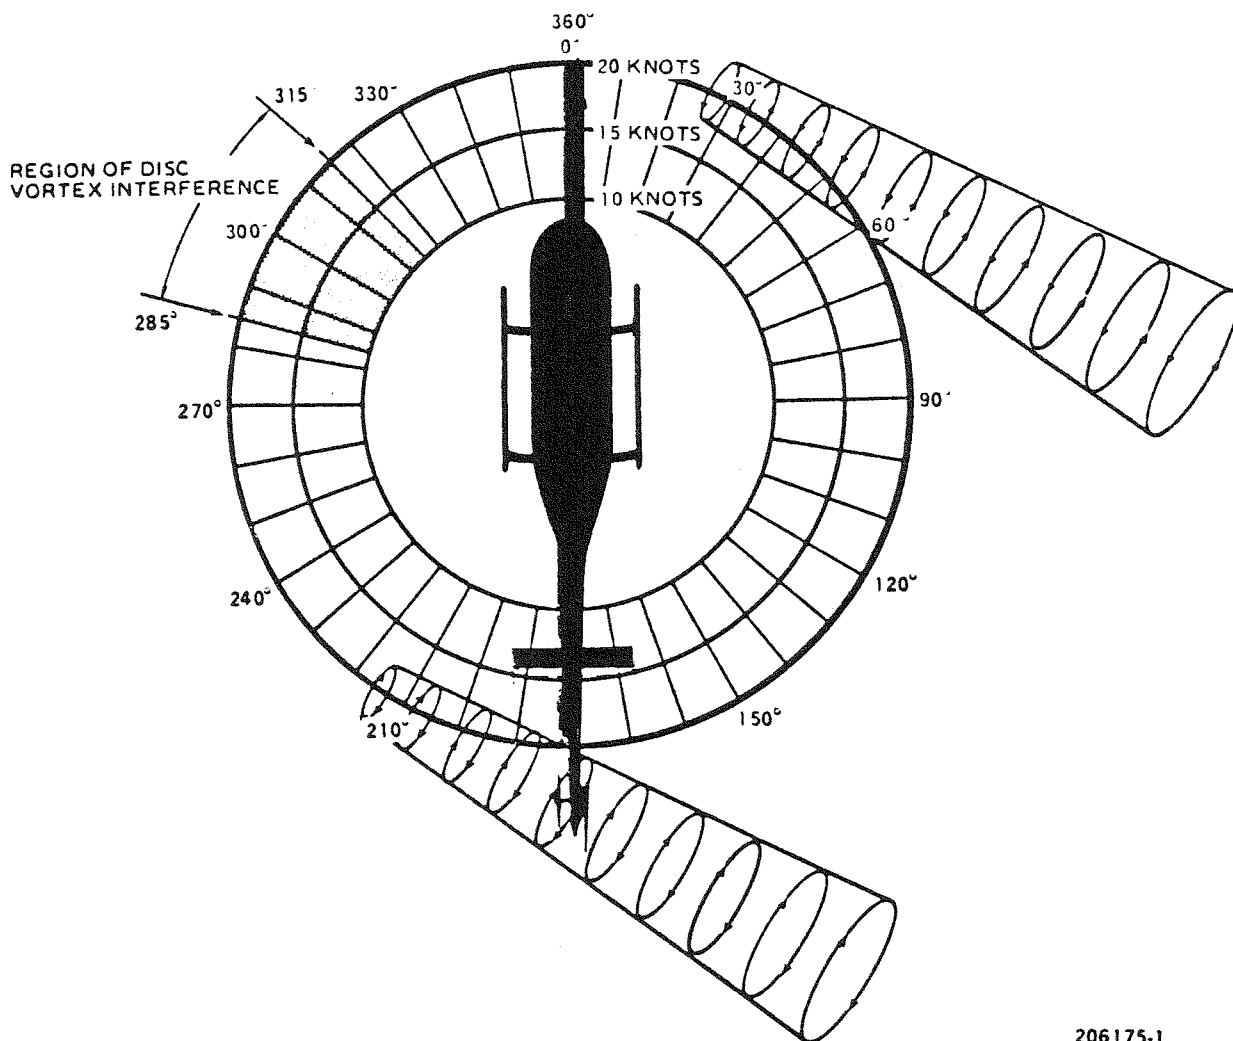
FIGURE 2. MAIN ROTOR DISC VORTEX INTERFERENCE

### Main Rotor Disc Vortex (285 to 315 degrees)

Winds within this region, as shown in Figure 2, can cause the main rotor vortex to be directed onto the tail rotor. The effect of this main rotor disc vortex is to change the tail rotor angle of attack. Initially as the tail rotor comes into the area of the main rotor disc vortex during a right turn, the angle of attack of the tail rotor is increased. This increase in angle of attack requires the pilot to add right pedal (reduce thrust) to maintain the same rate of turn. As the main rotor vortex passes the tail rotor, the tail rotor angle of attack is reduced. The reduction in angle of attack causes a reduction in thrust and a right yaw acceleration begins. This acceleration can be surprising, since the pilot was previously adding right pedal to maintain the right turn rate. Analysis of flight test data during this time verifies that the tail rotor does not stall. The helicopter will exhibit a tendency to make a sudden, uncommanded right yaw which, if uncorrected, will develop into a high right turn rate. When operating in this region, the pilot must anticipate the need for sudden left pedal inputs.

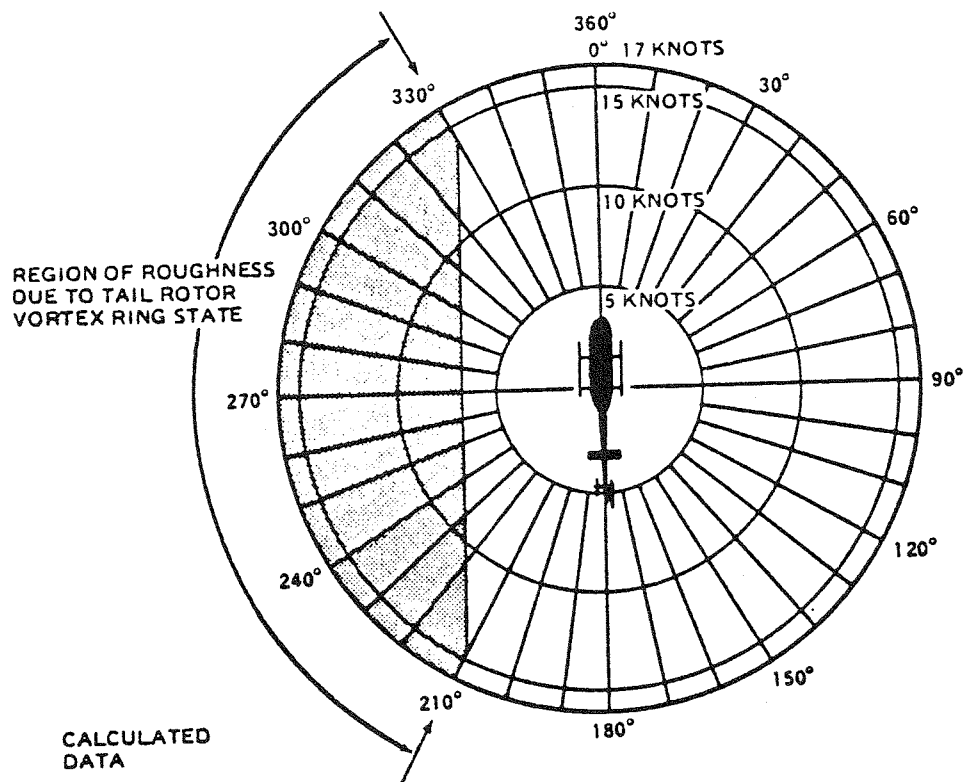
FIGURE 3. TAIL ROTOR VORTEX RING STATE

#### Tail Rotor Vortex Ring State (210 to 330 degrees)

Winds within this region, as shown in Figure 3, will result in the development of the vortex ring state of the tail rotor. The vortex ring state causes tail rotor thrust variations which result in yaw rates. Since these tail rotor thrust variations do not have a specific period, the pilot must make corrective pedal inputs as the changes in yaw acceleration are recognized. The resulting high pedal workload in tail rotor vortex ring state is well known and helicopters are operated routinely in this region. This characteristic presents no significant problem unless corrective action is not timely. If a right yaw rate is allowed to build, the helicopter can rotate into the wind azimuth region where weathercock stability will then accelerate the right turn rate. Pilot workload during vortex ring state will be high; therefore, the pilot must concentrate fully on flying the aircraft and not allow a right yaw rate to build.

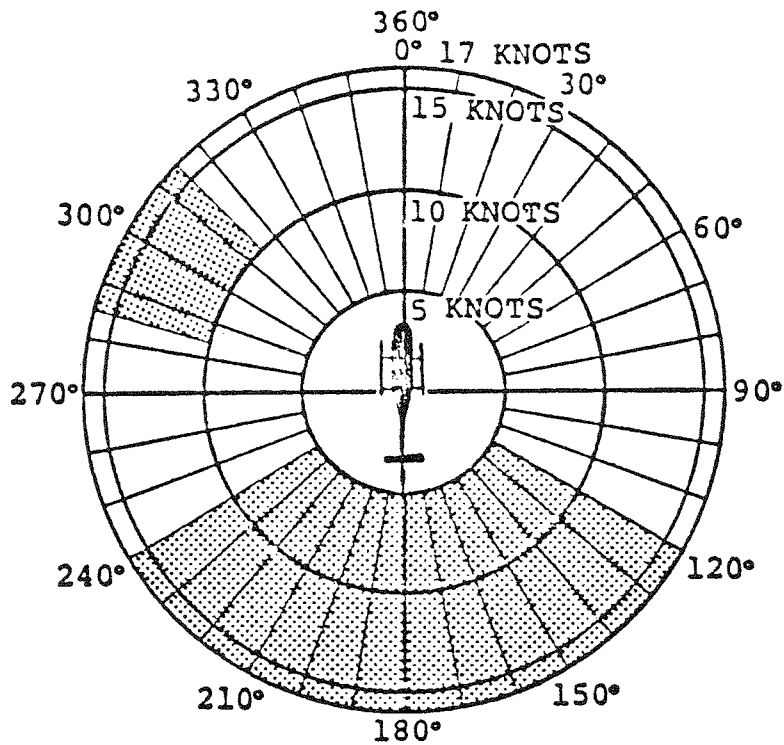
# RELATIVE WIND CHART

An unanticipated right yaw may occur when operating in the shaded areas of the chart.

This chart refers to unanticipated right yaw and does not replace the critical relative wind azimuth chart in the performance section of the flight manual which refers to tail rotor control margin.

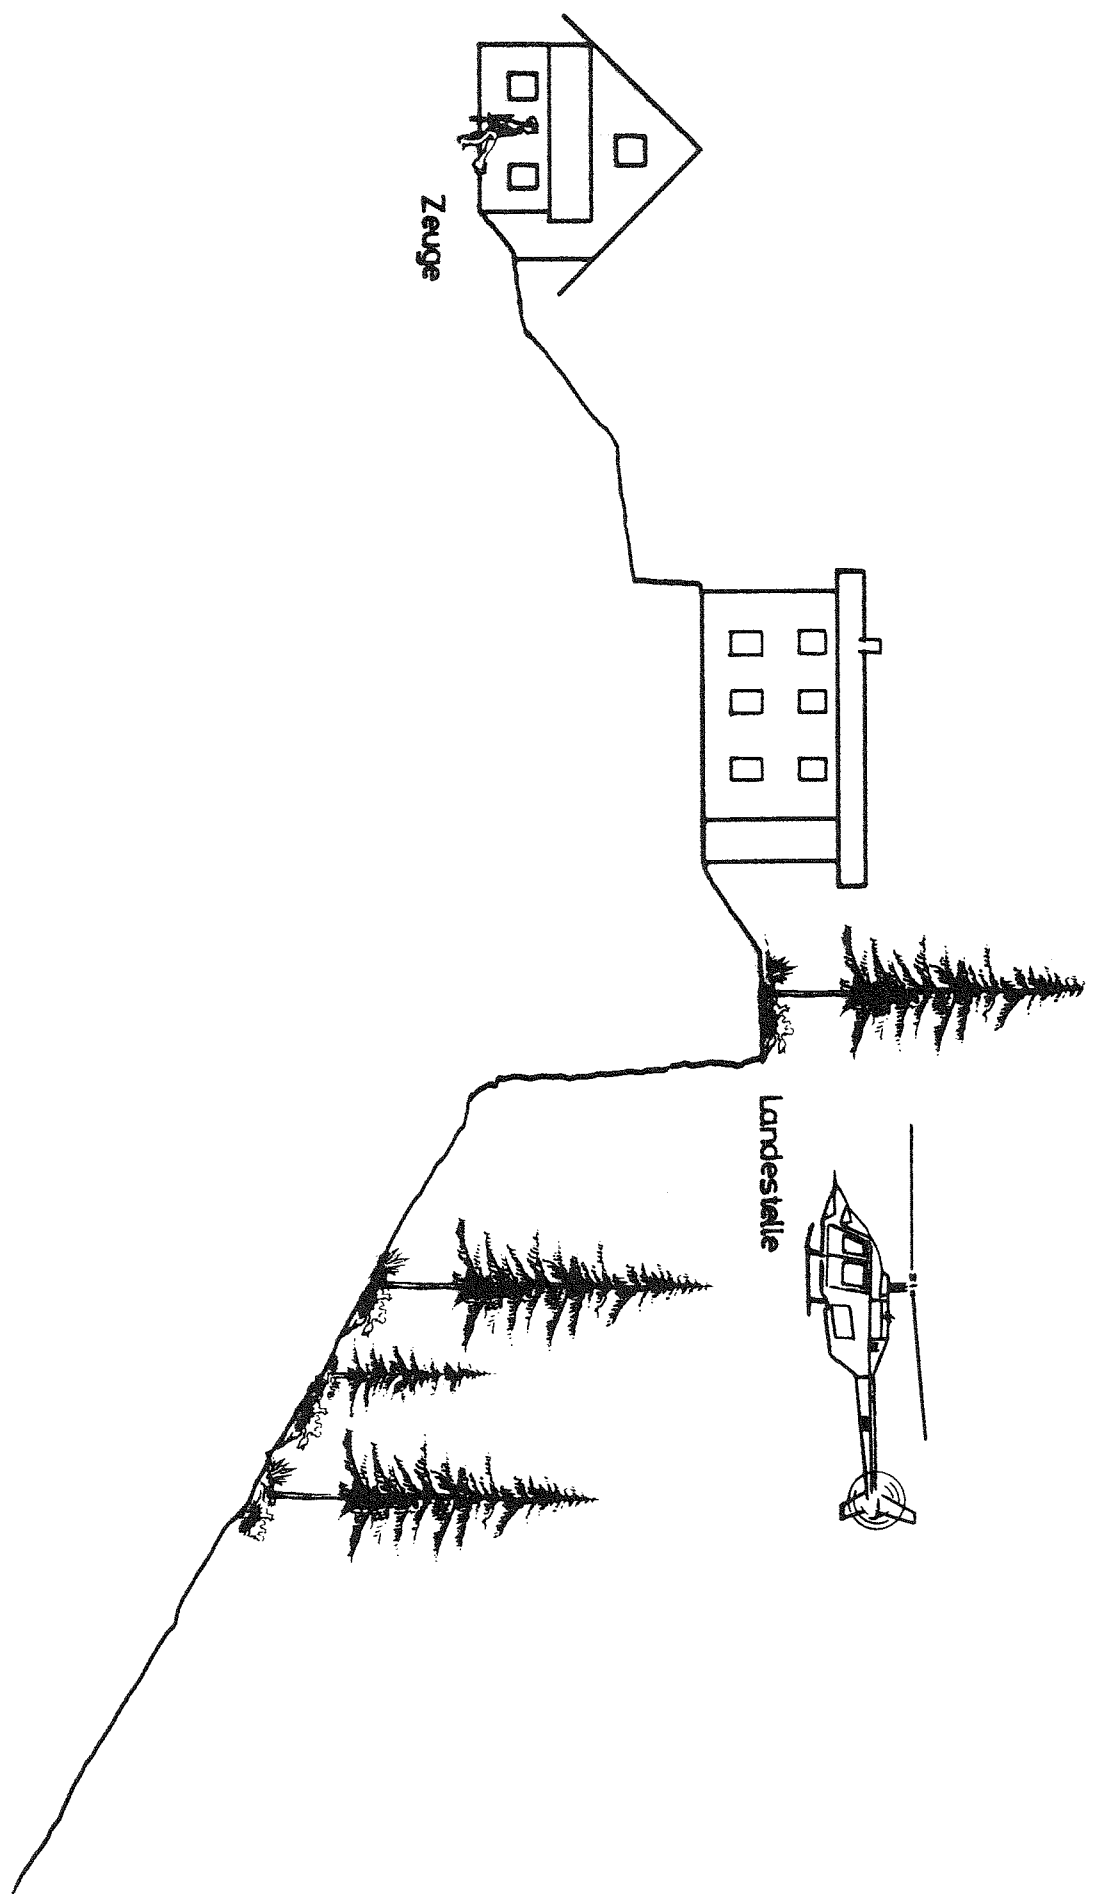
FURT/PIZOL SG

Anlässlich der Rekonstruktion einer Zeugenaussage an der Unfallstelle ergab sich, dass der vom Zeugen festgestellte zweite Anflug immer noch zu hoch erfolgte.

Der erste Anflugsversuch geriet zu hoch. Der zweite zum Absturz führende Anflugsversuch erfolgte offensichtlich wieder leicht zu hoch und zu langsam. Der Schwebeflug wurde vor der Landestelle und ausserhalb des Bodeneffektes durchgeführt (**Beilage**).

Abklärung der Zeugenaussage Z im Gelände  
am Tag der Zeugeneinvernahme vom 1.8.1984
