**Final Report
of the Aircraft Accident
Investigation Bureau**

with the helicopter Robinson R 44, F-GPHS

of 2 July 1996

in Chancy/GE

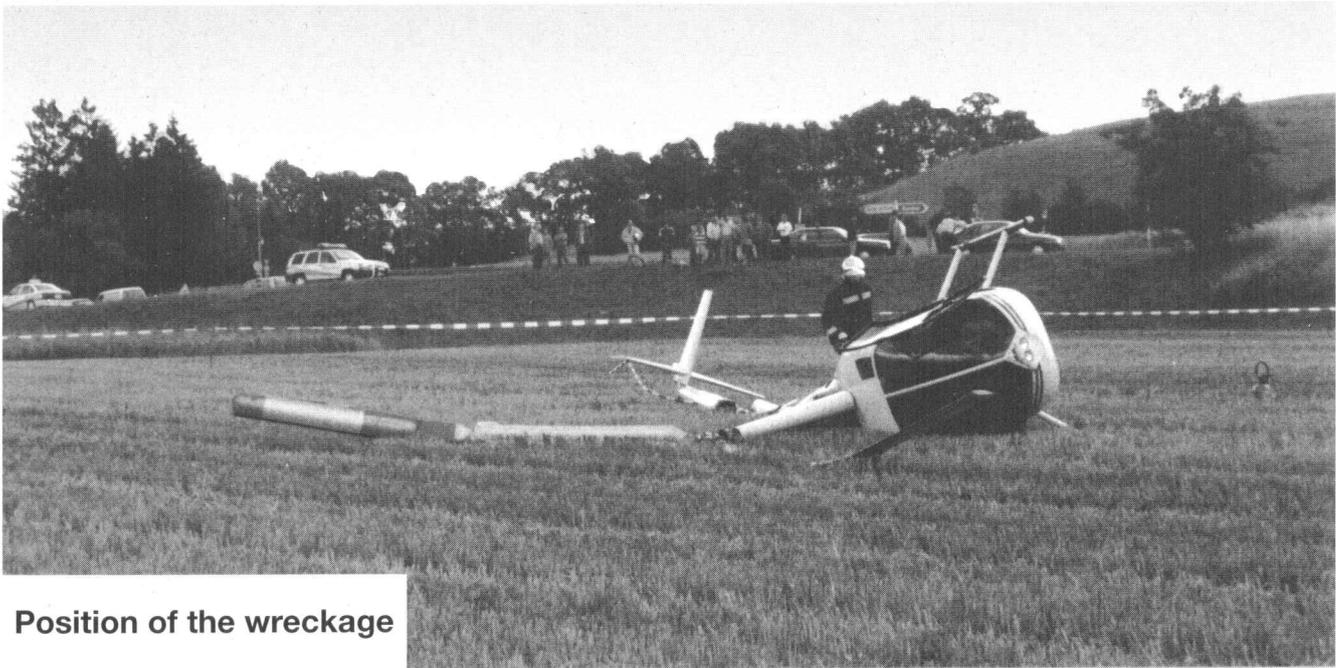
- Additional **facts and preliminary investigations** showed:
 - The helicopter rolled onto its right side in an open field near Chancy/GE Switzerland;
 - The main gearbox oil covered the helicopter's left side, the tailcone and stabilizer leading edge which had been cut off at impact;

Position of the wreckage

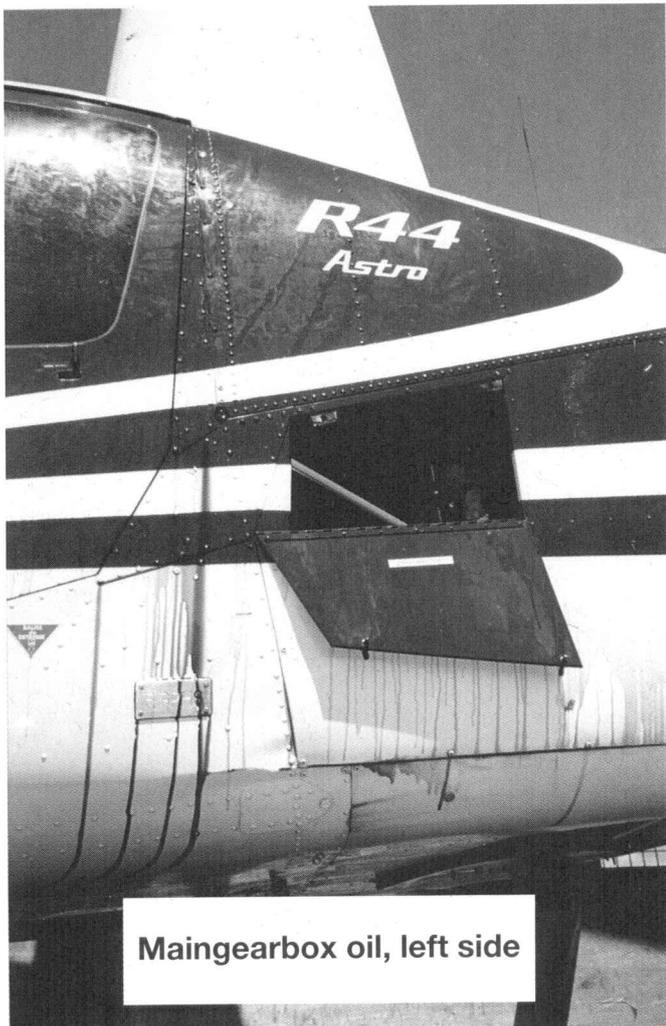
Main gearbox oil, left side

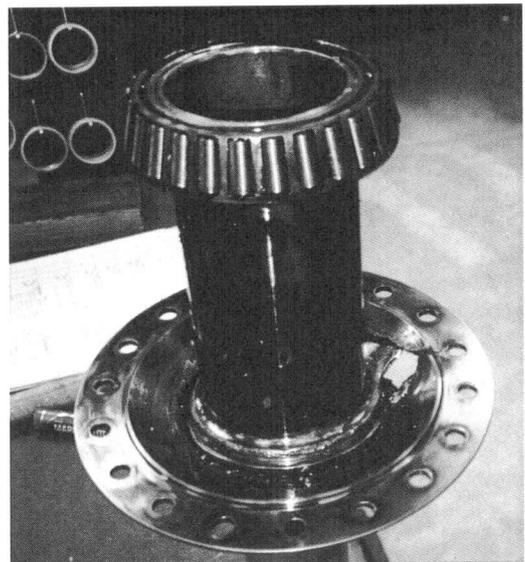
- Removal and partial disassembly of the main gearbox showed metal chips in the sump and a big crack in the gear carrier;

Disassembly showed the 18 NAS6606-2 bolt clamping the C146-3 ring gear and C268-1 gear carrier had loosened in service. Bolt torque in most cases had dropped to 25 to 50 inch lbs. This torque is equivalent to normal self locking nut drag, indicating no clamping between the ring gear carrier. Surface finish measurements of ring gear clamping surface showed 108 to 120 micro inch finish and a distinct phonograph groove appearance 63 micro inch finish is required.

Severe fretting developed around most bolts holes due to the loss of clamping. A fatigue crack progressed from a severely fretted bolt hole, across the flange, and circumferentially around the gear carrier, separating the gear mounting flange from the center section of the gear carrier. This resulted in a loss of positive drive to the main rotor:

The insufficient surface finish of the ring gear clamping caused the 18 bolts (NAS6606-2) to become loose in normal service. The problems continued with severe fretting around the bolt holes and the growth of a fatigue crack on the gear carrier, until it broke off.

Damaged main gearbox

RHC released Service Bulletin (SB) No 15, dated 2 August 1996, required inspection and modification of R 44 main rotor gearboxes.

The FAA released FAA AD (Airworthiness Directive) 96-18-22 (priority letter, AD) dated 29 August 1996.

By 18 September 1996 the Swiss FOCA (Federal Office for Civil Aviation) adopted FAA AD 96-18-22 as mandatory action.
