Schlussbericht des Büros für Flugunfalluntersuchungen

des Flugzeuges Piper J-3C-65L-4 (65 PS) HB-OFK

vom 4. August 1997

in Willisau (Mettenberghöhe)/LU

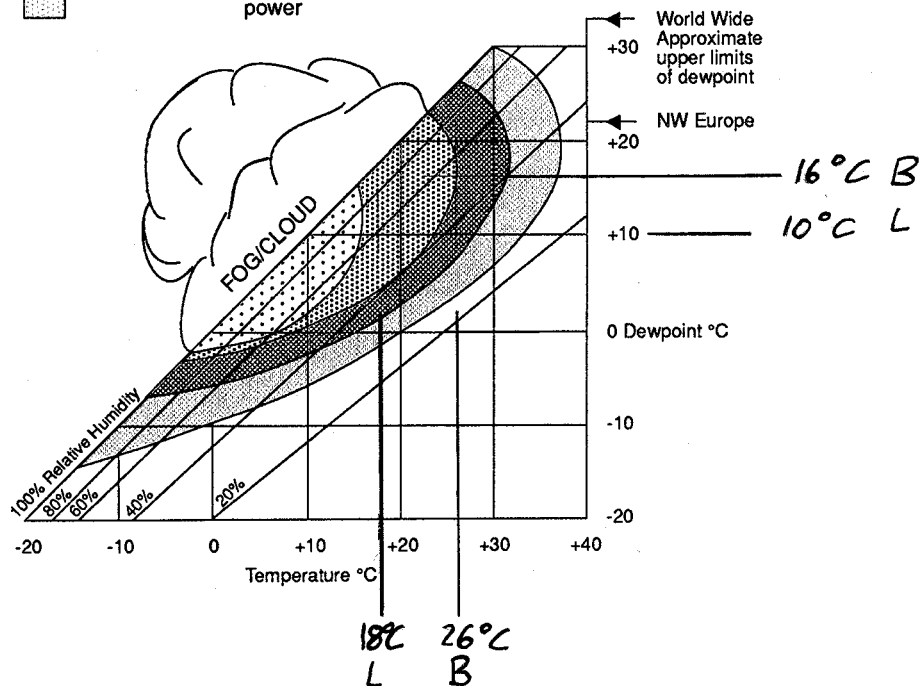
d. The chart below shows the wide range of ambient conditions conducive to the formation of carb icing. Particular note should be taken of the much greater risk of serious icing with descent power. The closer the temperature and dewpoint readings, the greater the humidity.

**Serious icing** – any power
-

**Moderate icing** – cruise power
-

**Serious icing** – descent power
-

**Light icing** – cruise or descent power
