Final Report of the Aircraft Accident Investigation Bureau

concerning the incident

to the airplane Mc Donald Douglas MD 83, OH- LPH, Finnair
on 15 april 2000
at Zurich Airport

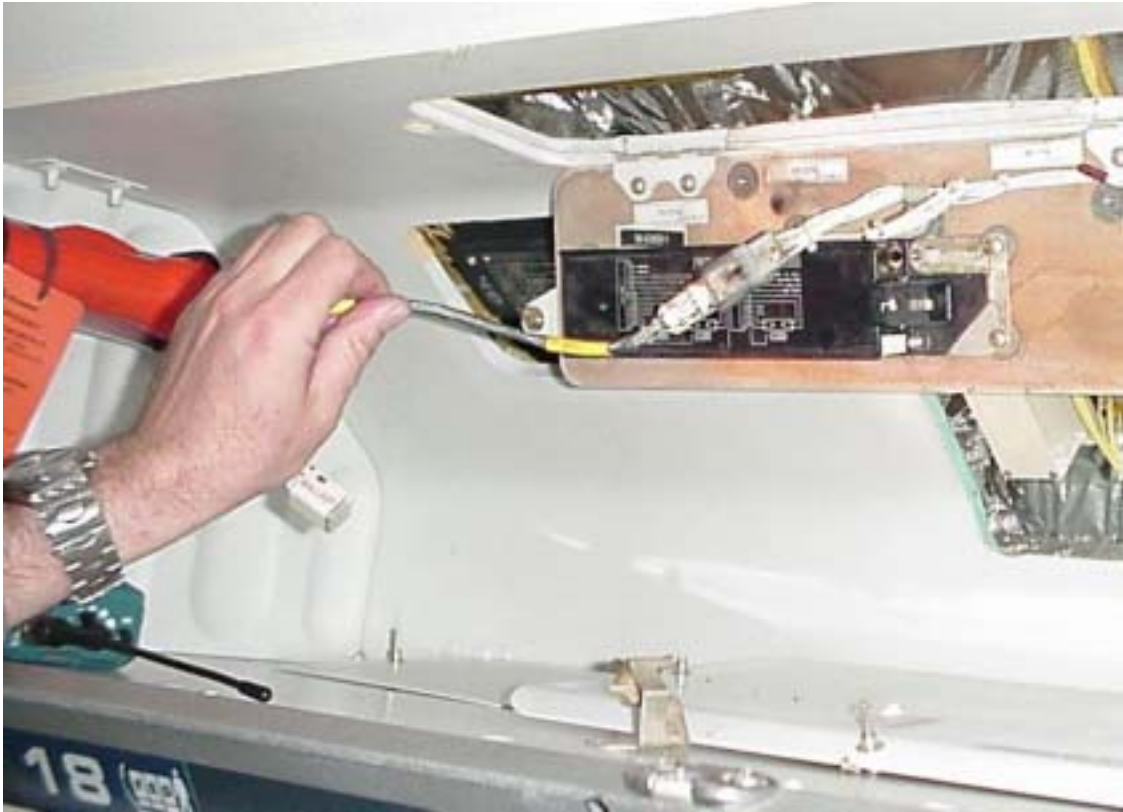
Fig. 1

- After opening of the ceiling panel above hat rack row 18 RH, the access door to the sidewall light ballast was opened. The connector on the a/c side wiring was found burned. (Fig. 1)

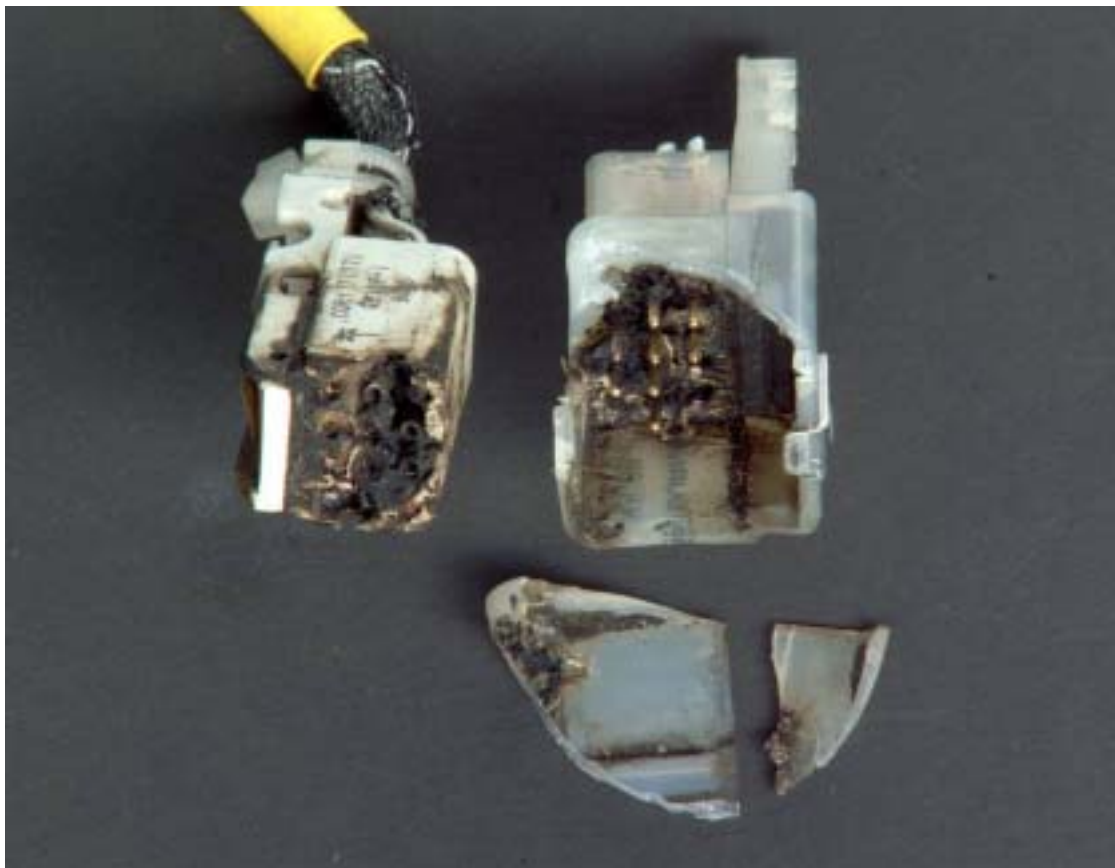
Fig. 2

- The connector was removed for investigation.
- The external housing of the female and male part of the connector did not show signs of external heat damage. (Fig. 2)

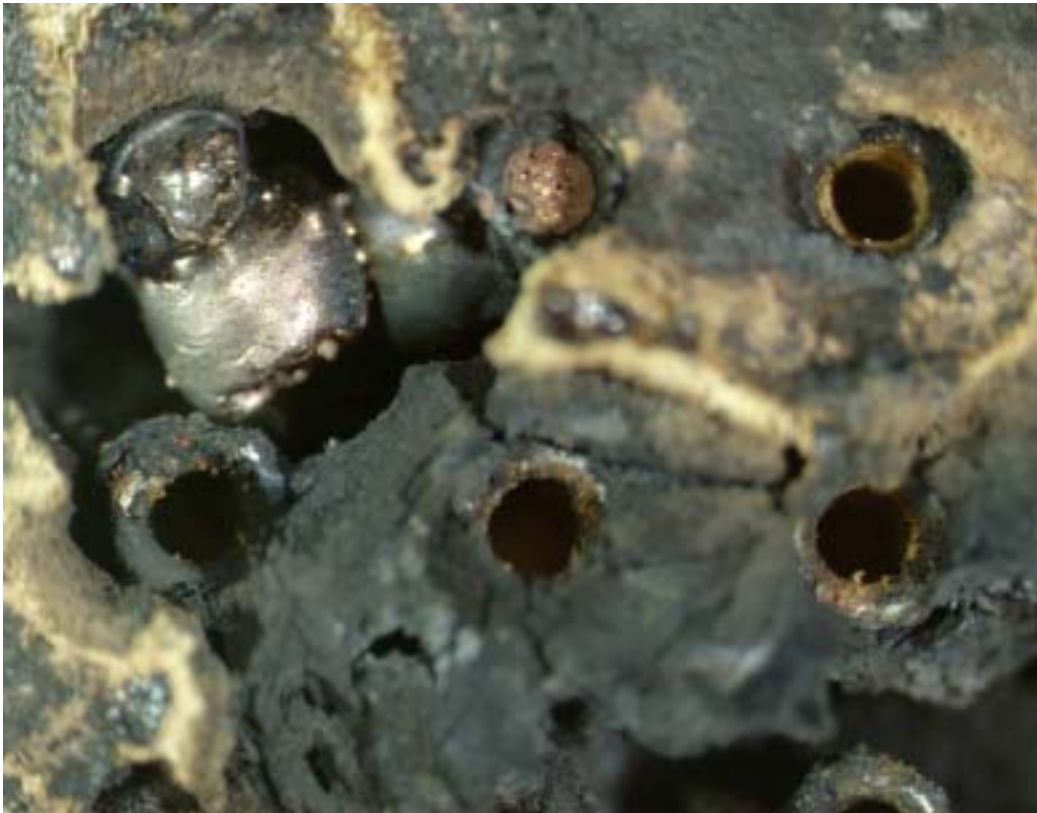
Fig. 3

- The connection between wire and contact did not show thermal damage and had a firm seat.
- In the socket part of the connector, at contact "A", there was a melted pearl of metal. (Fig. 3)

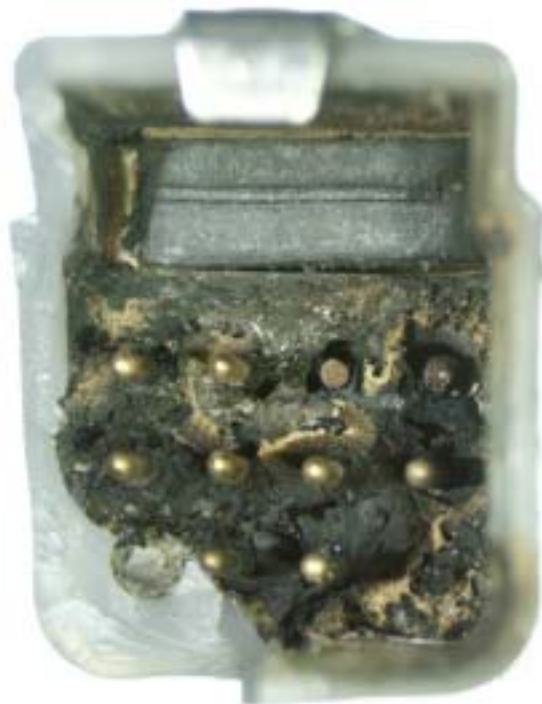
Fig. 4

- Otherwise in the pin part of the connector, the forward part of pin "A" is missing.
- The copper of the remaining pin "A" shows a strong blistering, which indicated high temperatures normally obtained through an electric arc. (Fig. 4)

Due to the found increase in temperature that was produced at pin "A" and was of such a nature, that an increase in resistance is suspected as a cause and not the presence of humidity in the connector.

This increase in resistance can result from a mechanically damaged pin or a malformed pin with a shaving. In this case, the current which has to pass will heat up the reduced remaining section and in case of AC- current may produce an arc. This arc will melt the copper as found in the burned connector.

The incident was caused by an increased electrical resistance on a contact of the connector between the a/c wiring and the special interconnect cable (P/N C773-10-450) to the ballast.
