**Final Report
of the Aircraft Accident
Investigation Bureau**

of the Helicopter Schweizer Aircraft Corp. 269C, HB-XZC

on 21 July 1999

Adelboden im Eselsmoos / BE

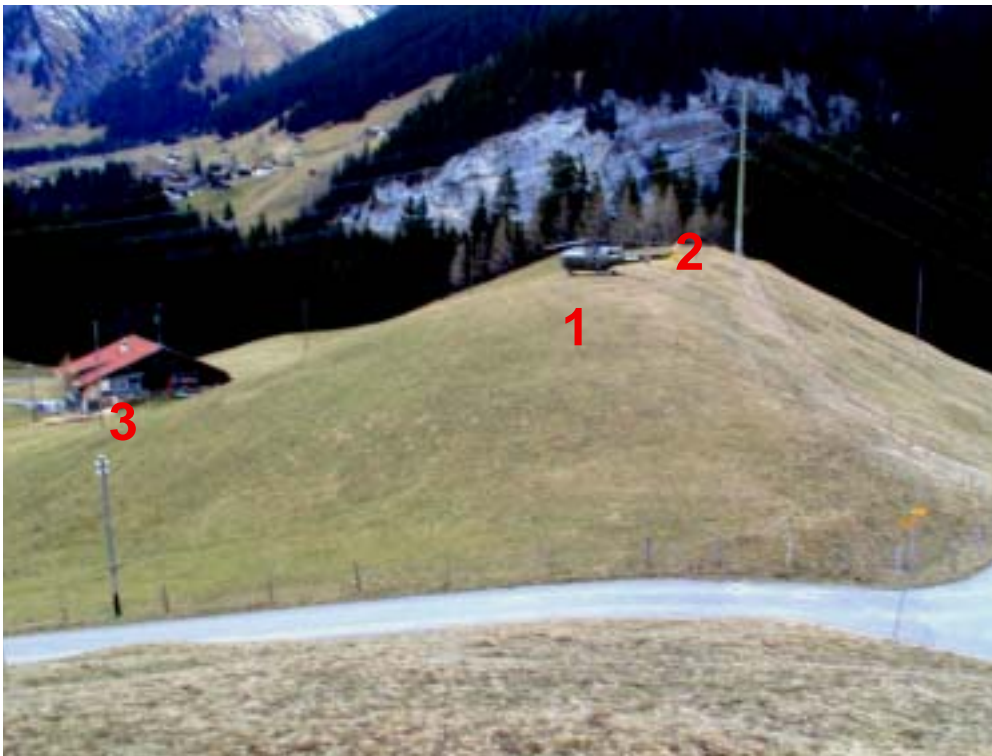
Landing zone – view direction 330°

Position 1: take off position – hover taxi direction position 2

Position 3: final position of the helicopter

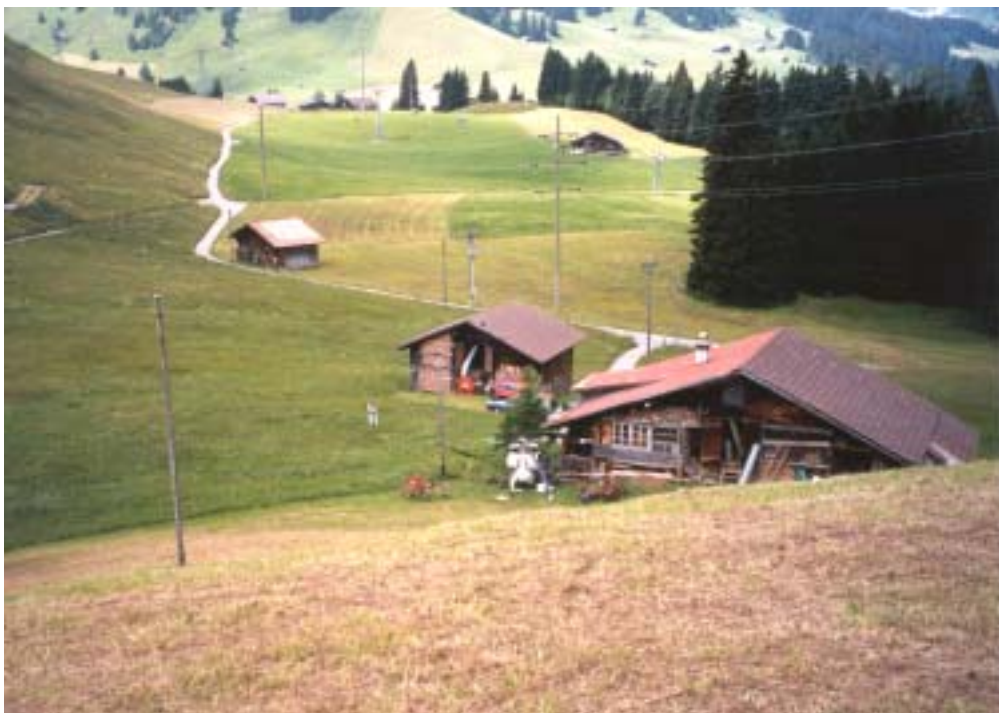
final position of the helicopter – view direction 210°
