Final Report of the Federal Commission on Aviation Accidents

between the helicopter Alouette III SA316B, HB-XJR

and the helicopter Jet Ranger II AB206B, HB-XNU

on 26 September 2000

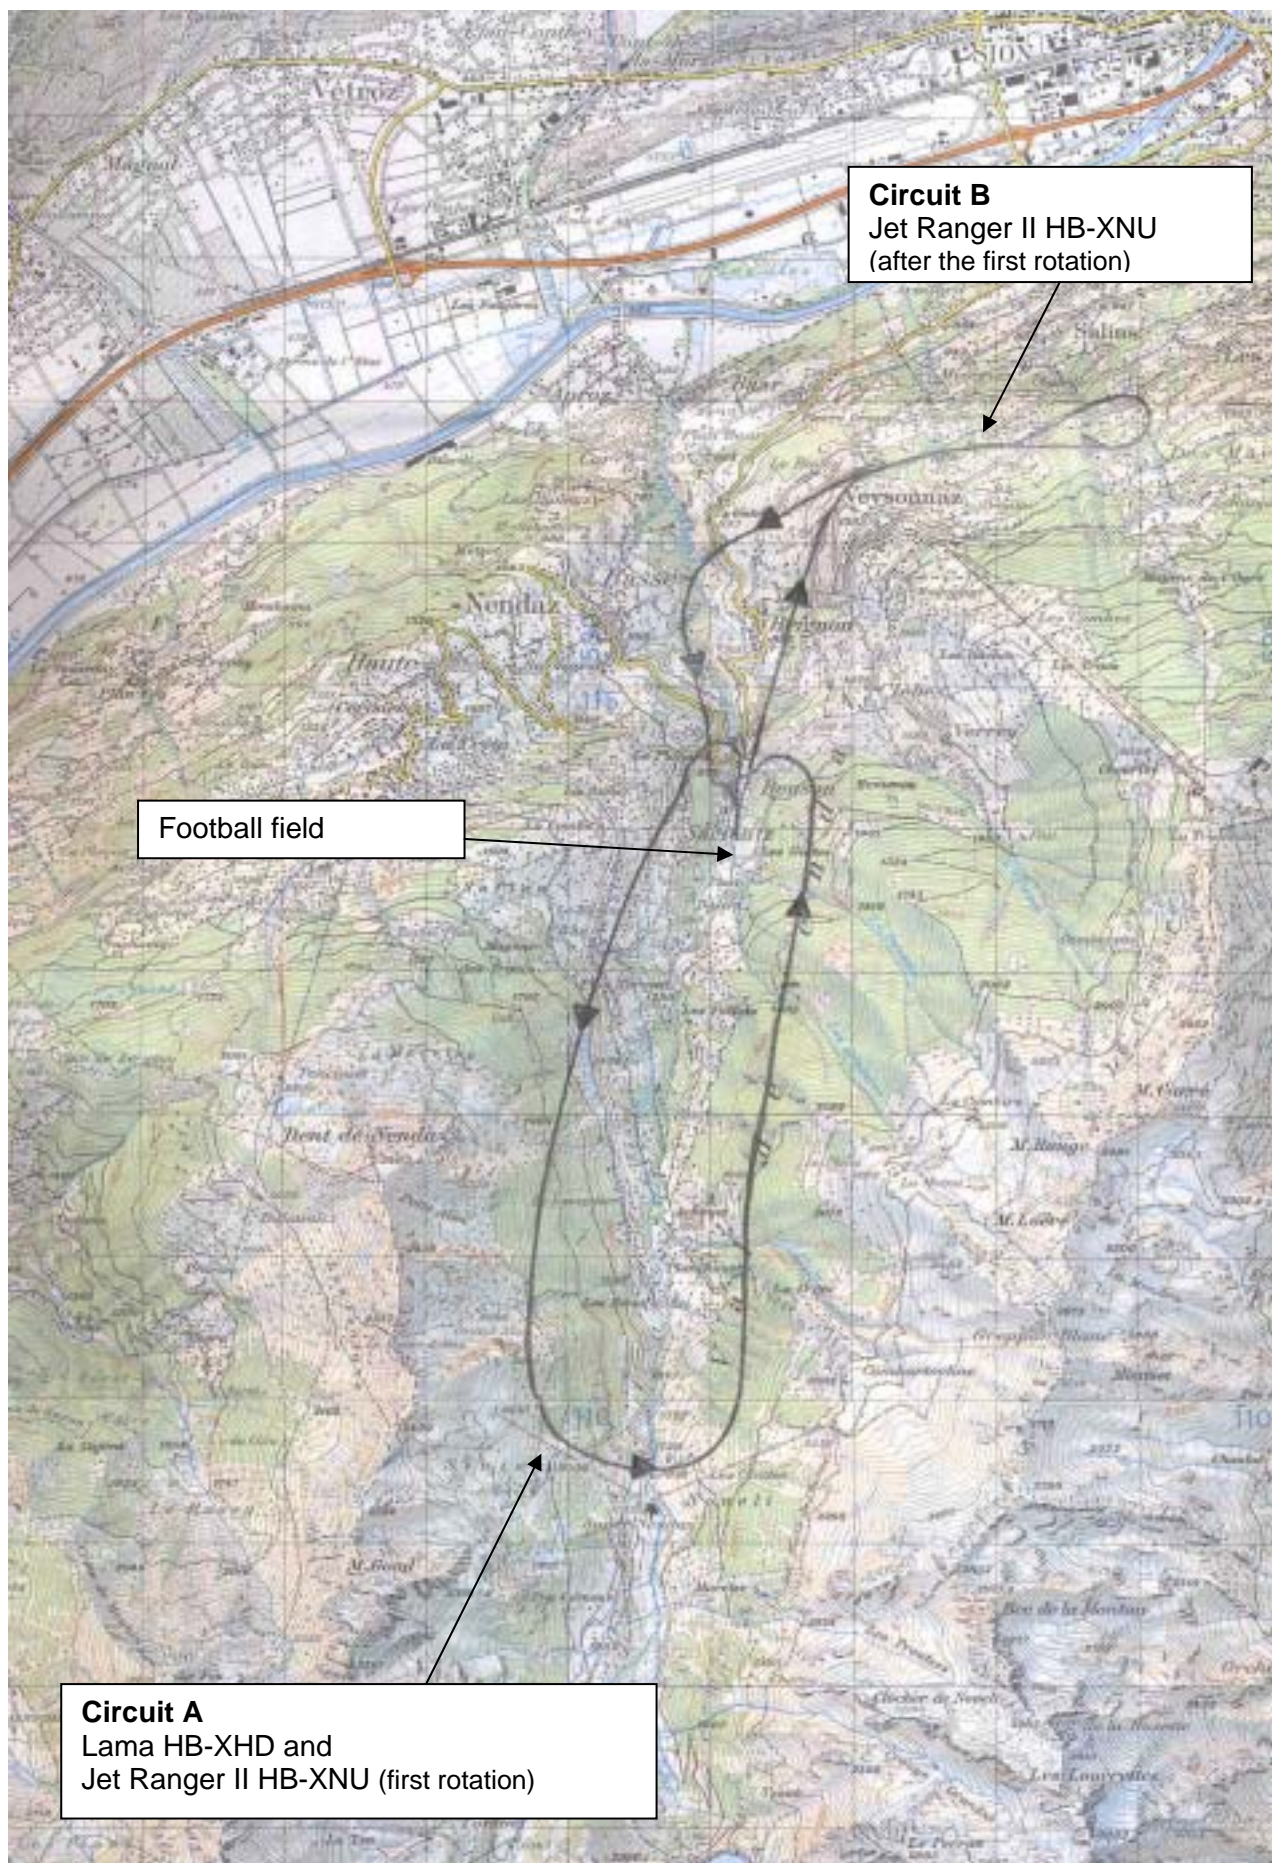
Circuits traversed by the helicopters Lama HB-XHD and Jet Ranger II HB-XNU

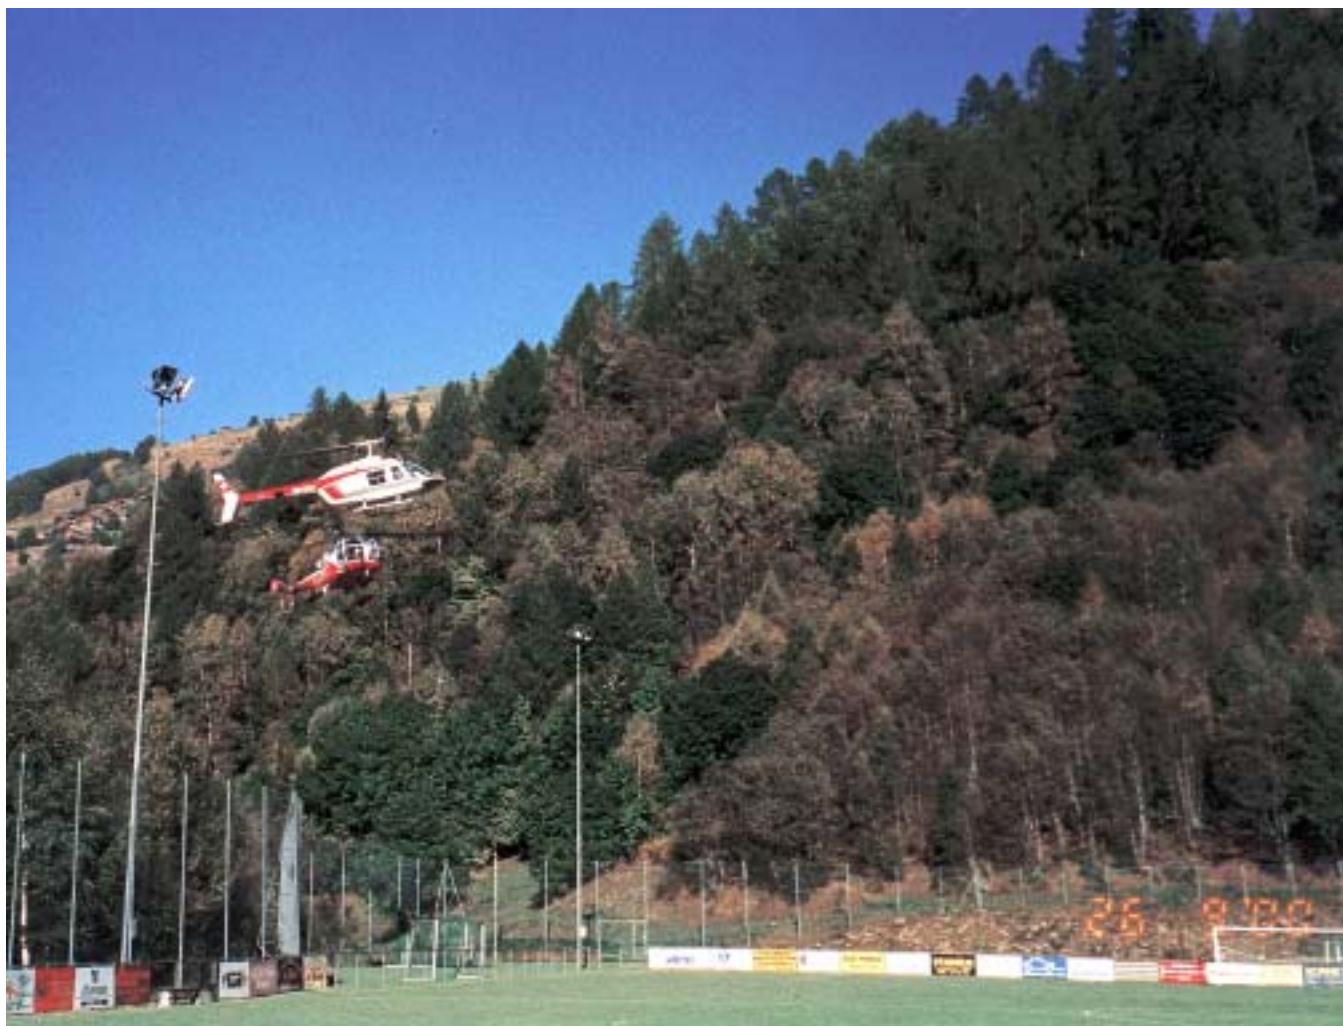
Position of both helicopters immediately before the collision.

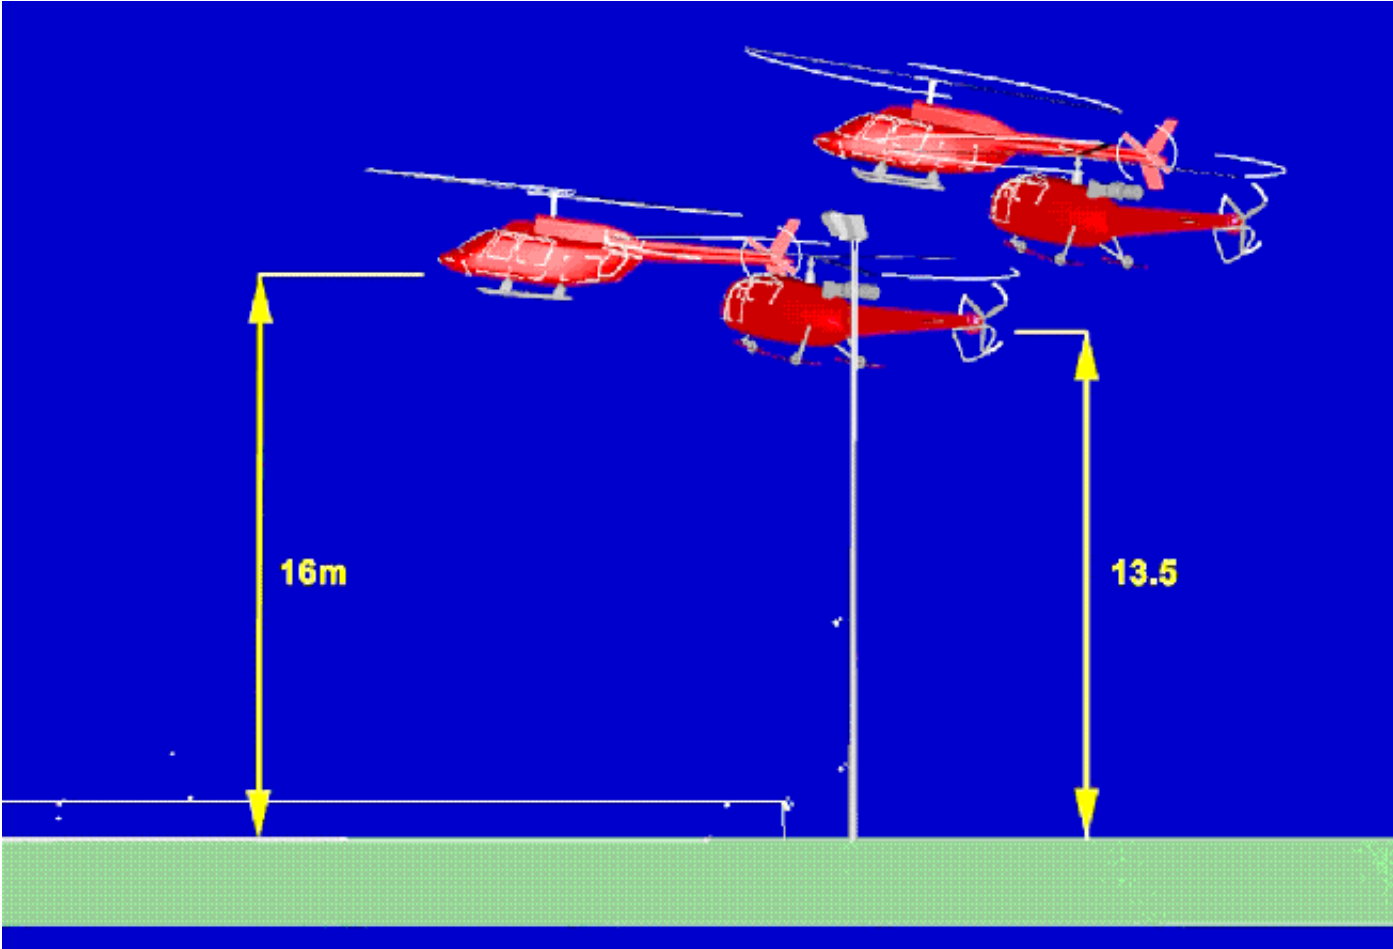
Respective height of both helicopters at the time of the collision.

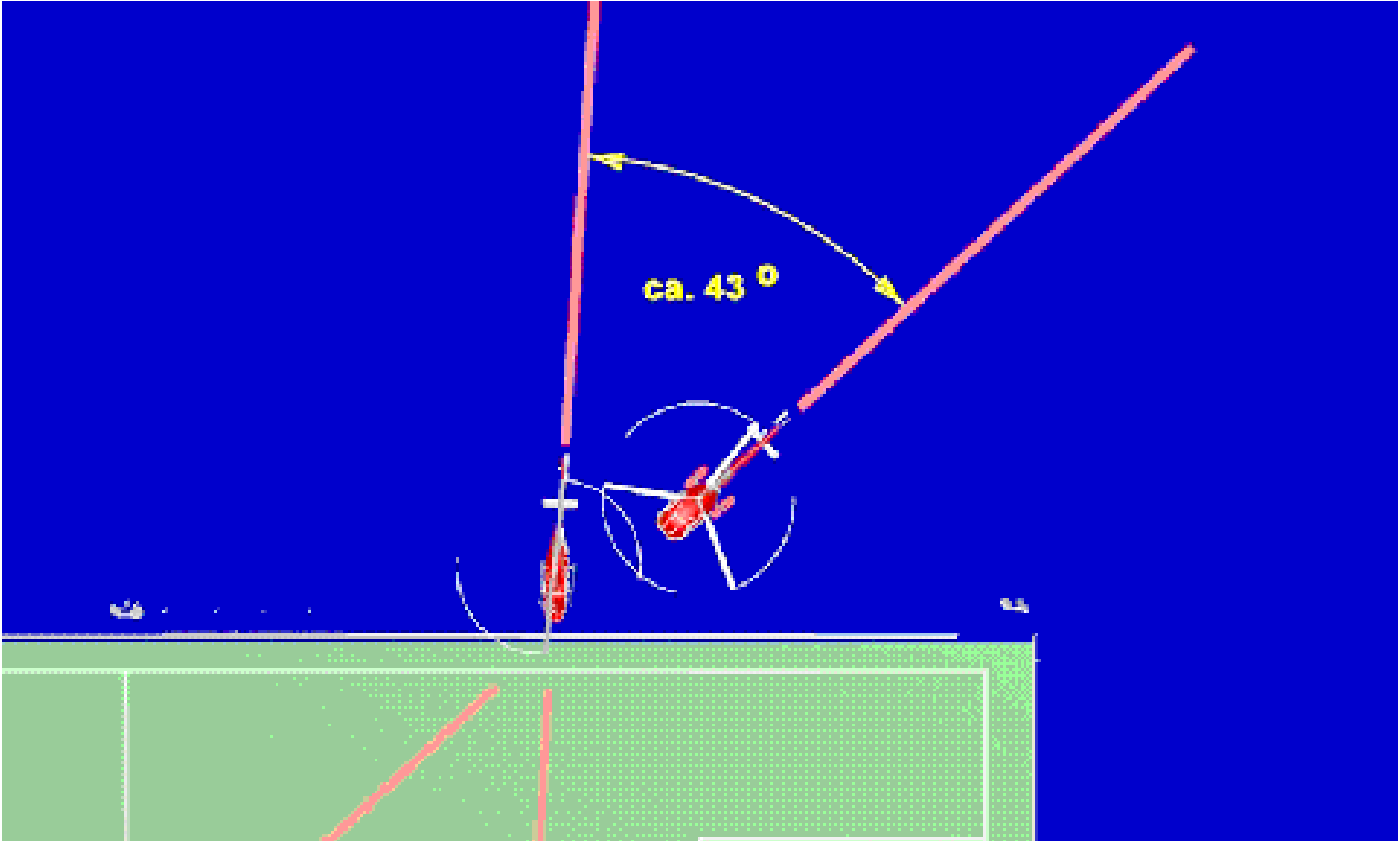
Angle of convergent flight path followed by the helicopters HB-XJR and HB-XNU.

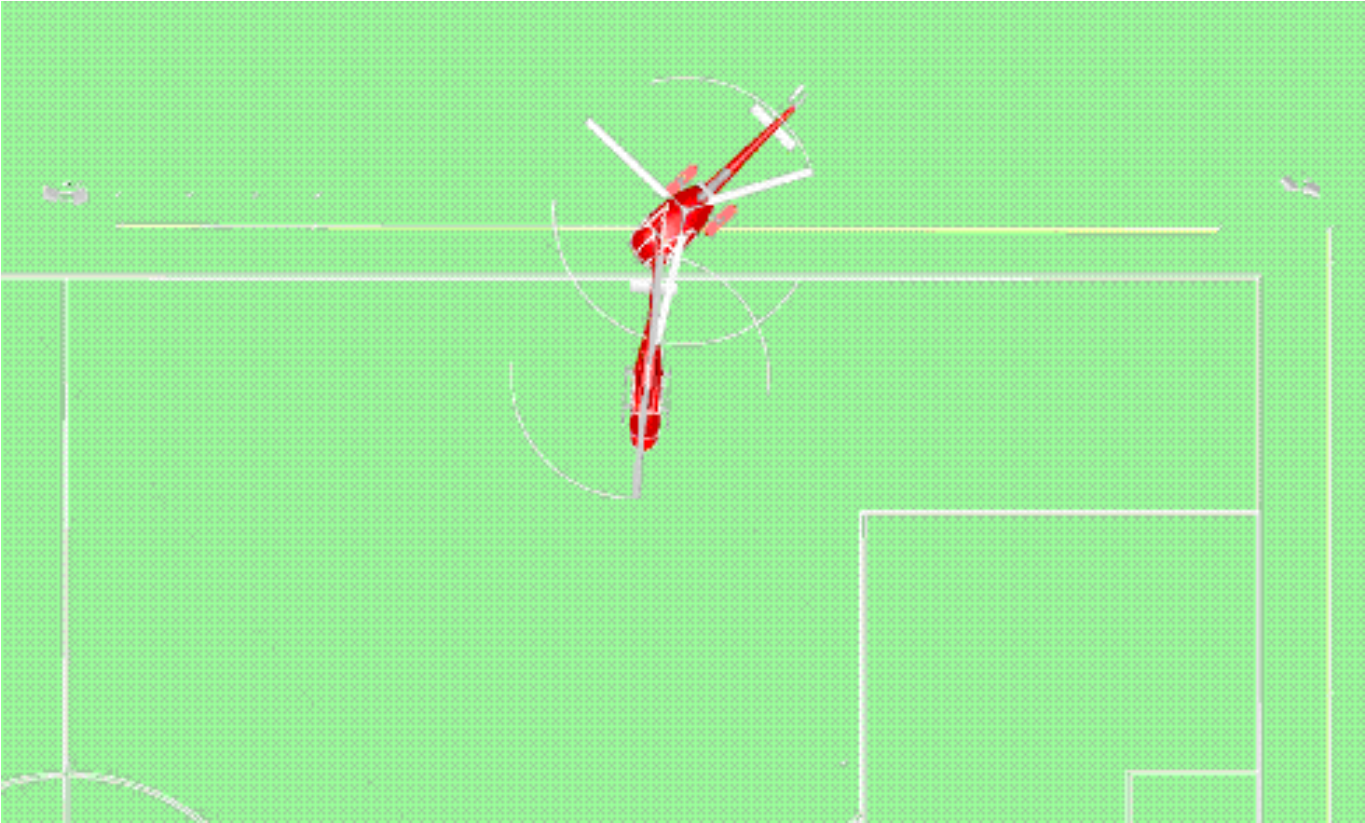
Location of the collision (north boundary of football field).

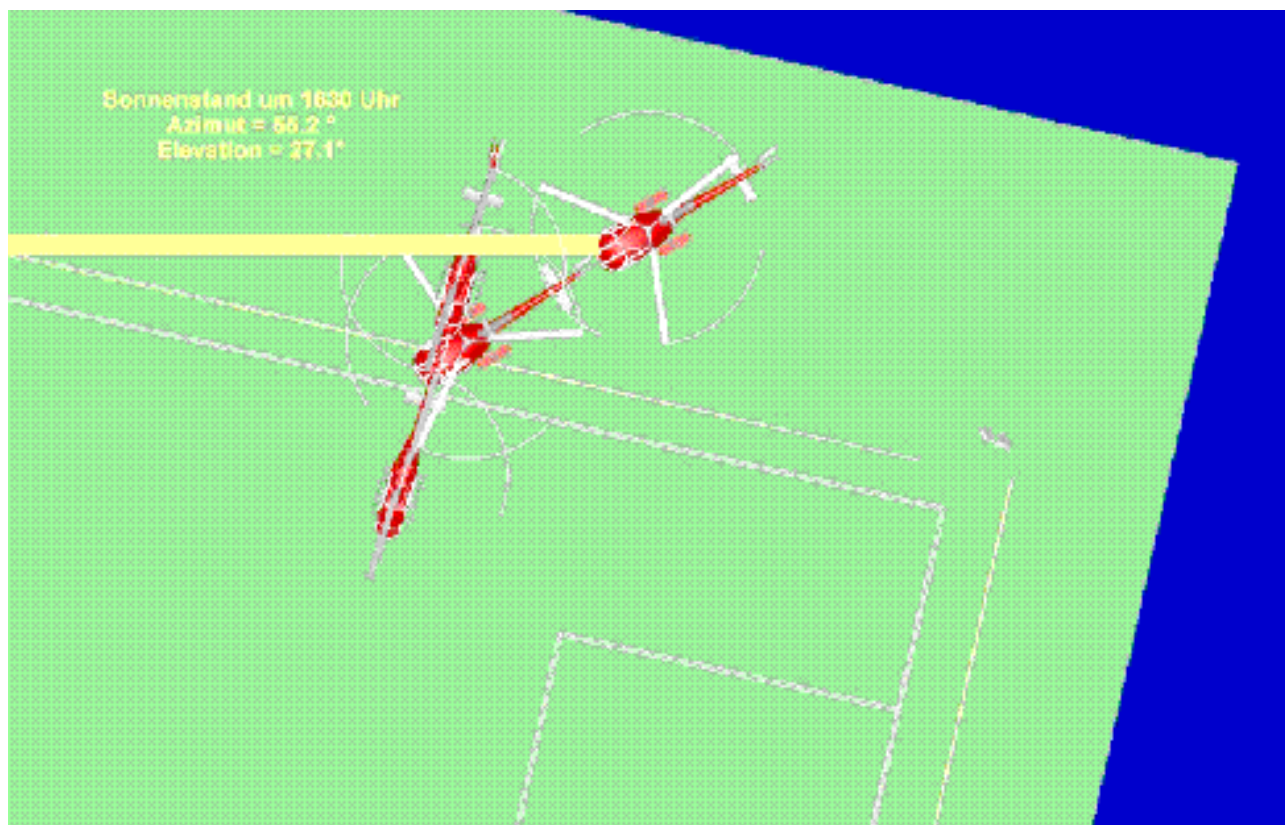
The video sequence recorded in the course of the approach demonstrates that the pilot of the Alouette III HB-XJR was calm and that his concentration was directed at the landing area. In addition, it shows that he was wearing sunglasses and that the position of the sun dazzled him on the right-hand side; this may have prevented visual contact with the Jet Ranger II HB-XNU.

Position of the sun for the pilot of the Alouette III HB-XJR.

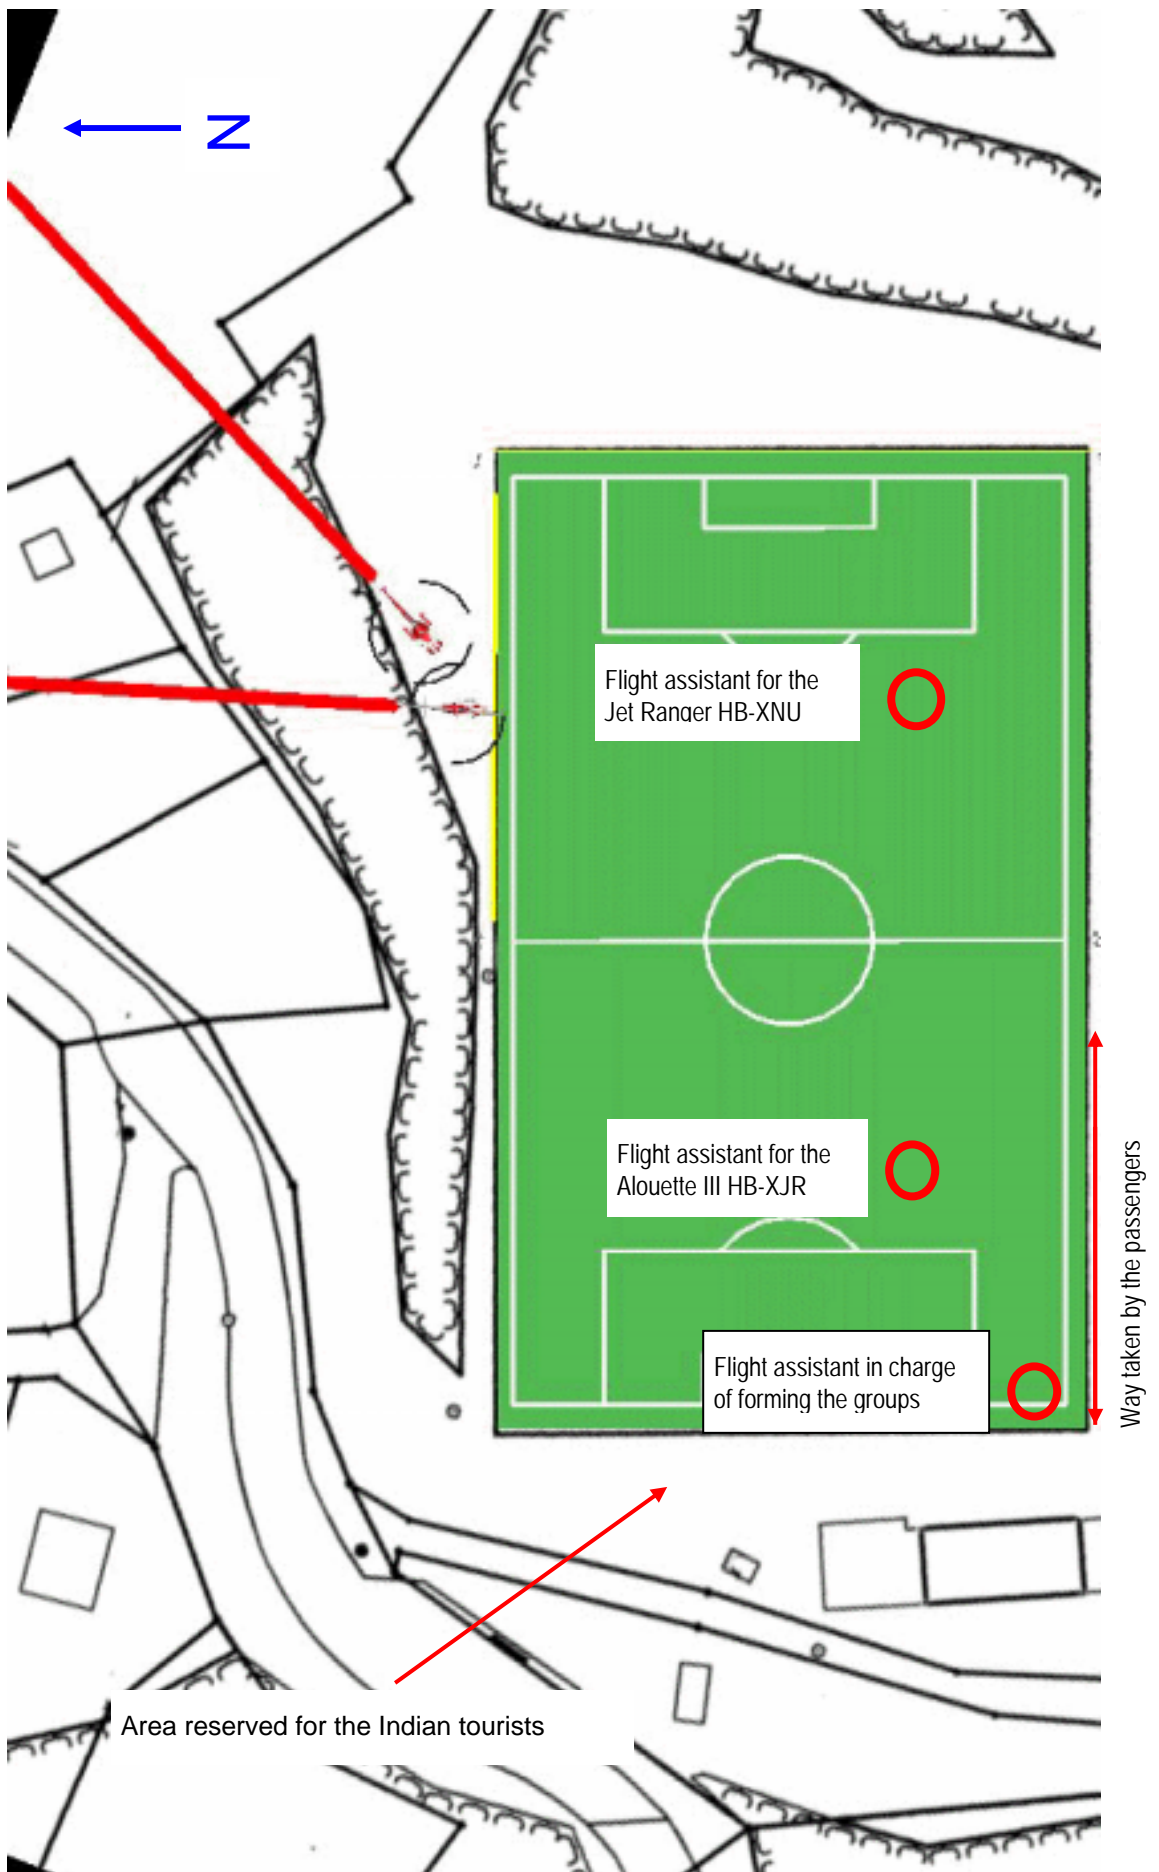
Position of the flight assistants and area reserved for the passengers
