Final Report of the Aircraft Accident Investigation Bureau

concerning the incident

of the airplane Mc Donnell Douglas DC-9-83, HB-IUM
on 5 June 2000
at Geneva Airport

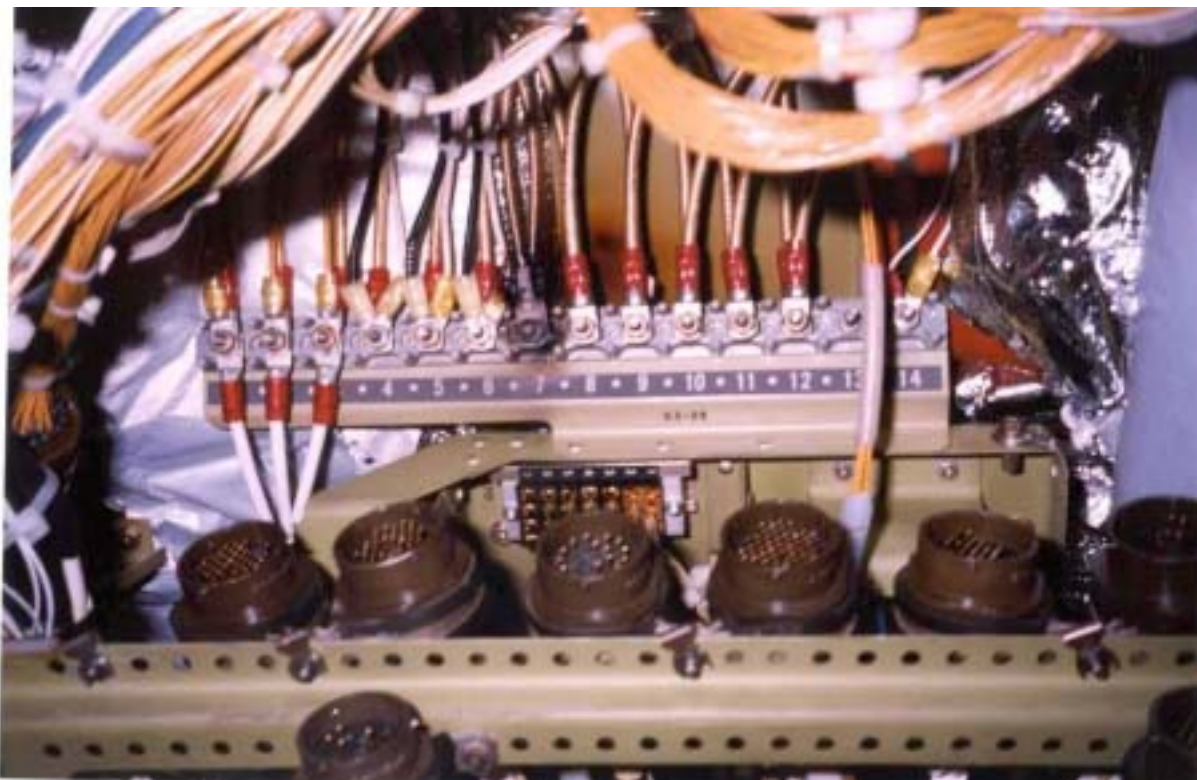
Fig. 1 Terminal Board S3-25 in situ

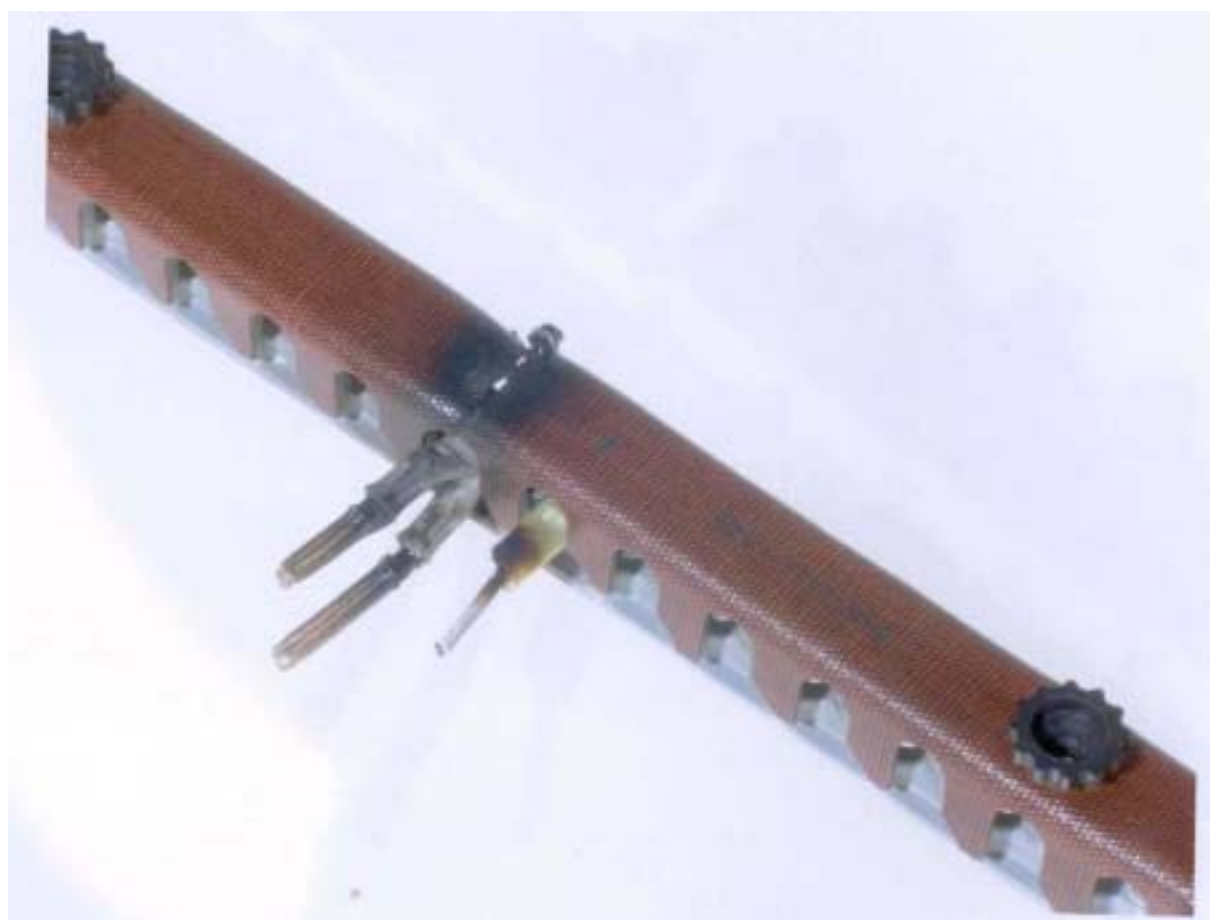
The analysis of the protection cover and wire pieces is stating an increase of temperature due to an insufficient pressure between the terminals. The temperature may have increased to between 800° C and 1000° C. No arcing was observed. The damage to the protection cover and the proximity cable terminal are to be considered as secondary damage.

The incident was caused by an increased electrical resistance due to an insufficient pressure between the terminals on contact 7 of the terminal board assy S3-25.

Fig. 2 Terminal Board with heat damage

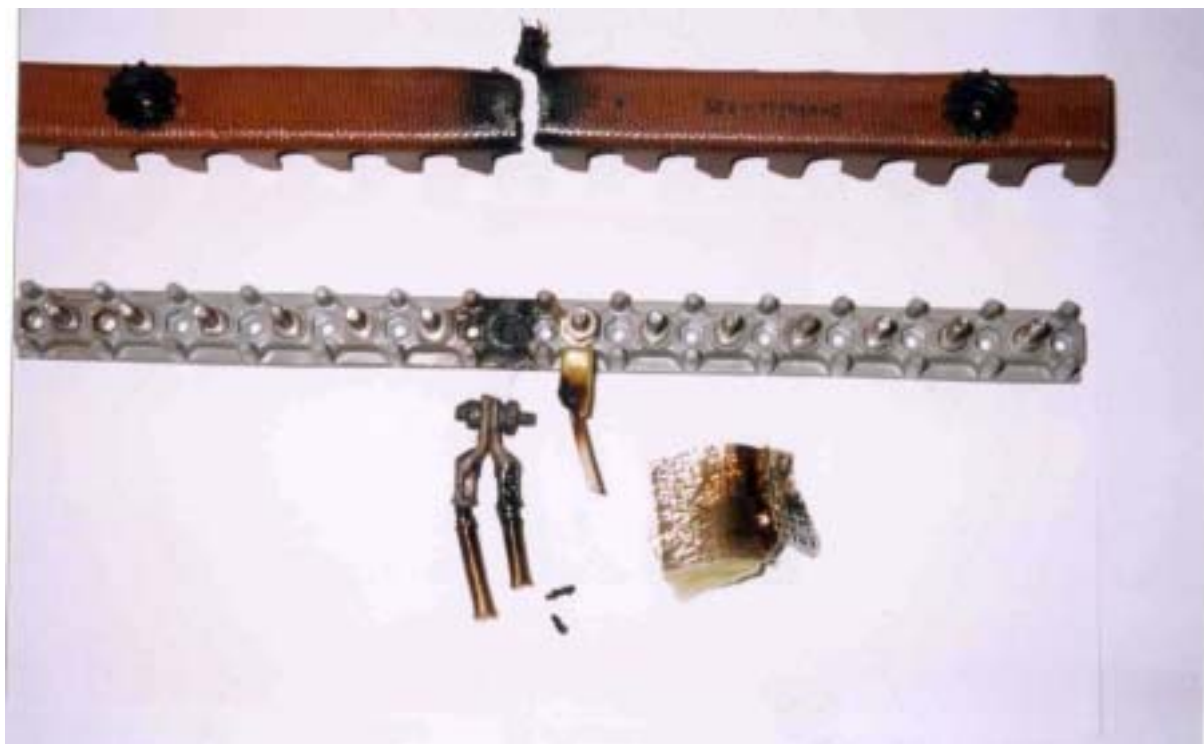
- All crew members held licences.
- The aircraft had no story of smell or smoke.
- The aircraft had undergone a D- and C3- check in December 1999 at Shannon Aerospace together with a modification package.
- After opening the necessary access panels, at STA 218, a burned contact on the terminal board assy S3-25 was located (Fig. 1).
- The terminal board assy and the associated, burned terminals were removed for investigation.
- The terminal Nr. 7 of the terminal board assy P/N MS27212-6-14 showed extensive heat damage (Fig.2).
- The connection between wire and contact did not show thermal damage and had a firm seat.
- The terminals of the attached cables H735L8C and H735M8C showed extensive heat traces (Fig. 3).

Fig. 3 Terminals with overheated connection

If properly torqued and the lock washer in good condition, the connection should remain firm.
