Final Report Nr. 1789 of the Federal Aircraft Accident Board

concerning the incident (Airprox)

CRX 3443 / RMC 2032

on 18 February 2002

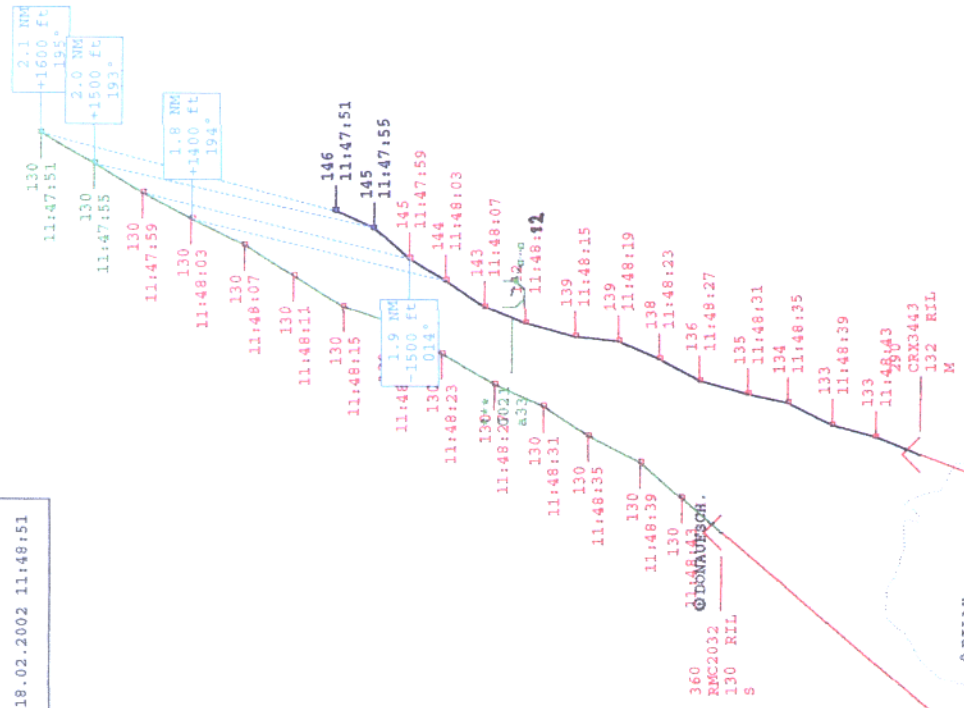
Analysis: ATIR CRX3443 18.2.2002 Time [UTC]: 18.02.2002 11:48:51

During this critical phase, the two aircraft approached each other to within a lateral separation of 0.6 NM and a simultaneous altitude difference of 200 FT.
