# **Final Report** **by the Aircraft Accident** **Investigation Bureau**

**on the collision on the ground between**

Crossair AG AVRO RJ100, HB-IYX

TAM, Brazilian Airlines Airbus A330-200, PT-MVB

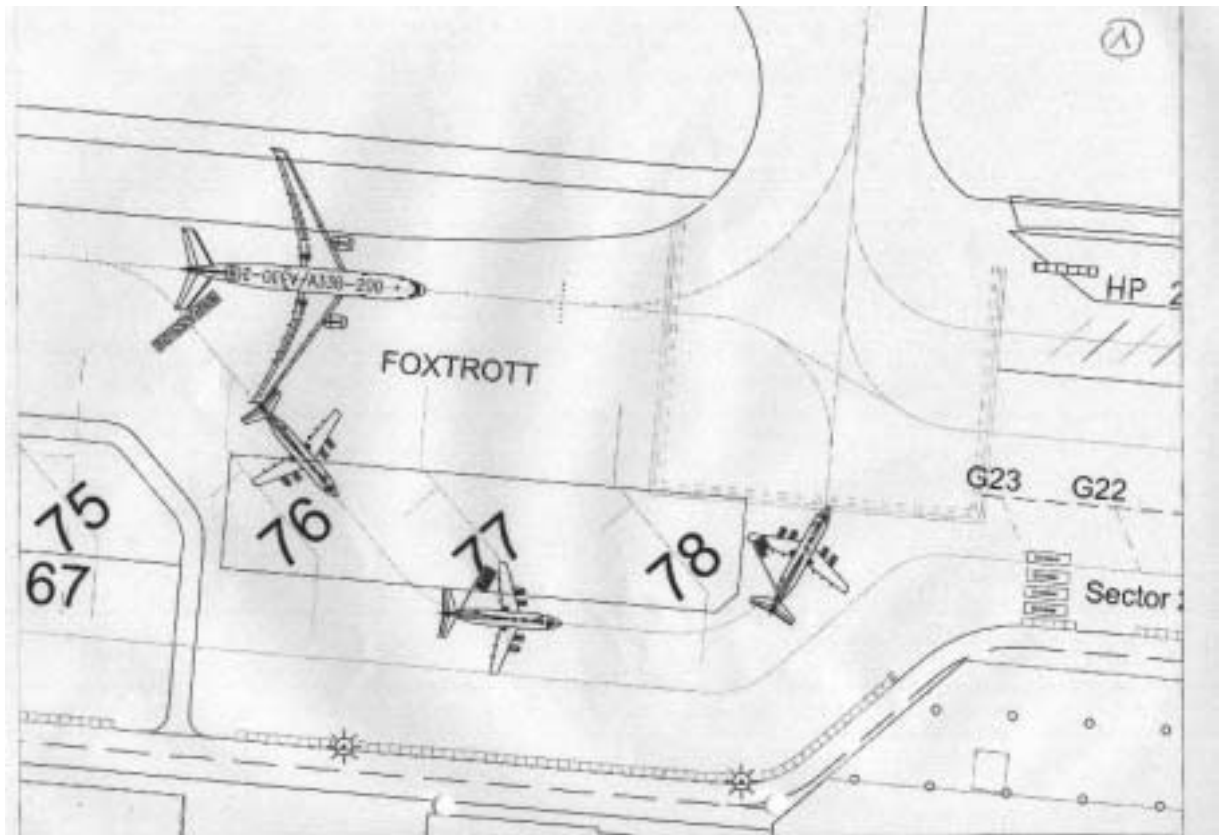
Appendix 1

The collision occurred because the crew of the taxiing TAM8071 did not realise that CRX874 was stationary on the right of their taxiway and had not yet taxied completely into the standby for de-icing position and that the space available was not sufficient for an aircraft of the size of an A330-200 to pass.

Sketch simulation collision A330-200 vs AVRO RJ100
