**Final Report
of the Aircraft Accident
Investigation Bureau**

concerning the incident (Airprox)

between AFR222J and DLH5431

on 16th July 2002

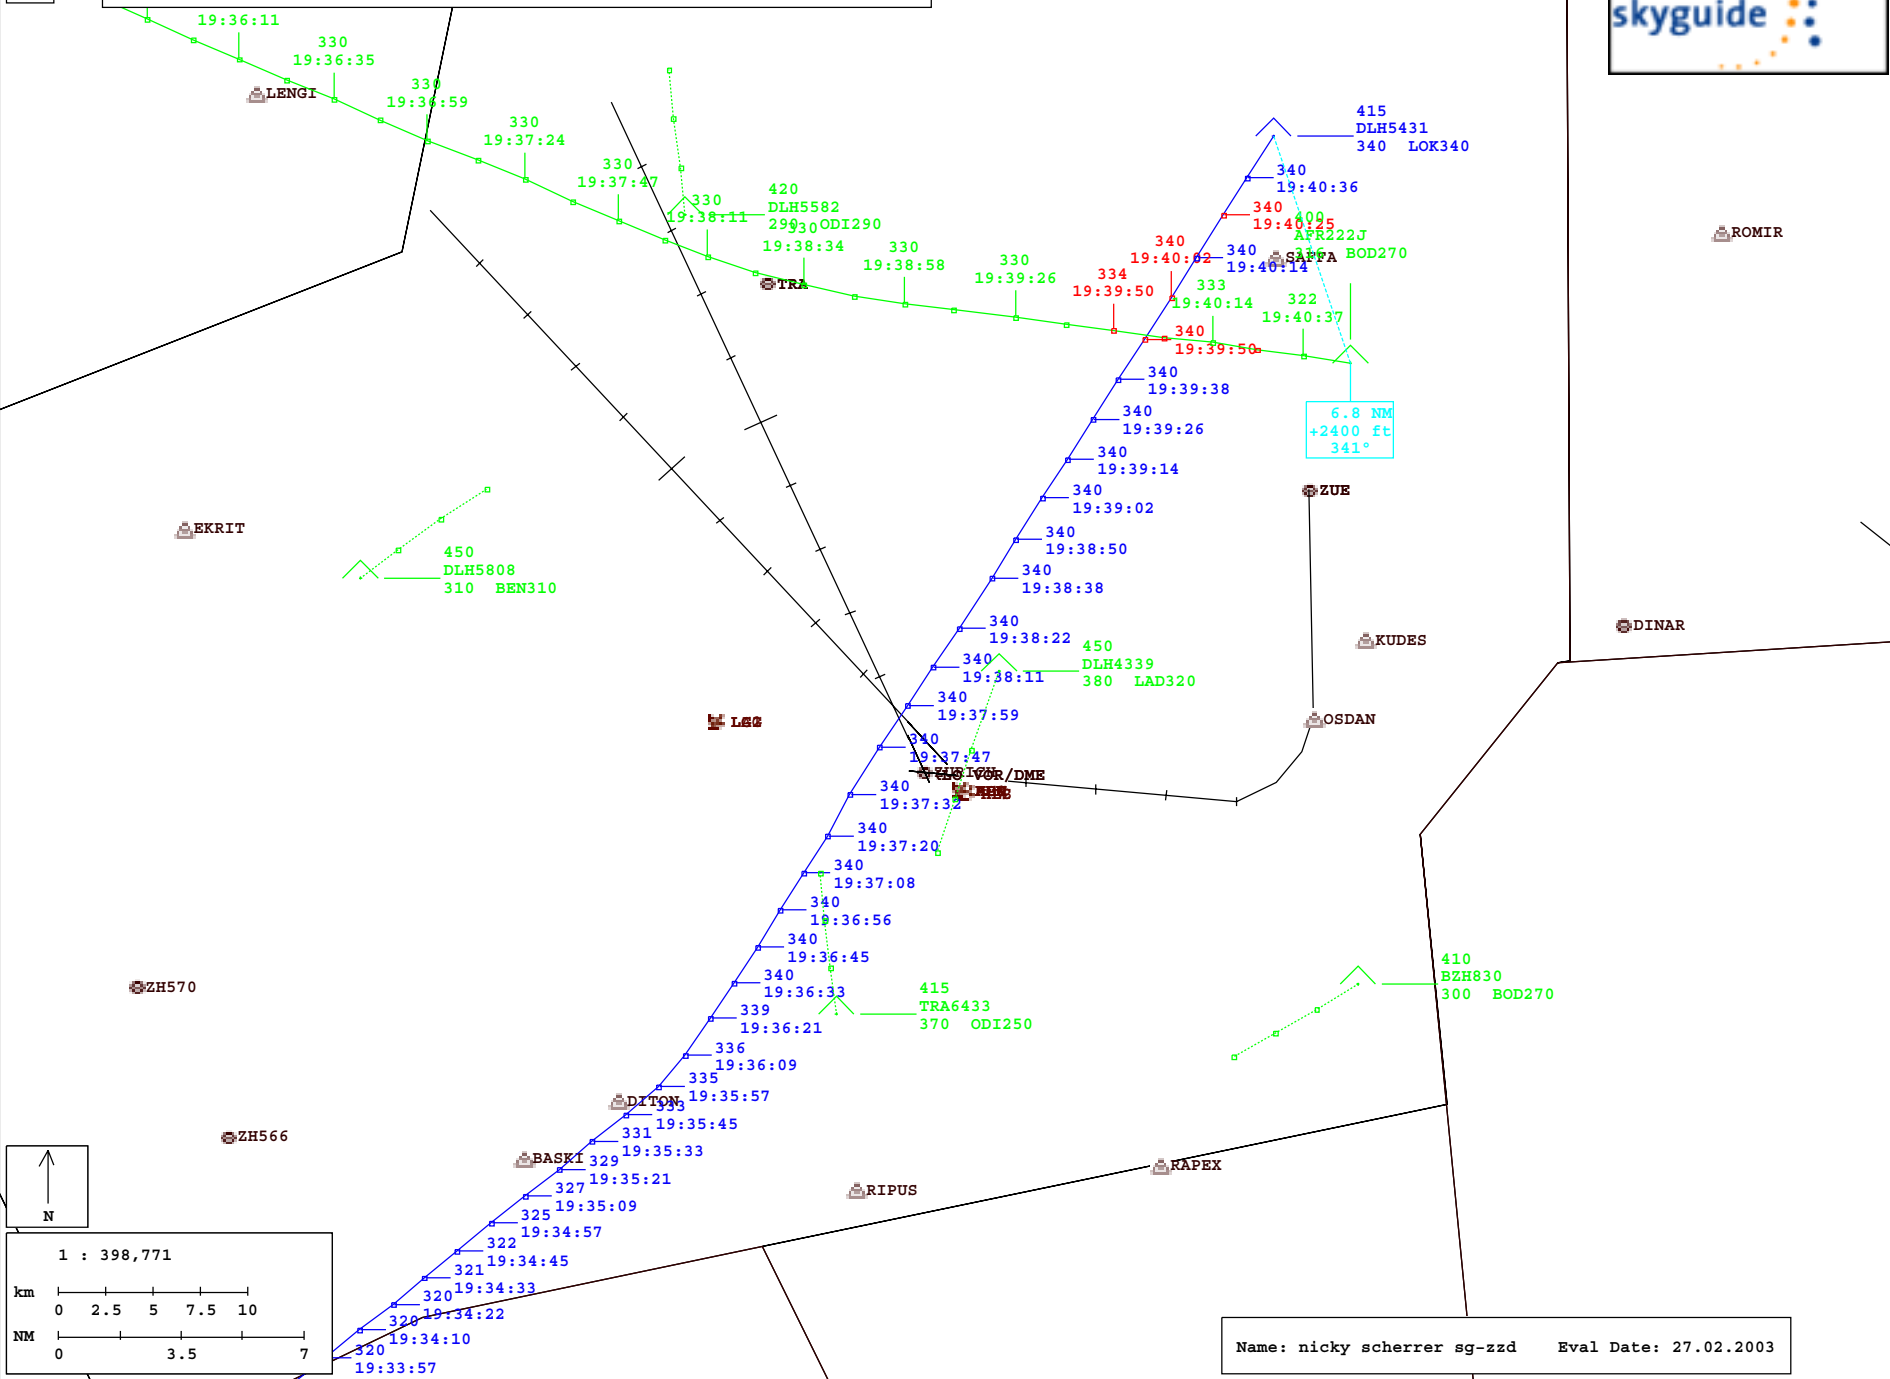
Src ACN Analysis: airprox afr222j of july 16, 2002 Time [UTC]: 16.07.2002 19:40:54

As a result of the sequence of events described, there occurred a distinct violation of separation rules; according to the radar plot, the two aircraft approached as close as 0.6 NM; with a simultaneous altitude difference of 600 FT. Since the radar plot available shows a point in time about 1.5 s before the closest approach, the actual violation was probably even more serious, at least in terms of lateral separation.

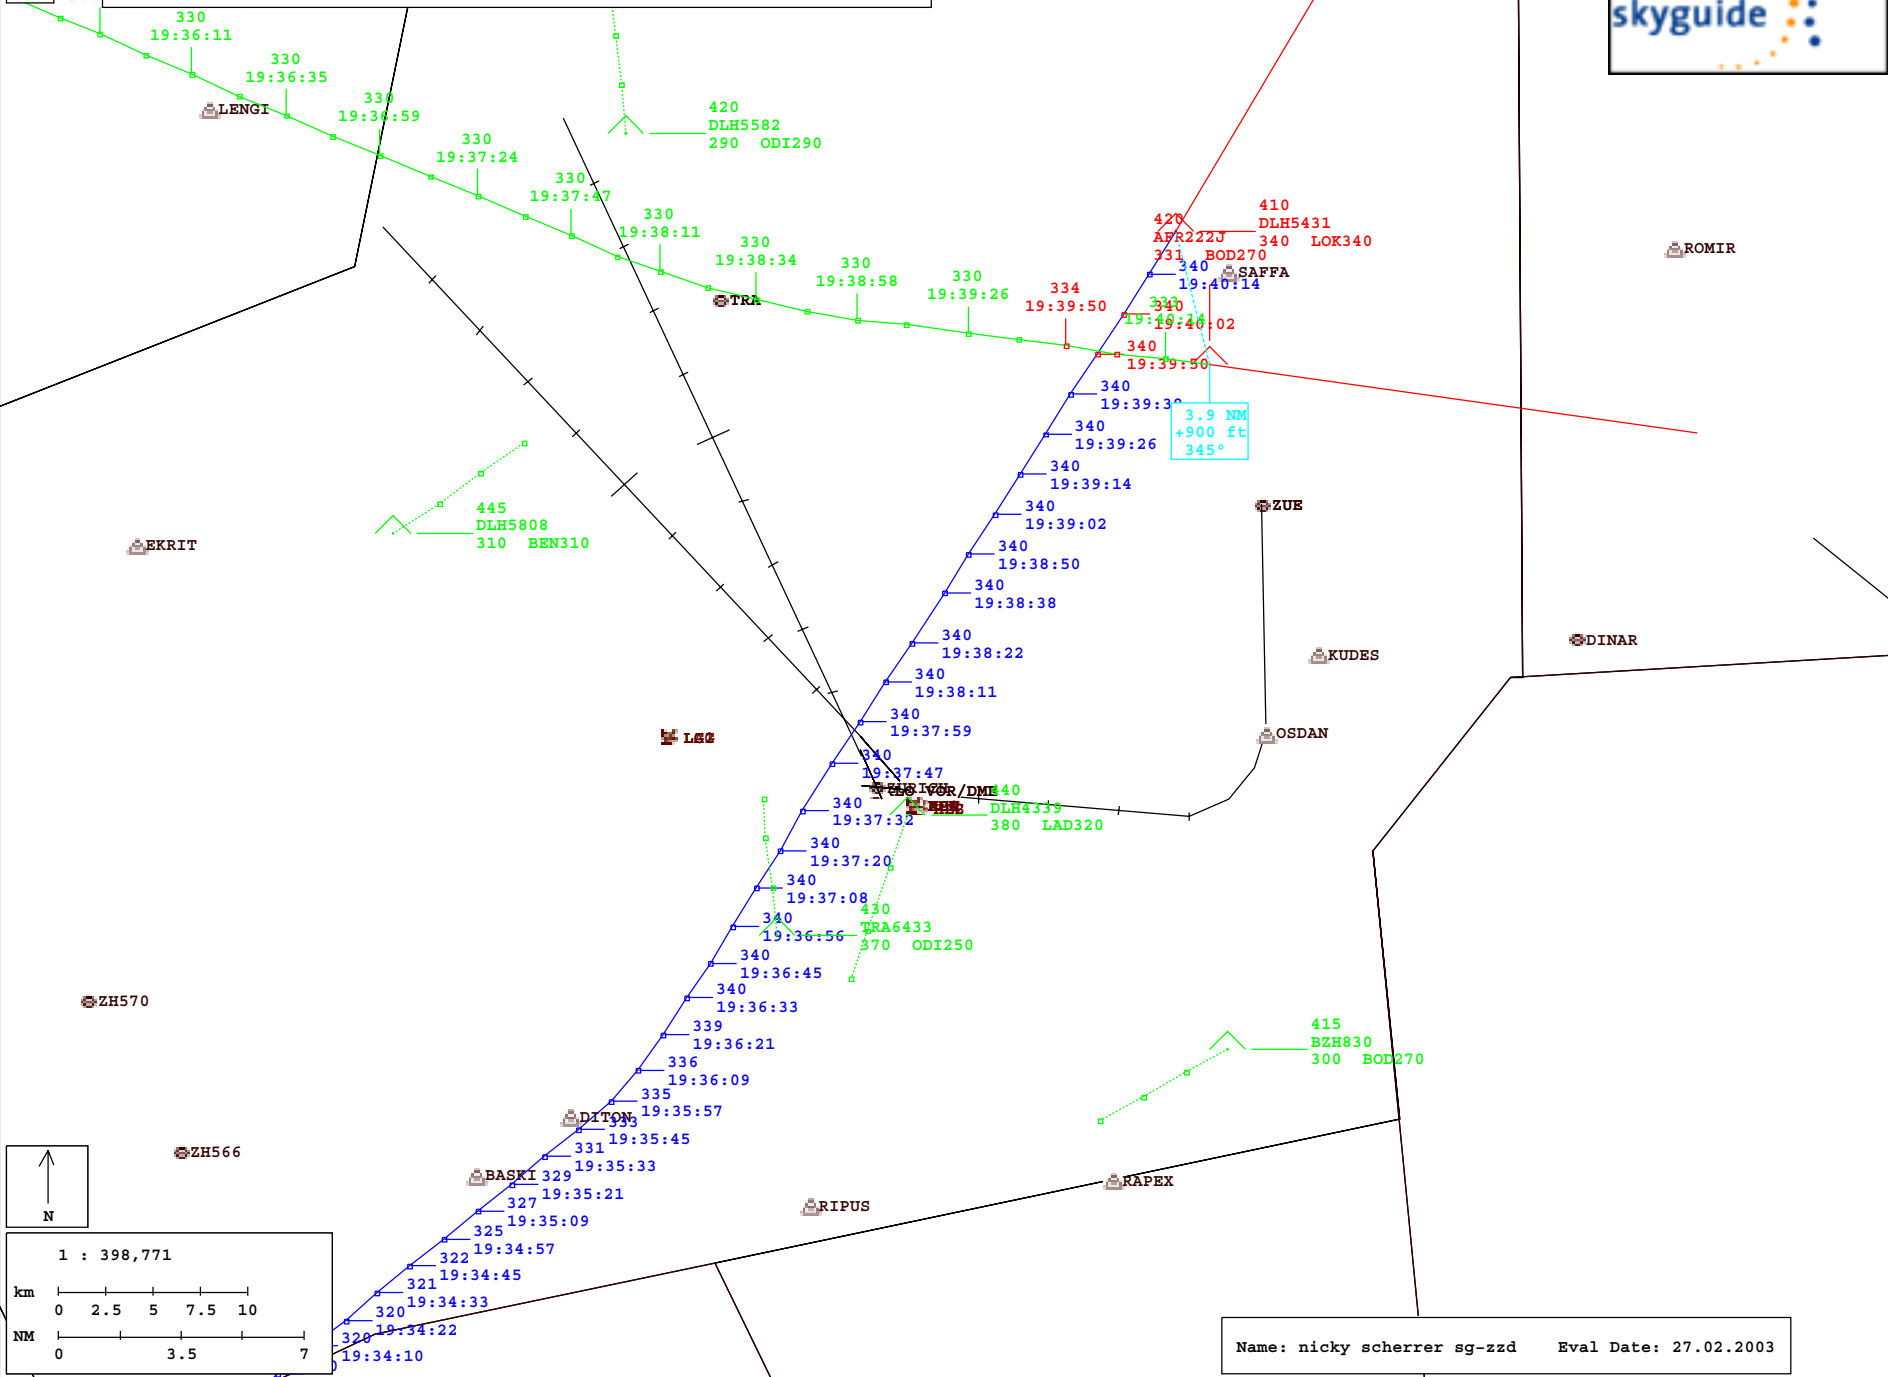
Src ACN 33
 Analysis: airprox afr222j of july 16, 2002 Time [UTC]: 16.07.2002 19:40:30

- AFR222J correctly confirmed the clearance to descend to FL 310 and the frequency change to Upper 1 Sector.
- At 19:39:38, 40 seconds after AFR222J had received clearance to descend to FL 310, the radar plot shows this aircraft at FL 332 and it was about 2.5 NM from the crossing point with the Lufthansa aircraft. Twelve seconds later the AFR222J shows FL 334 according to the radar plot and the Air France aircraft was just before the crossing point.
