Final Report of the Aircraft Accident Investigation Bureau

of the airplane Airbus A321-111, HB-IOC
on 20 February 2001
at Geneva Airport

FINAL REPORT

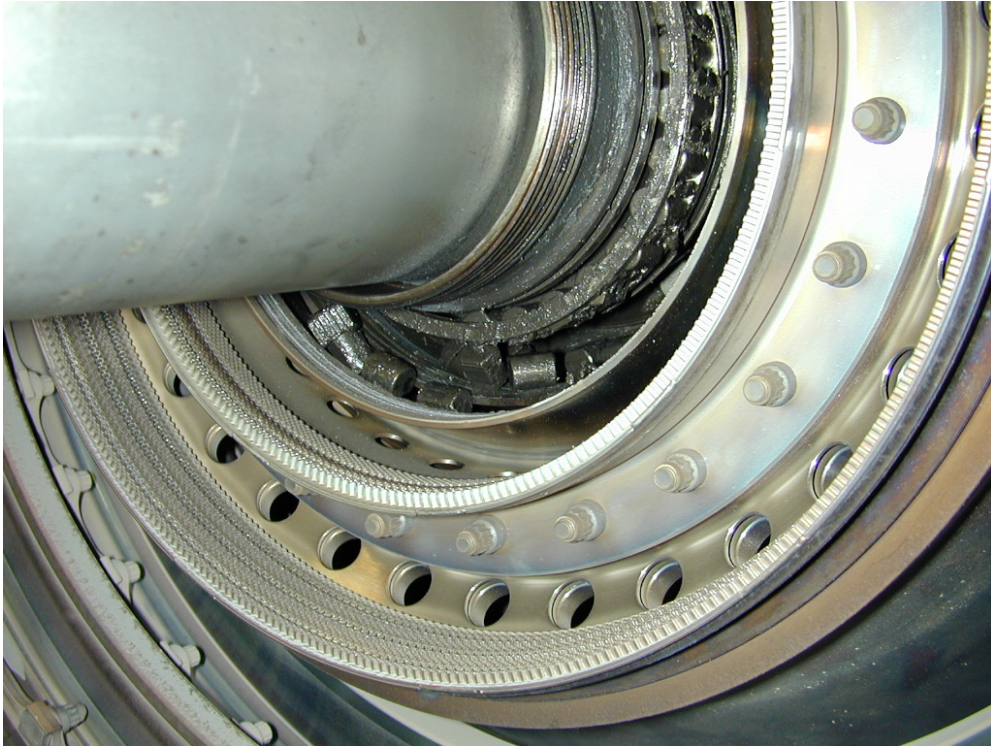
Fig. 1 Engine view Bearing 4

- The engine was removed for investigation. Disassembly started with presence of BFU representative and confirmed a defective bearing No. 4.

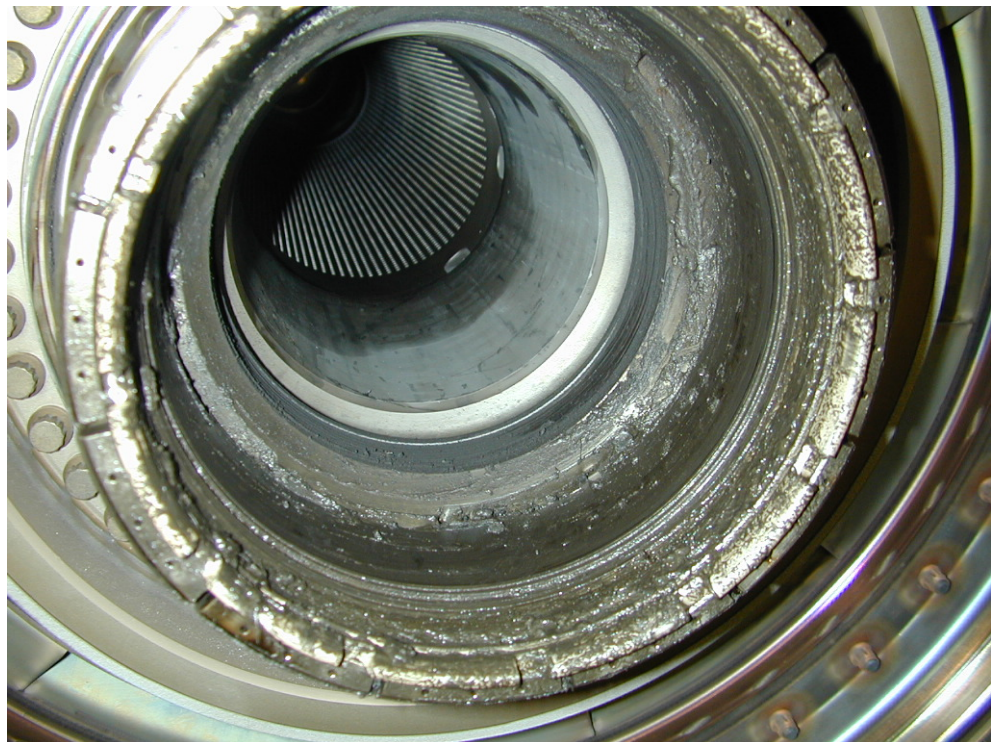
Fig. 2 Bearing No 4 Outer race

The incident was the result of the failure of Bearing No. 4 during the Flight from LHR to GVA. Despite the fact, that some days earlier, the engine #2 had showed a popped out chip detector indicator in BRU, there is no relation to the incident of 20 February 2001. The material removed after this incident has been analyzed and did not show Bearing material as used on Bearing No.4.

The incident was caused by the failure of bearing No. 4 of the engine #2 with resulting damage to the HPT blade tips.

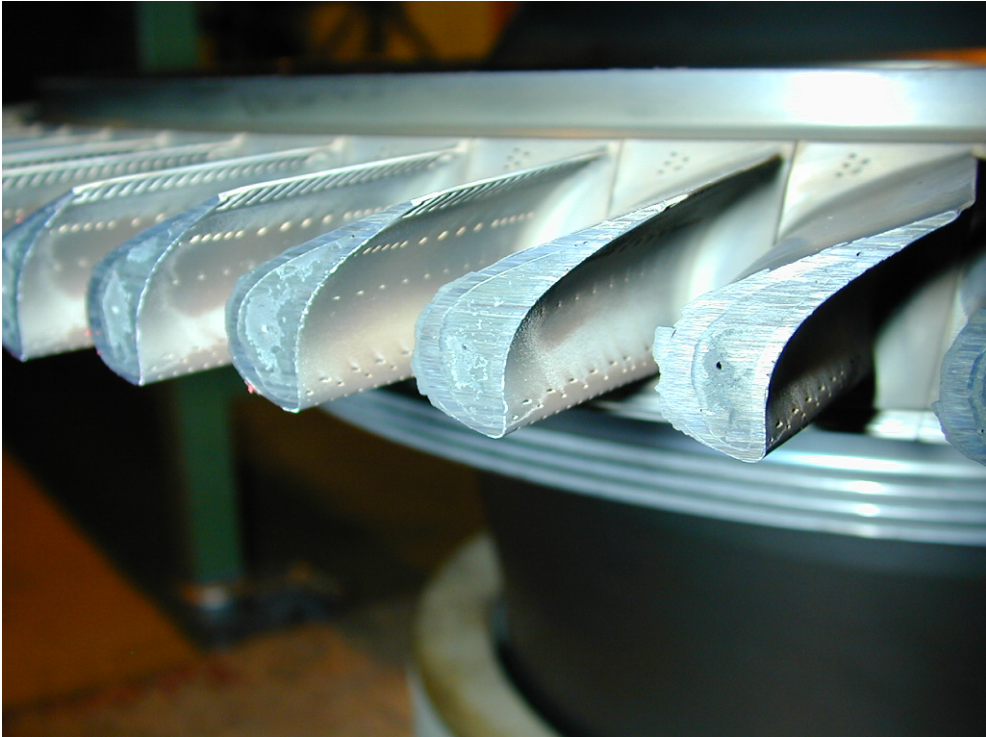
- The aircraft was landed by the CDR, which took over control as the vibrations got stronger.
- The disrupted gas flow due to the damaged blades and heavily fluctuating pressure P3 let the flame move back into the exhaust zone, where unburned fuel from the not properly working engine was ignited and was visible as fire.

Fig. 4 Damaged blade tips
