**Final Report
by the Aircraft Accident
Investigation Bureau**

concerning the incident

of the airplane Embraer EMB 145 LU, HB-JAT
on 20 August 2002
at Zurich Airport

FINAL REPORT

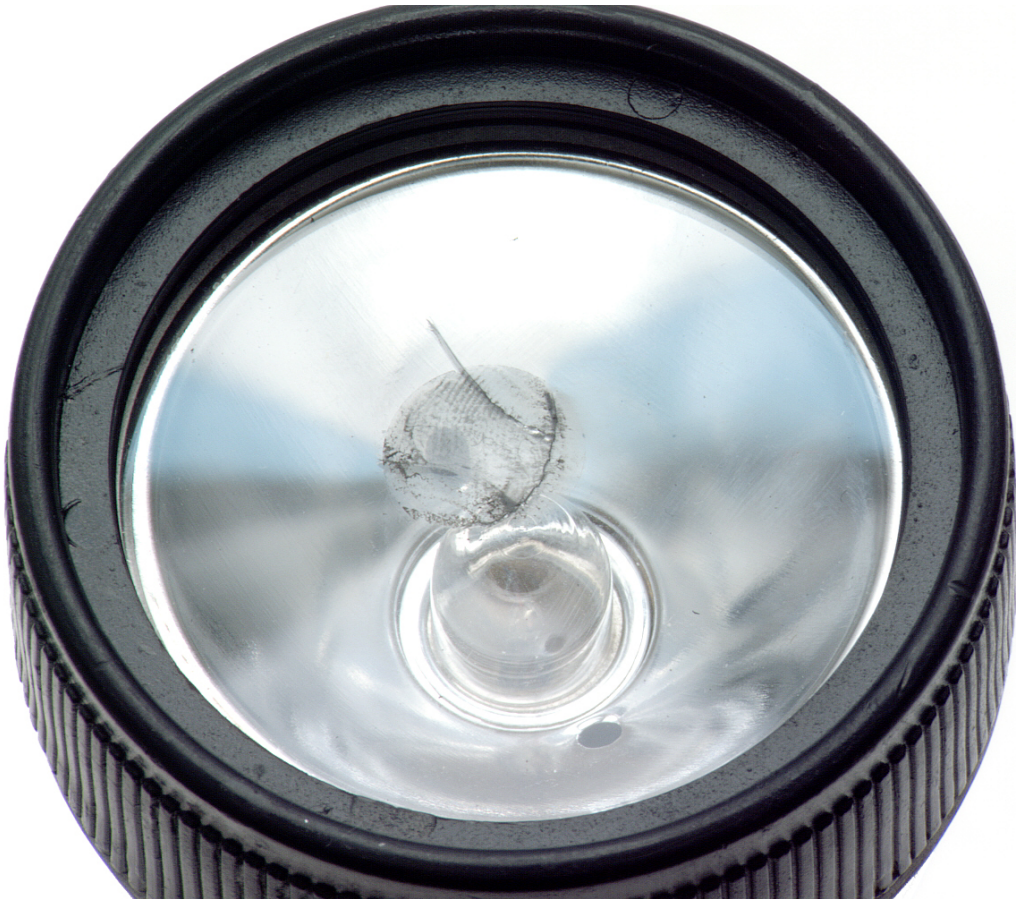
- The removed lamp sowed heat signs on the lens and at the upper cover of the lamp holder.
- The DME corporation has issued a SERVICE INFORMATION LETTER Y2-01-0022 addressing the problem of melted components of it's EF-2C lamps. It was proposed to use a bulb of a lower intensity (P/N A1-14-0001-002), which would create less heat than the originally used bulb (P/N A1-14-0002-002).

When the lamp was stored in the holder after use without being switched "OFF" it would remain lit and would heat up the lens. As the heat is restricted by the top cover of the holder it is unable to escape.

Normally the battery would be depleted after a certain time or at least be discharged to a lower voltage. Through the installed recharging circuit the time of full bright light is extended and the lens and cover heated up more and for longer time. Therefore the lens and cover were starting to melt and started developing on acrid odour which was interpreted by the crew as "electric smell".

The torch lamp was examined. It was confirmed that a temperature of 230°C is reached under these circumstances. At this temperature, a plastic smell was observed. Already at a temperature of 200°C the plastic of the lens and the holder start to melt and become viscous.

The incident was caused by an overheated RH torchlight, which has inadvertently remained switched on when placed in its recharging bracket.

Fig. 1 Lens of Torch lamps with melted plastic

The engineering of the operator proposed to drill a hole in the upper cover of the holder. Thereby the heat will not be trapped between the lens and the cover of the holder and also the crew will see the light shine through the top of the holder if the lamp has not been turned off.

This modification has been carried out on all Torch lamps installed in Embraer 145 cockpits of the operator through an internal service bulletin LX-ER4-33-1.

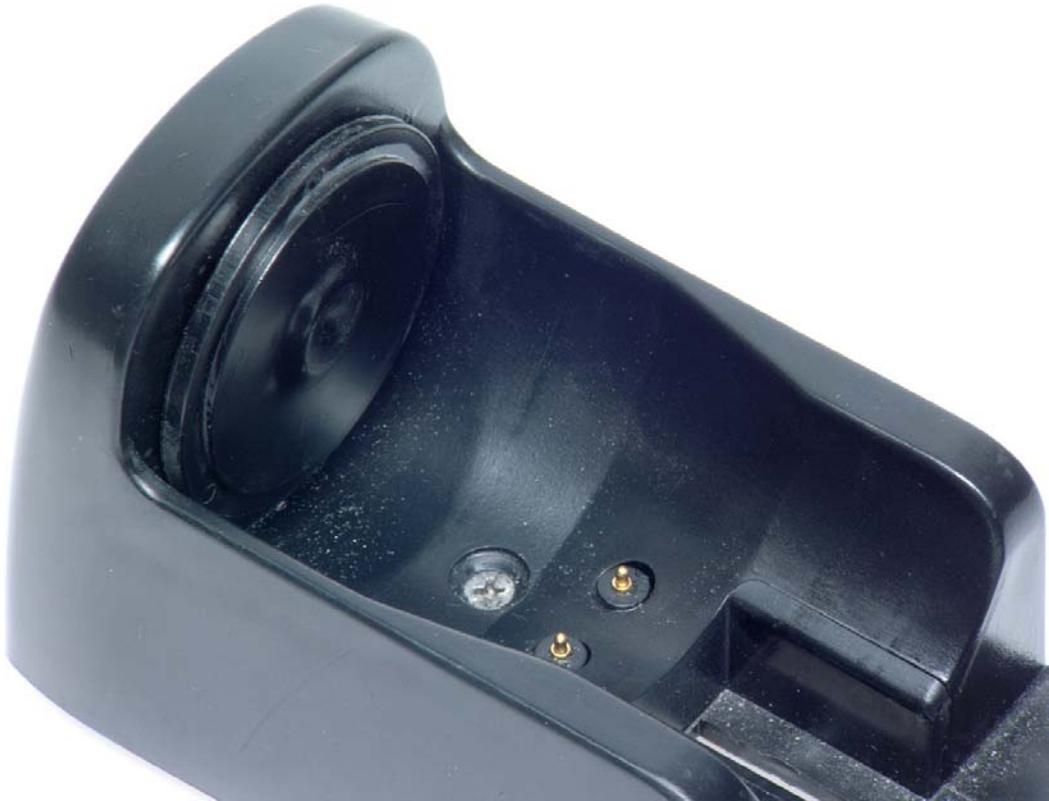
Fig. 2 Top Cover of Torch lamp holder
