# Rapport final No. 1806 de la Commission fédérale sur les accidents d'aviation

de l'hélicoptère MD 500N, HB-ZBI

survenu le 27 octobre 1999

à Sion / VS

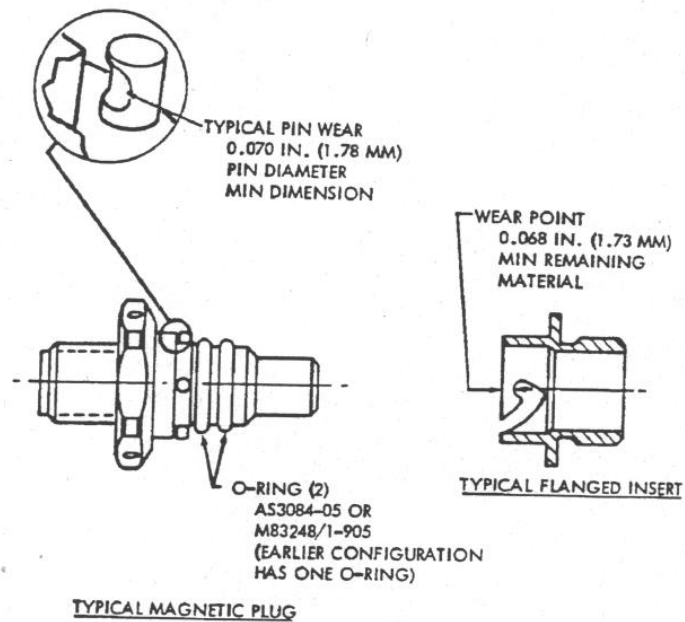
Quick Disconnect Magnetic Plug Wear Limits  
Figure 303

- (a) Inspect the three locking pins for proper condition and wear. The minimum allowable pin diameter on any one pin is 0.070 in. (1.78 mm). The plug should be replaced by a serviceable item if any one or more pins are worn to less than 0.070 in. (1.78 mm) diameter. (See Figure 303.)

- (b) Inspect the insert for proper condition and wear of the locking cam slot. The material remaining between the end of the cam slot and the edge of the insert must be more than 0.068 in. (1.73 mm). (See Figure 303.) Replace the insert with a serviceable item if excessively worn. (Refer to Commercial Engine Bulletin 250-C20R CEB 72-4017 for details of insert replacement.)

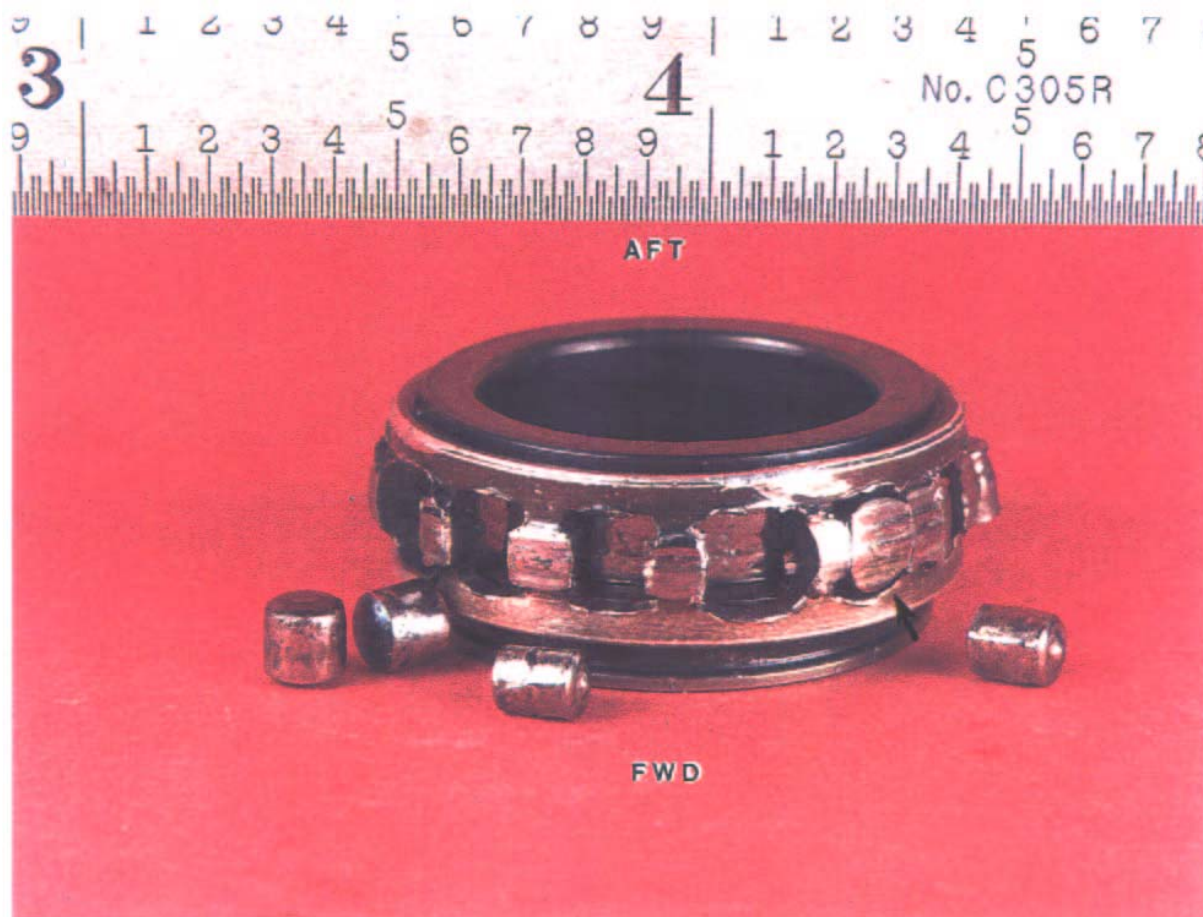
Le roulement # 1 était encore à sa place mais était fortement endommagé. Certes, tous les rouleaux étaient présents mais, au démontage, trois sont tombés du boîtier.

La perte de puissance du moteur a été avant tout provoquée par la forte déformation du roulement # 1. Il s'en est suivi un fort dégagement local de chaleur, à l'origine des dommages secondaires (déformations des stators et de la roue de turbine).

- *The primary cause of the Number 1 Bearing damage was considered to be separator and roller wear.*
- *Considerable microstructural damage due to local heat generation was considered secondary to the damage caused by wear.*

Figure 1. As received condition of No.1 Roller Bearing showing enlarged roller pockets, liberated rollers and heavily deformed roller indicated by arrow.

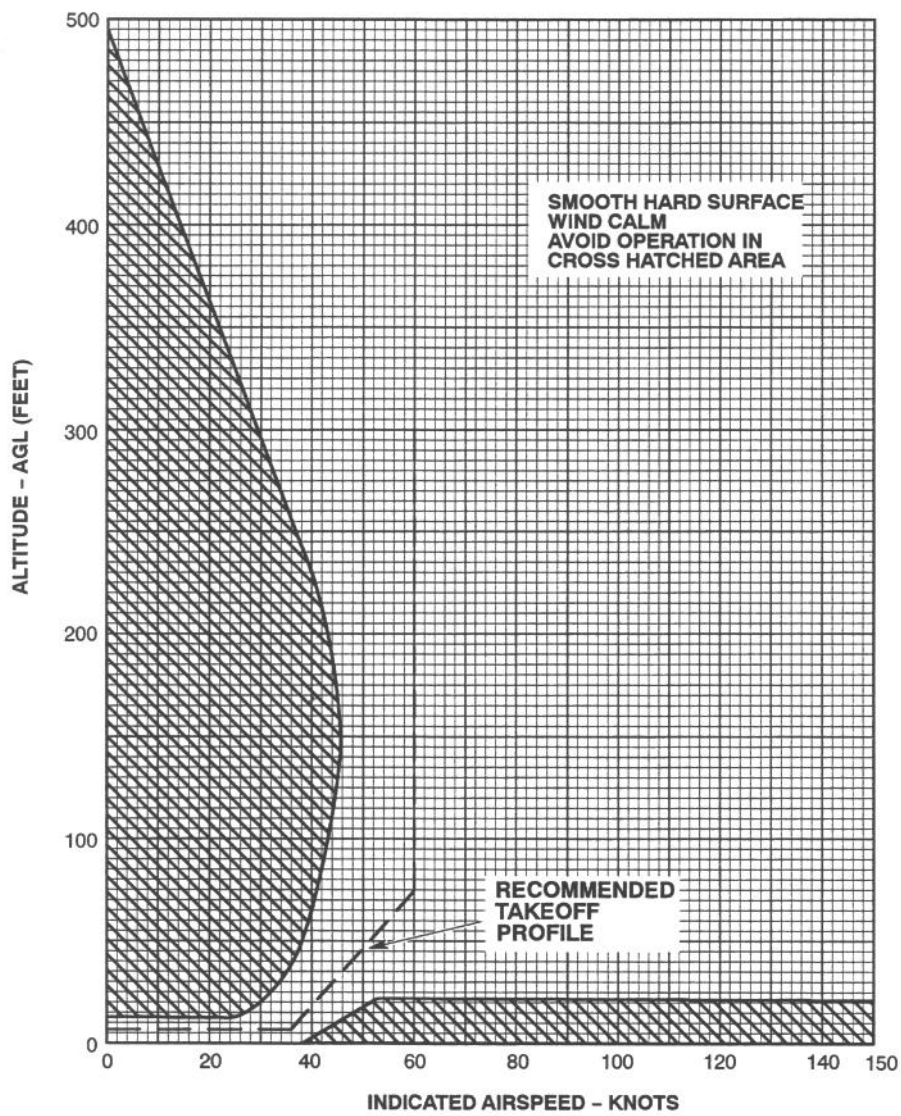
Figure 5-4. Height Velocity Diagram

La panne de moteur s'est produite à une vitesse et à une altitude qui représentent une phase de vol critique se situant en marge du diagramme altitude-vitesse (voir annexe 3). Par ailleurs, le terrain se prêtait mal à un atterrissage d'urgence en raison des différents obstacles. L'instructeur a réussi à identifier immédiatement la panne de moteur et a effectué l'autorotation.
