**Final Report**  
**by the Aircraft Accident**  
**Investigation Bureau**

on the incident

of the aircraft Embraer EMB-145LU, HB-JAX  
on 30 November 2002  
at Zurich Airport

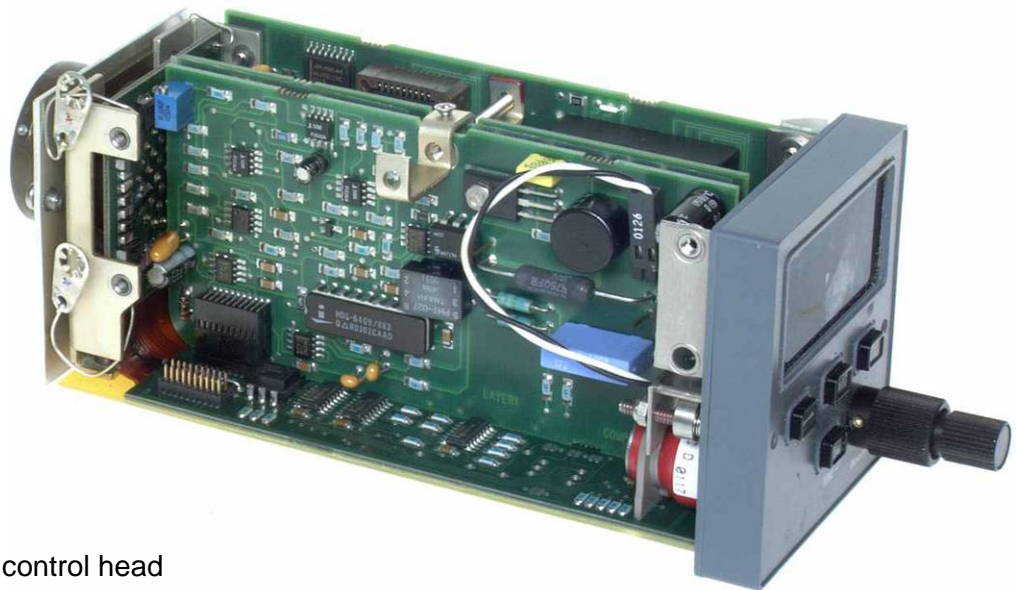
Fig.1

- The source of electrical smell was located as the tuning back-up control head (TBCH) CD 850 P/N 7513000-835 S/N 01102103 (Fig. 1).
- The investigation of the burnt area showed, that the electrical smell was produced by the disintegration (burning process) of printed circuit board material and flex board material.

Tuning back up control head

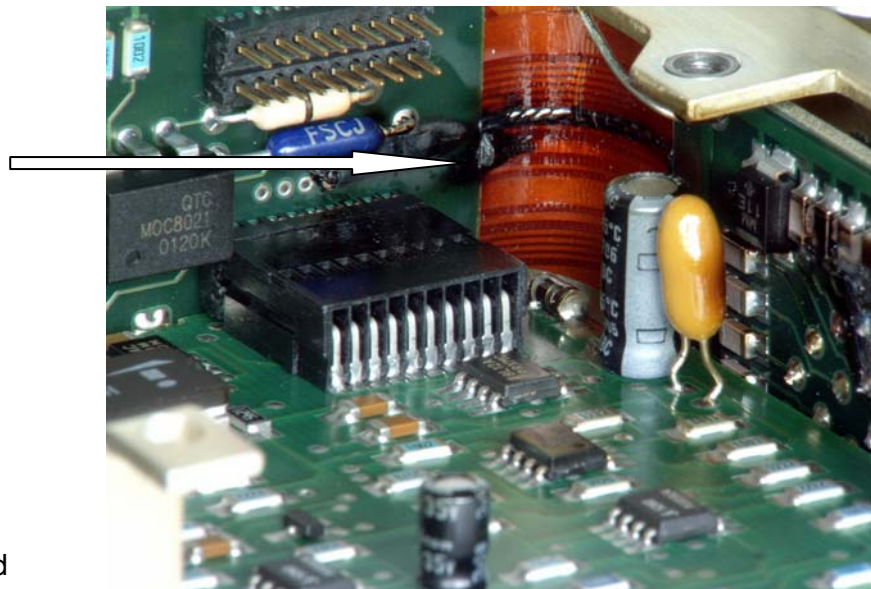
Fig.2

- Damage was found in three areas:
  - SMD resistors on the 7516359-910 power supply printed circuit board (PCB)
  - burnt flex print connecting the power supply circuit board with the multilayer main PC board

- heat damage on the multilayer main PC board, were on the top side the resin is burnt away until the glass fiber layer (Fig. 2 & Fig. 3).
- Some copper tracks were melted away. The temperature necessary to melt copper is approximately 1100 °C. This composite material starts to disintegrate at temperatures of approximately 330 °C.

- Analysis from the unit manufacturer stated the following: "The root cause of this failure was found to be the failure of the Q401 transistor. The Q401 transistor on the power printed circuit board (PCB) failed (random part failure) which in turn shorted the 28 VDC power to ground. This caused excessive current to flow through the 28 VDC traces on the power PCB. This excessive current caused the traces to burn along with R418 and the flex connector. The short circuit could have persisted for several seconds and resulted in the emission of smoke ...".

Damage on Flexboard

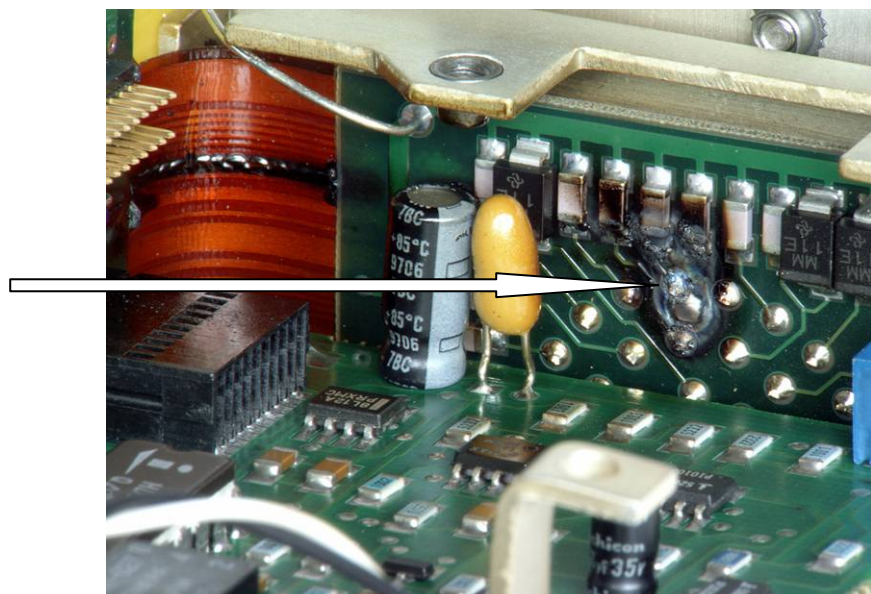
Fig.3

Damage on PCB
