Final Report
by the Aircraft Accident
Investigation Bureau

concerning the incident

of the Cessna 750 Citation X aircraft, N999CX
on 20 March 2002
Zurich Airport

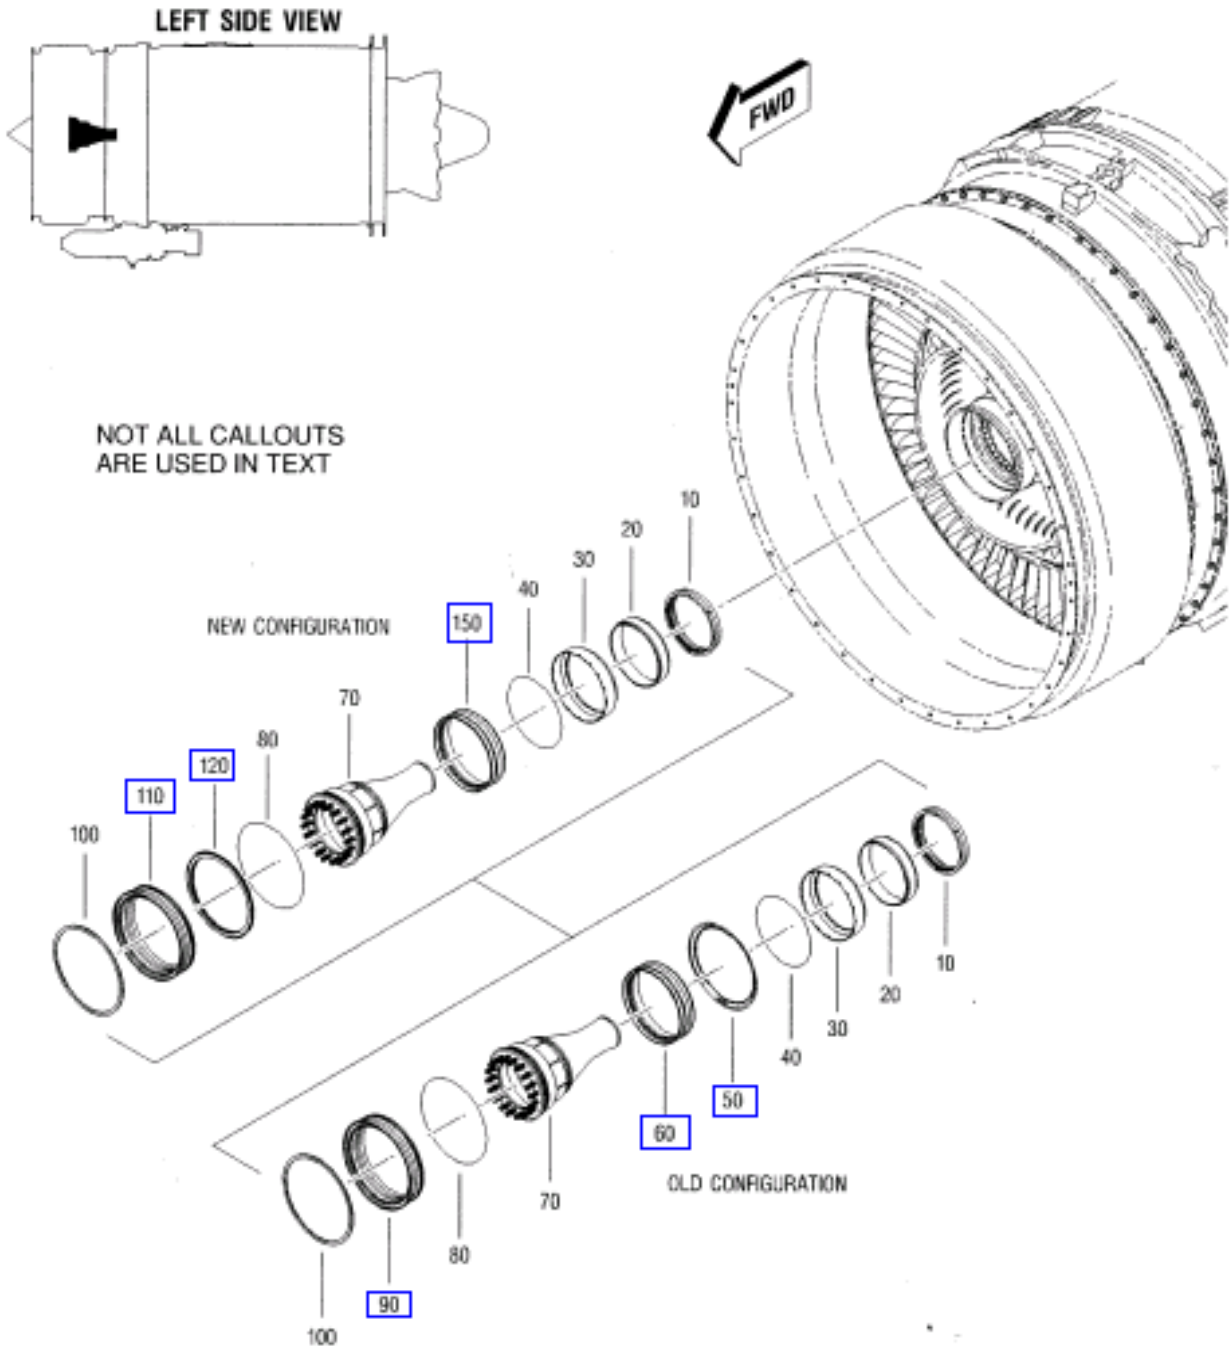
Annex 1

- After consultation with the engine manufacturer, Rolls Royce, the left-hand engine was kept shut down for 24 hours, and then an internal boroscope inspection was carried out. This showed that, due to a faulty fan (no 1) carbon seal, oil was spreading though the entire engine, burning on hot parts during operation and some was present in liquid form in the bleed air supply duct.

- According to the manufacturer's information, this leak had occurred because of a defective seal (fan carbon seal). At the time of the fault, the manufacturer was already offering a solution via a Service Bulletin (SB). The manufacturer described the improvement achieved with the Service Bulletin SB AE3007C-A-72-133 (Appendix 1) as *"an improved design carbon seal, including a new arch-bound segmented fan carbon seal assembly, a new fan carbon seal runner, a new fan carbon seal baffle and a new aft side fan Teflon lip seal."*

Fan Drive Shaft, Fan Carbon Seal, Fan Teflon Lip Seal, and Fan Carbon Seal Runner
