Final Report by the Aircraft Accident Investigation Bureau

concerning the accident

to the aircraft Cessna CE 560 Citation V, HB-VLV

on 20 December 2001

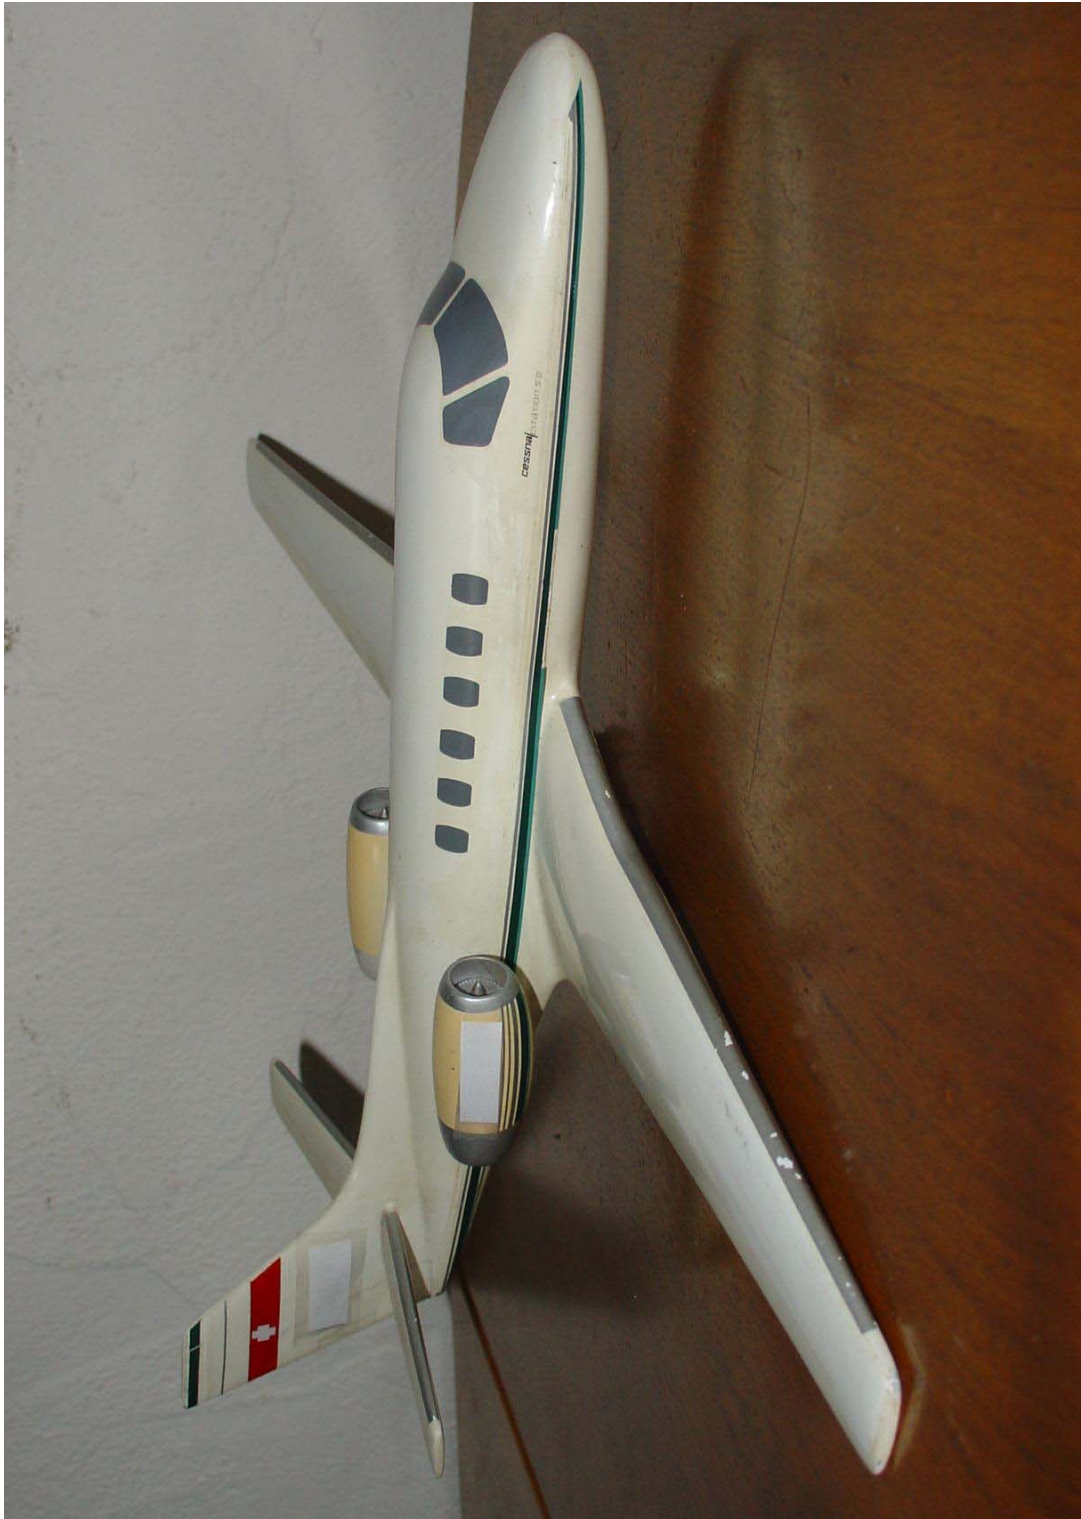
5.6 Attitude on impact

At 21:07 UTC the aircraft impacted onto the frozen ground 400 m to the south-east of the end of runway 34 and skidded in a northerly direction, leaving a trail of debris. The main body of the wreck finally came to rest 500 m beyond the site of initial impact on runway 14/32. The rescue services reached the burning wreck after a few minutes.
