Investigation report No. 1835 on the accident to the tethered balloon HiFlyer on 23 July 2004 in Lucerne

Aircraft Accident Investigation Bureau

Investigation report

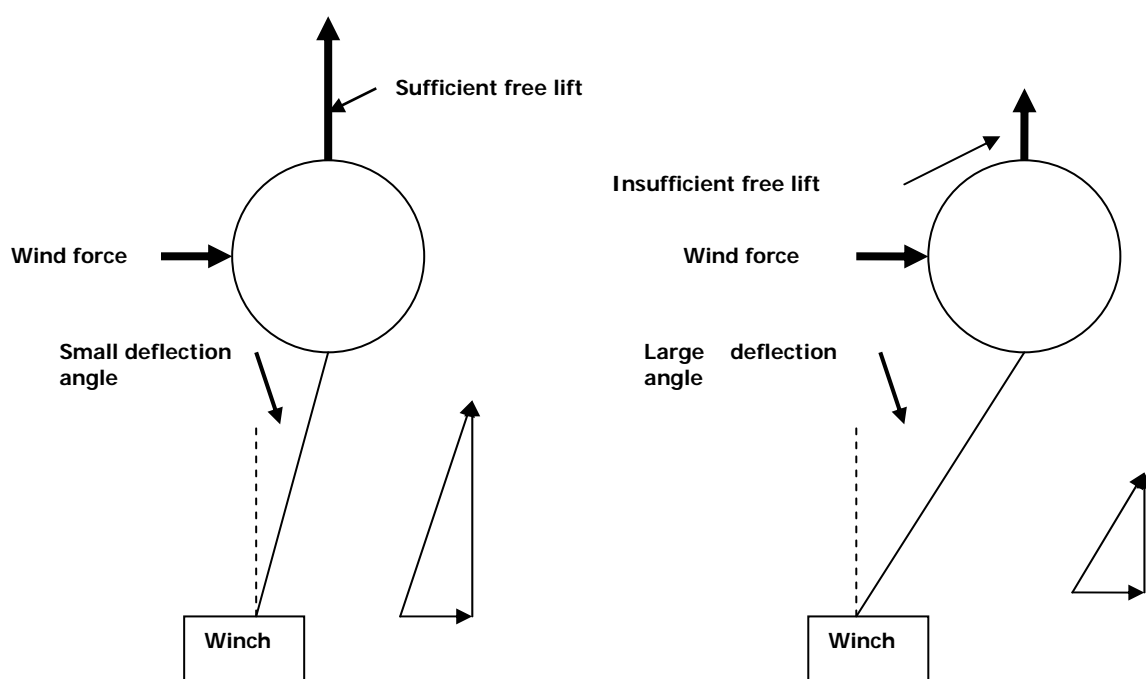
A cable length of 140 metres was assumed for the balloon deflection calculations. The following sketches show that for the same wind speed the deflection angle is dependent on the free lift:

The following table shows the resulting deflection angles at maximum allowable wind speeds and required minimum operating free lift:

Peak wind speed [kt]	Minimum operating free lift [tonnes]	Deflection angle [degrees]
0 - 5	0.9	0 - 2
5 - 10	1.2	1.3 - 5.3
10 - 15	1.6	3.6 - 8.1
15 - 20	2.2	5.5 – 9.7
20 - 25	2.8	7.4 – 11.5

- No. 339: It is recommended that the manufacturer of the HiFlyer fit damping elements to the gondola and/or the winch cable in order to minimise the risk of damage to the cable at extreme angles of deflection.

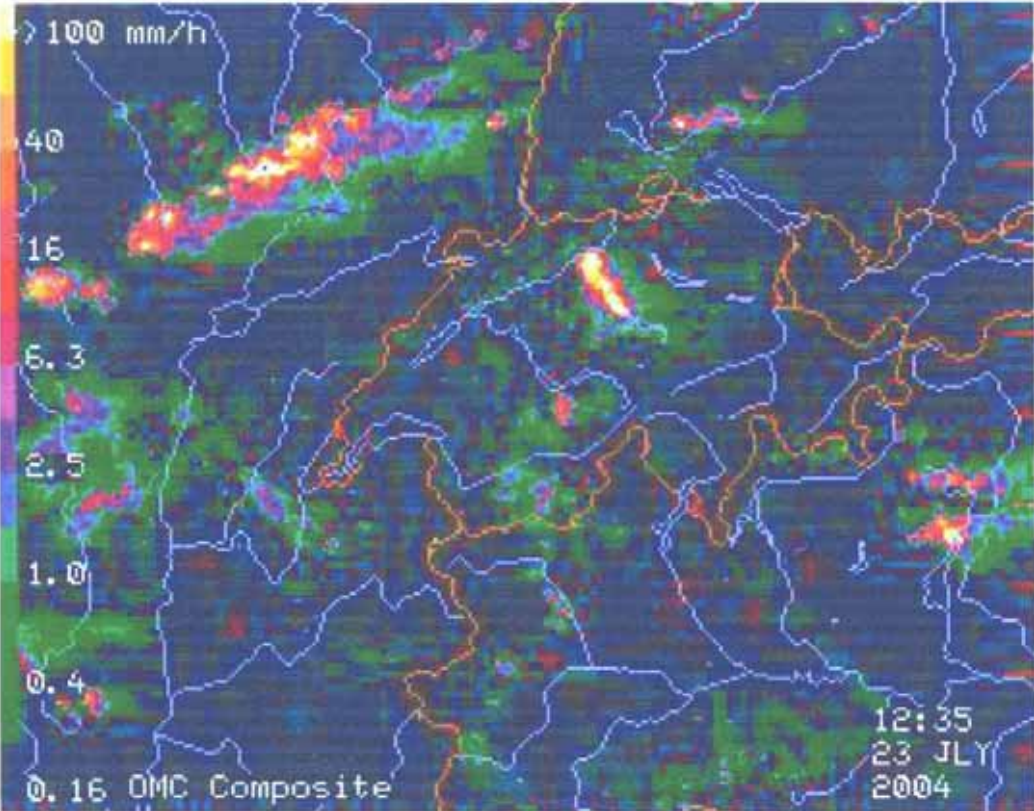
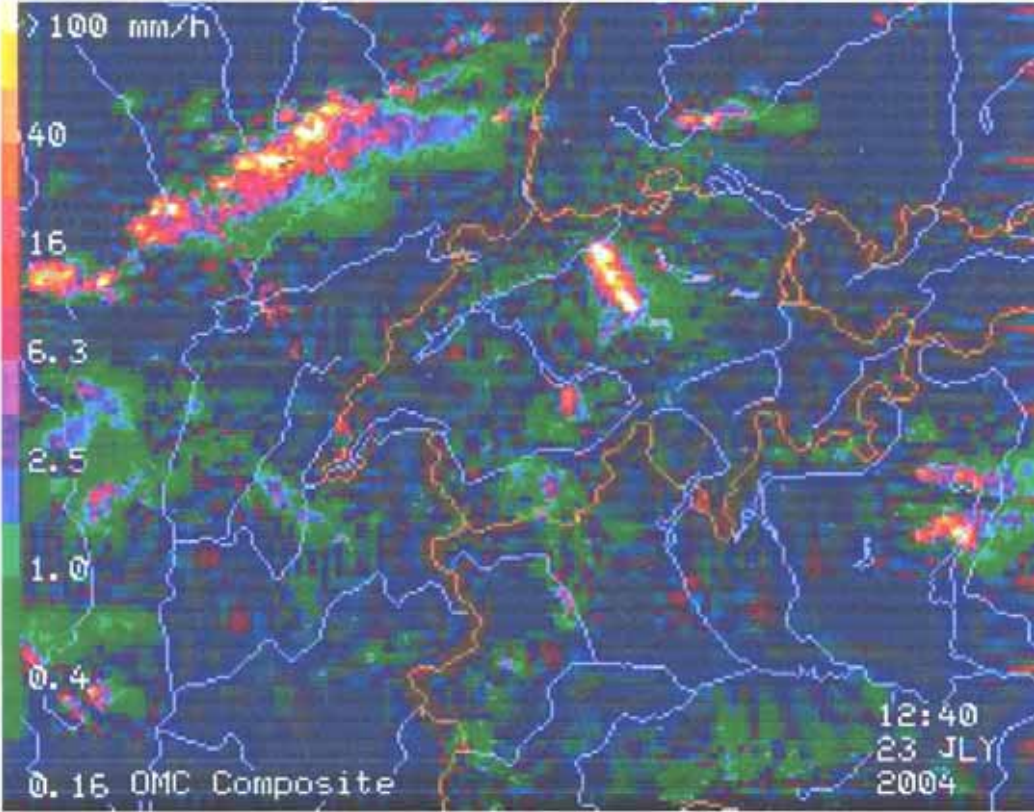
Radarbilder, 23. Juli 2004, 1235 + 1240 UTC

The pressure contrasts over central Europe were only slight. Mild, humid air was flowing towards the Alps in a southwesterly upper air current. Several centres of thunderstorm activity formed in Switzerland during the course of the day. One of these centres was slowly passing over the canton of Lucerne in an easterly/north-easterly direction. At 14:35 LT the thunderstorm cell was located on a line from Aarau to Lucerne (cf. Annexes 7.1, 7.2).

Between 14:40 LT and 15:00 LT the on moving thunderstorm cell caused peak gusts of 29 kt (54 km/h) at the Cham measuring station.
