# **Final Report No. 1844 by the Aircraft Accident Investigation Bureau**

concerning the serious incident  
to the aircraft Embraer EMB-145LU, HB-JAH  
operating under flight number CRX 3439  
on 28 November 2001  
during approach to Zurich Airport

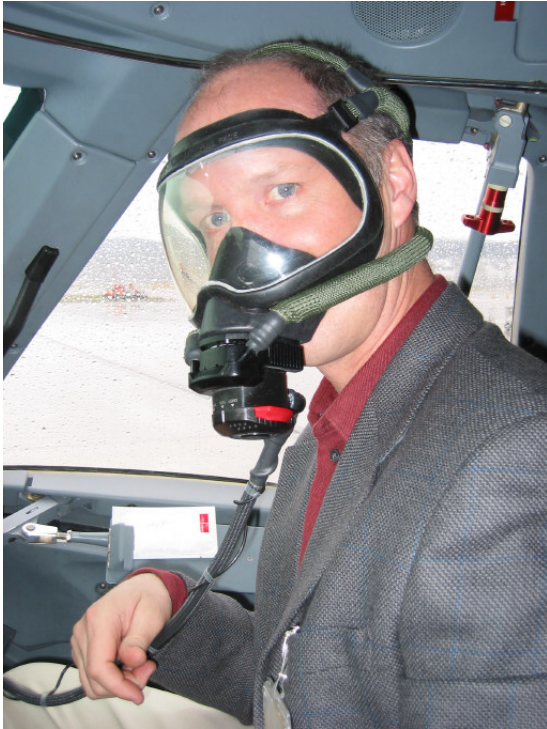
Picture 1

The aircraft HB-JAH was equipped with quick donning full face masks (picture 1), manufactured by B/E Aerospace. A push-button activated inflatable harness system allows a quick donning of those masks. They were stored in separate stowage compartments called "stowage box" located left of the pilot seat and right of the copilot seat (picture 2). Those stowage boxes have been layed out for oxygen masks without a full face part while in this aircraft full face masks were installed. The space in the stowage box to stow the full face mask, was very tight. To allow an easy pull out of the masks out of the stowage boxes and to avoid scratches on the full face mask screen the manufacturer installed a cloth bag, called "liner", in the stowage boxes.

Full face mask

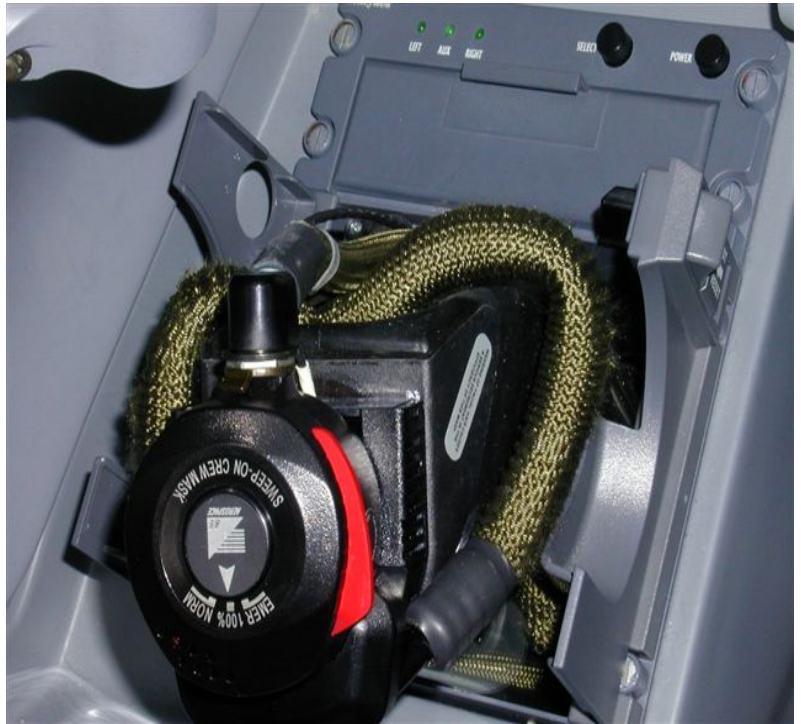
Picture 2

The copilot reported problems pulling his oxygen mask out of the stowage box. During the investigation it was found that there was no liner installed because there have been some cases in which the mask and the liner got caught up.

For flights above FL250 quick donning masks are required. According to certification requirements they have to be donned within 5 seconds. Practical tests with other crews and other aircraft out of the operators EMB 145 fleet showed that as a rule the masks were not donned within the required 5 seconds due to problems to get the masks out of the stowage box.

Oxygen mask, halfway pulled out of the "stowage box"

Ten (10) months before this serious incident the manufacturer of the masks informed the operators in a "service information letter" about the mentioned problems and proposed a modification. This modification included a new liner, which is attached to the bottom of the stowage box and which is supposed to remain in the stowage box when the mask is pulled out. This modification has not been performed on Crossair's airplanes. Later on, partly as a consequence of this serious incident, the modification has been performed on all of Crossair's Embraer 145.

- *Modification of the mask liner*  
*Installation of a modified mask liner to provide a rapid and unhindered unstowage and application of the oxygen mask. (Quick-Donning). (B/E Aerospace 118816-SIL-1)*
- *Contamination of the full face mask screen*  
*Replacement of the faulty masks with new masks, produced under new quality guidelines. Additionally, check of the masks within the maintenance program every 400 hours.*
- *Mask microphones*  
*Removal of the reed-switch causing communication problems. (B/E Aerospace 145250-SIL-2)*
- *Quick Donning Training*  
*Introduction of a fleet wide temporary Last Flight of the Day Check of the oxygen masks done by the pilots. During this check the masks have to be pulled out of the stowage box and then tested for their functionality.*

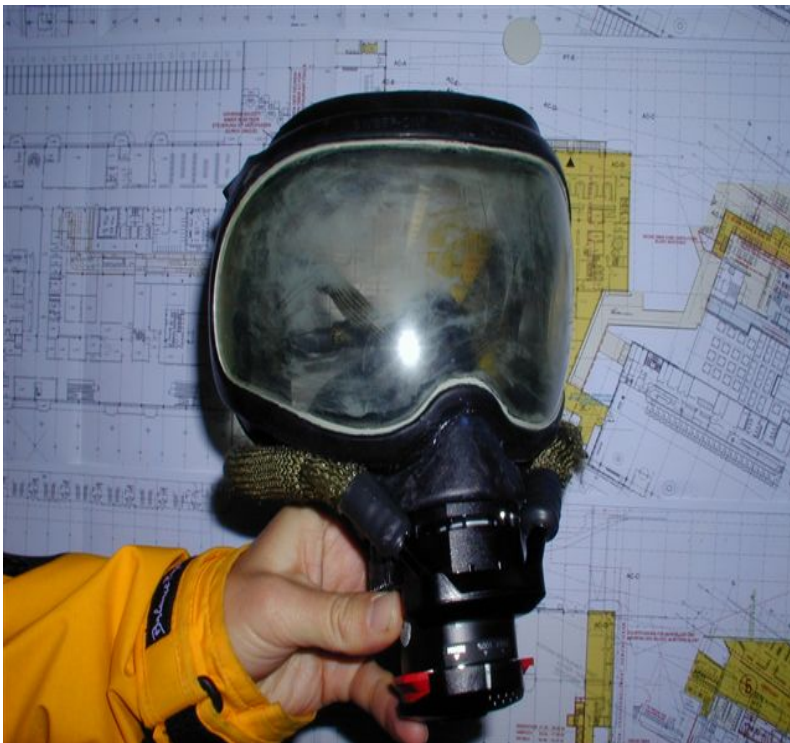
Picture 3

Wearing the oxygen mask with its restricted transparency, the copilot assumed that the development of smoke had increased. The screen of his mask was on the inside and the outside covered with a layer. During a spot check on some aircraft of the EMB-145 fleet the investigators found four (4) other masks with considerable soiled screens.

About three months after this serious incident, the manufacturer of the masks informed all operators having installed this type of mask about the origin and the process to remove this layer. This layer developed some time after the production of the masks due to a material like wax, used in the production process and not properly removed afterwards.

The heavily contaminated screen of the copilot's full face mask gave him the impression of an increased smoke development. Therefore the assessment of the situation made by the two pilots was quite different. The additional communication problems inside the cockpit as well as with air traffic control hampered the crew coordination in a way that it practically broke down, at least during certain phases of the approach.

Copilot's heavily contaminated full face mask screen
