**Final Report
of the Aircraft Accident
Investigation Bureau**

concerning the incident (Airprox)

between DLH3703 and KLM1931

on 26 April 2004

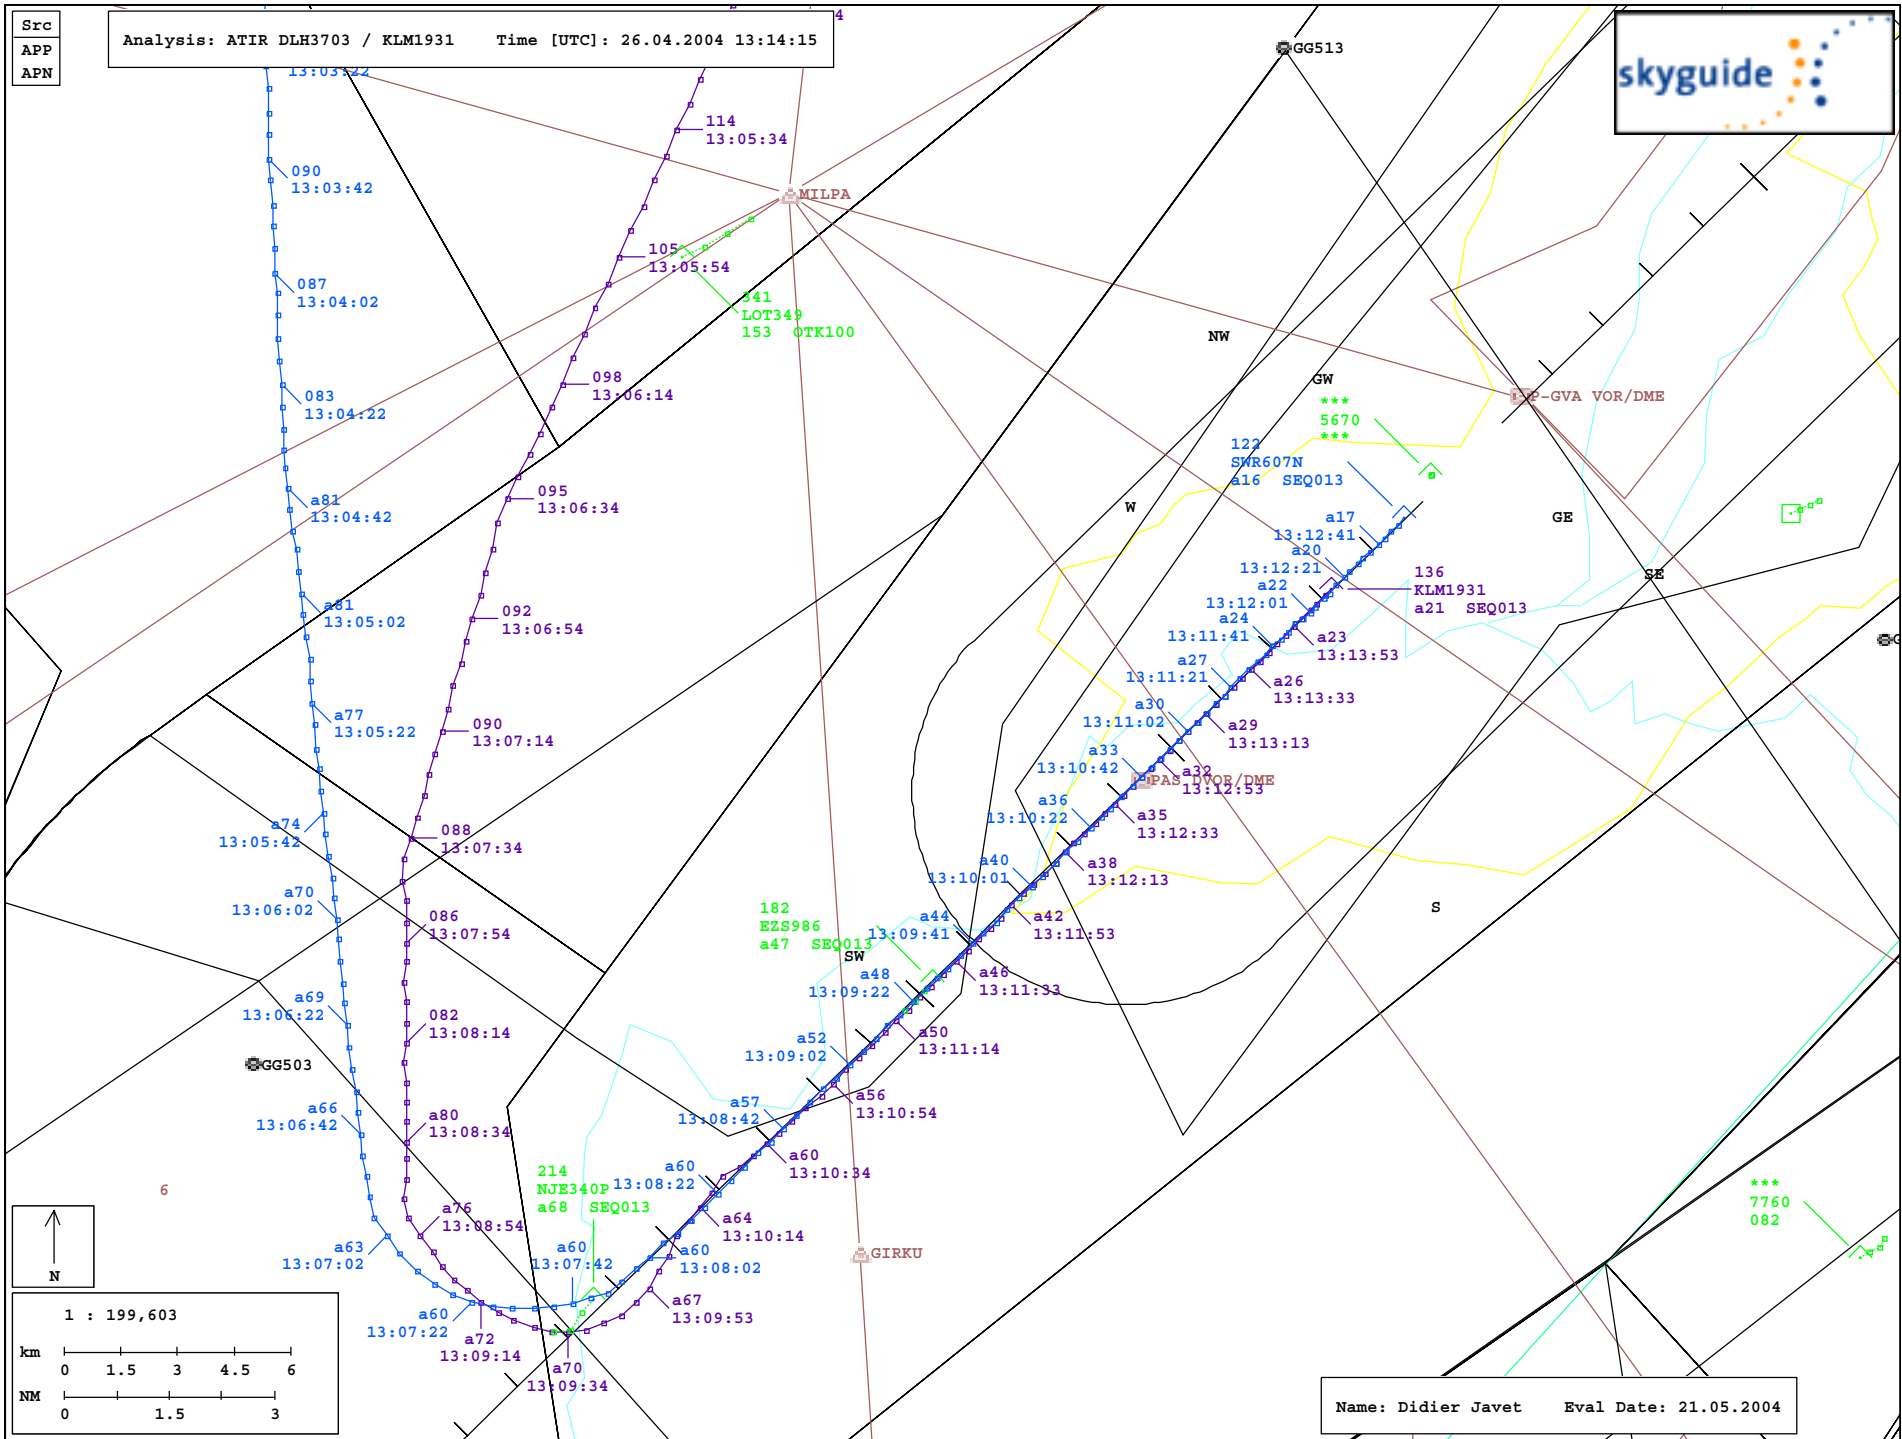
Analysis: ATIR DLH3703 / KLM1931 Time [UTC]: 26.04.2004 13:14:15

- Between 13:13:11 and 13:14:15, the aerodrome controller handled 15 bilateral radio communications, mainly with aircraft under VFR conditions.
- At 13:14:15, the aerodrome controller cleared aircraft KLM1931 to land.

- Aircraft KLM1931 was at a distance of 1.5 NM and an altitude of 2000FT.
- At 13:14:20, the pilot of aircraft KLM1931 read back this clearance.
- At 13:14:22, the aerodrome controller handed over aircraft SWR607N to the APRON frequency 121.75 MHz.

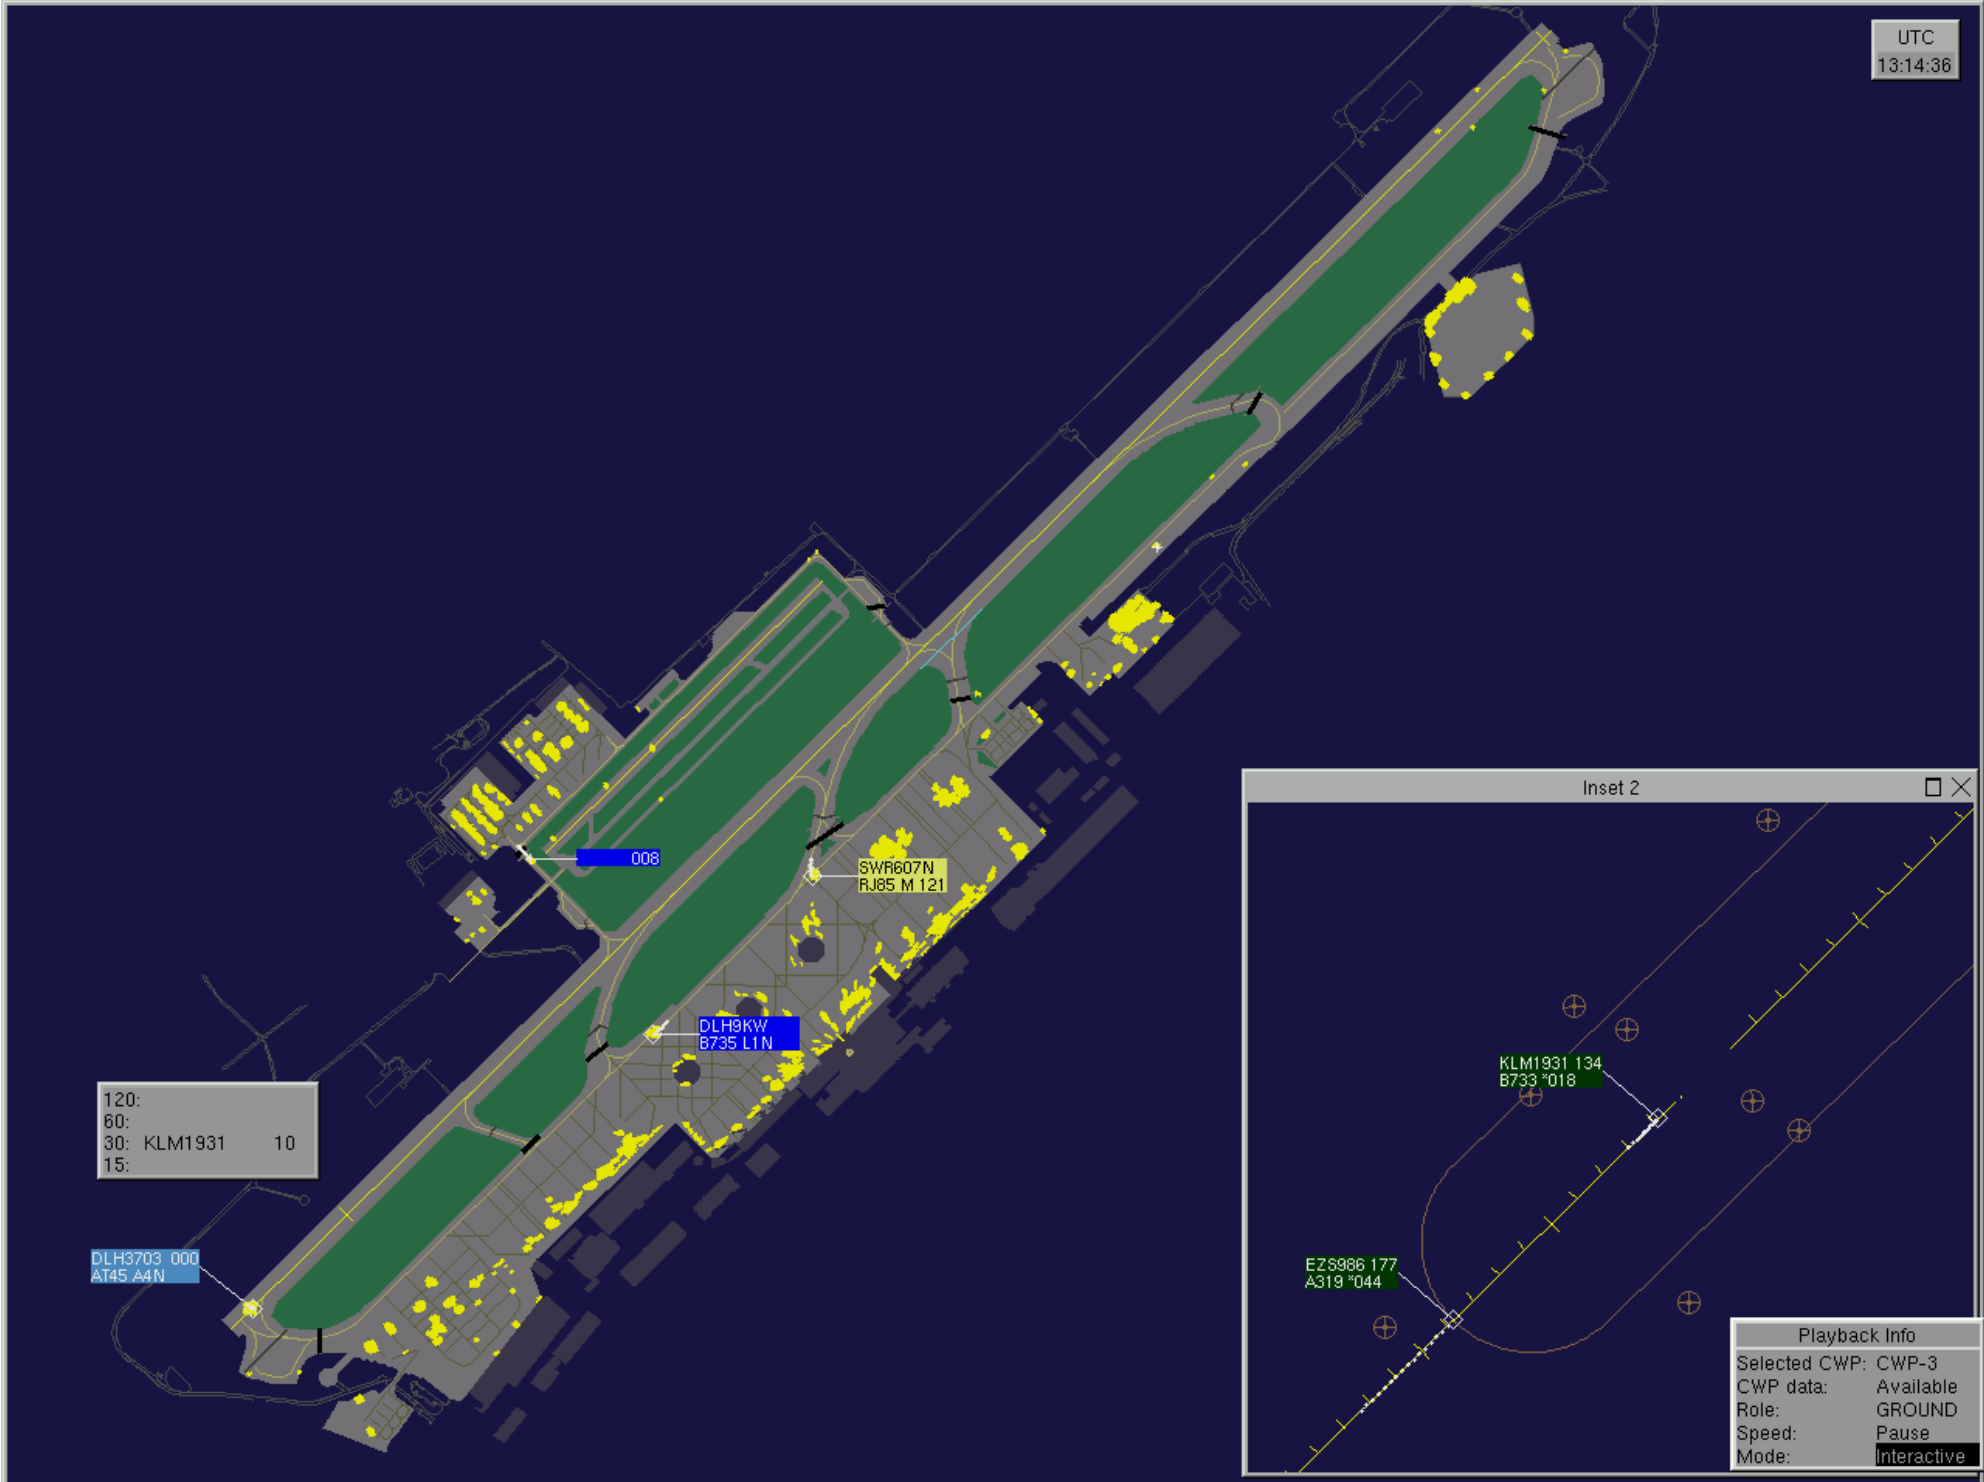
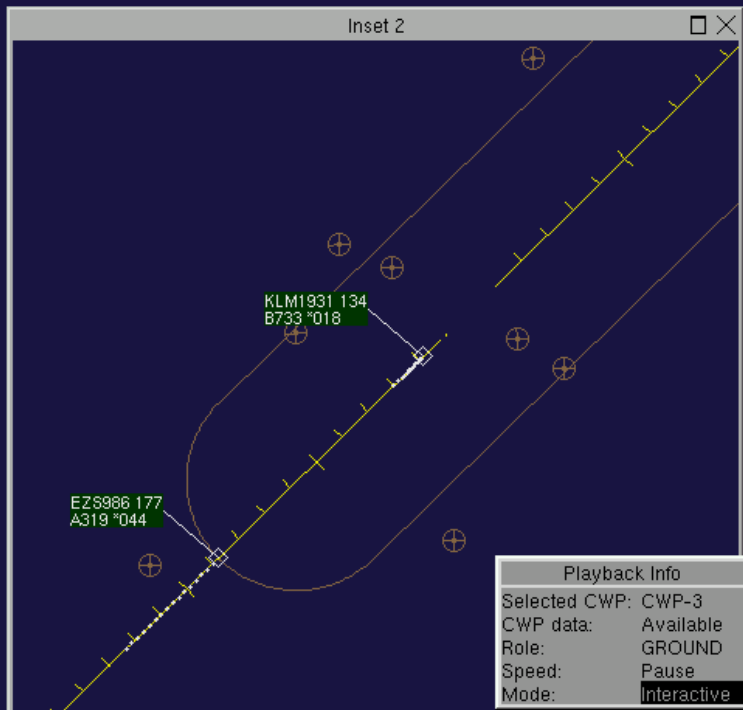
UTC
13:14:36

- At 13:14:30, the pilot of aircraft DLH3703 stated that he was on the runway.
- At 13:14:36, the aerodrome controller instructed the pilot of aircraft KLM1931 to go around and climb to an altitude of 7000 FT in the direction of Saint-Prex VOR, without giving him information about the traffic on the runway.
