Final Report by the Aircraft Accident Investigation Bureau

concerning the serious incident

to the aircraft EMB-145LU, HB-JAU

on 16 November 2003

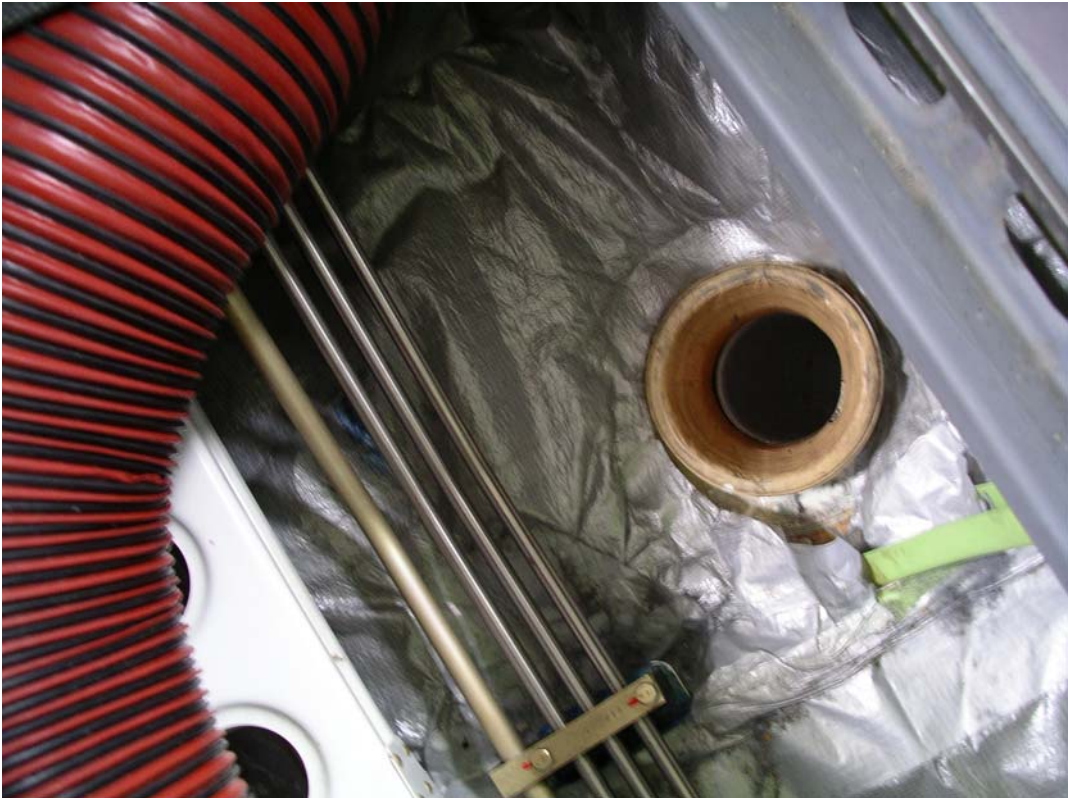
Figure 1

- During a system test of ECS Packs#1 and #2 with engines running (high power test), a very loud noise was heard in the area of seat row 8. The cabin floor was opened in this area (Annex 1 figure 2) and it was found that the hose leading from recirculation fan #1 to ECS Pack#1 had separated near the cabin entry point (Annex 1 figure 1). The hose was reconnected.

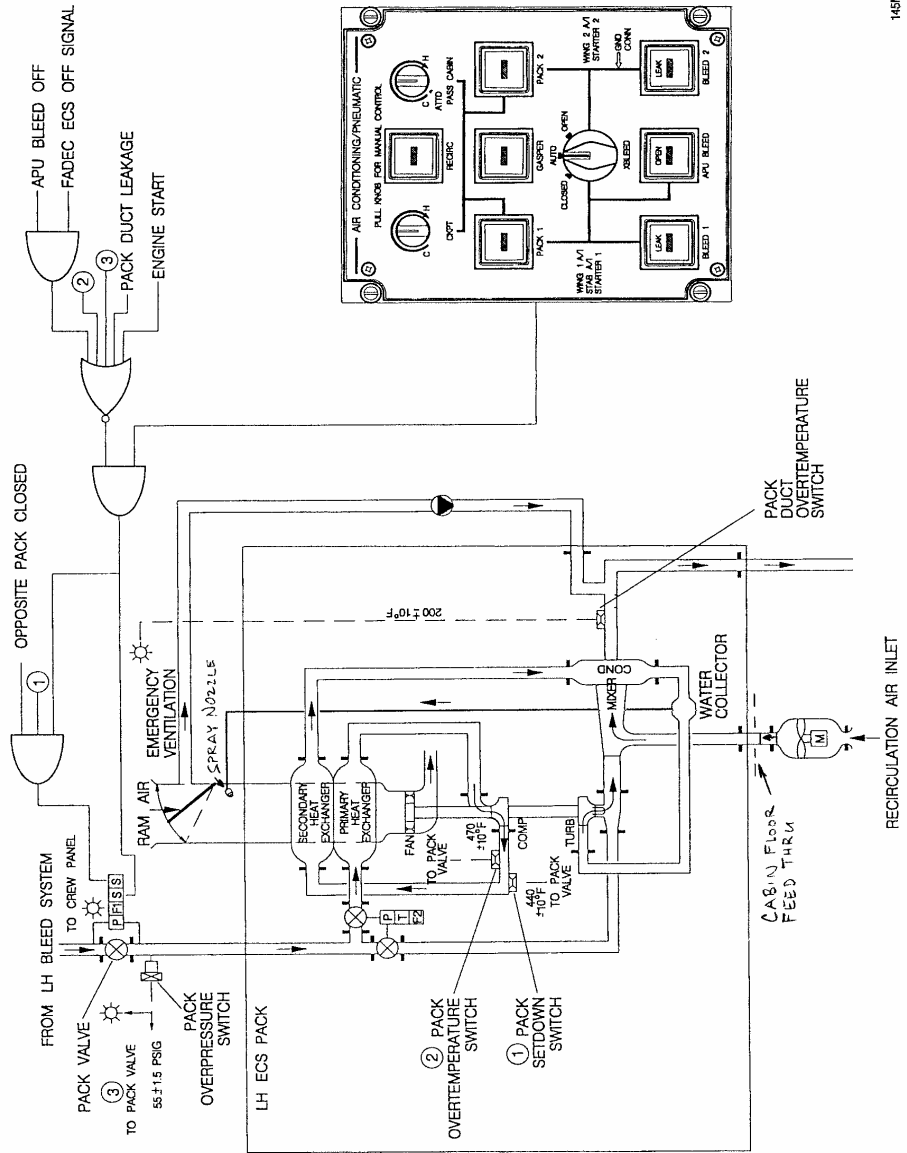
EMB 145 Aircraft Maintenance Manual (PART 1)
COOLING PACK SYSTEM - SCHEMATIC DIAGRAM , S eet 1

- The spray nozzle, which carries water away from the water collector to the ram air duct, was examined to see if it was clear. In the process, a foreign body was found in the spray nozzle. This was a small piece of solder residue, which had presumably found its way from the condenser via the water collector into the spray nozzle and in the process had blocked it.

The occurrence of fumes and frost can be explained as follows (cf. Annex 2): as a result of the blocked spray nozzle, the water which had accumulated in the water collector could no longer be carried away. This now reached the turbine, where ice crystals were then formed. These in turn blocked the condenser and high pressure was created in the direction of the recirculation fan. The non-return valve fitted at the outlet of the recirculation fan prevented pressure from being released and the hose failed near the cabin entry point. The ice crystals now reached the cabin, formed the fumes in question and led to the drop in the cabin temperature. The situation normalised itself again at low engine power.

1. A check to ensure that the spray nozzles are clear every 500 flying hours (1A check).
2. Cleaning of the spray nozzles every 2000 flying hours (4A check).
