Final Report of the Aircraft Accident Investigation Bureau

concerning the incident (Airprox)

between HB-FLK and DLH8AY

on 15 February 2004

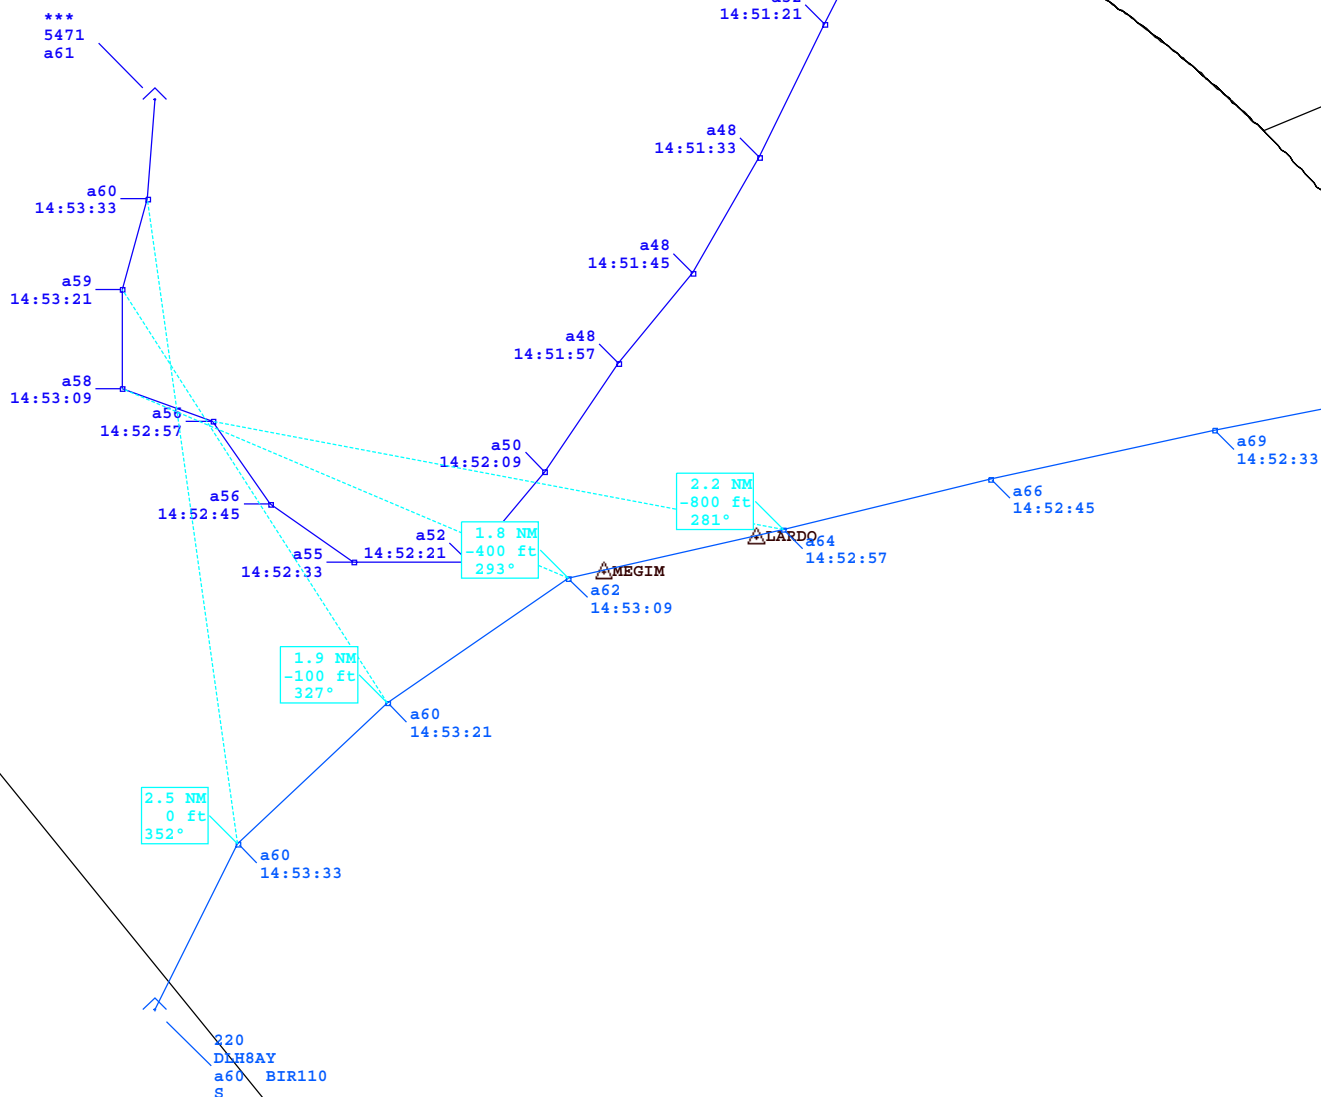
Analysis: HB-FLK / DLH8AY Time [UTC]: 15.02.2004 14:53:50

- According to the radar plot, at 14:53:09 the two aircraft crossed with a lateral separation of 1.8 NM and an altitude difference of 400 ft.
- At 14:53:21, the distances between the two aircraft, according to the radar plot, were a lateral separation of 1.9 NM and an altitude difference of 100 ft.
