Final Report of the Aircraft Accident Investigation Bureau

concerning the incident (Airprox)

between EZS932 and SWR1344

on 30 August 2003

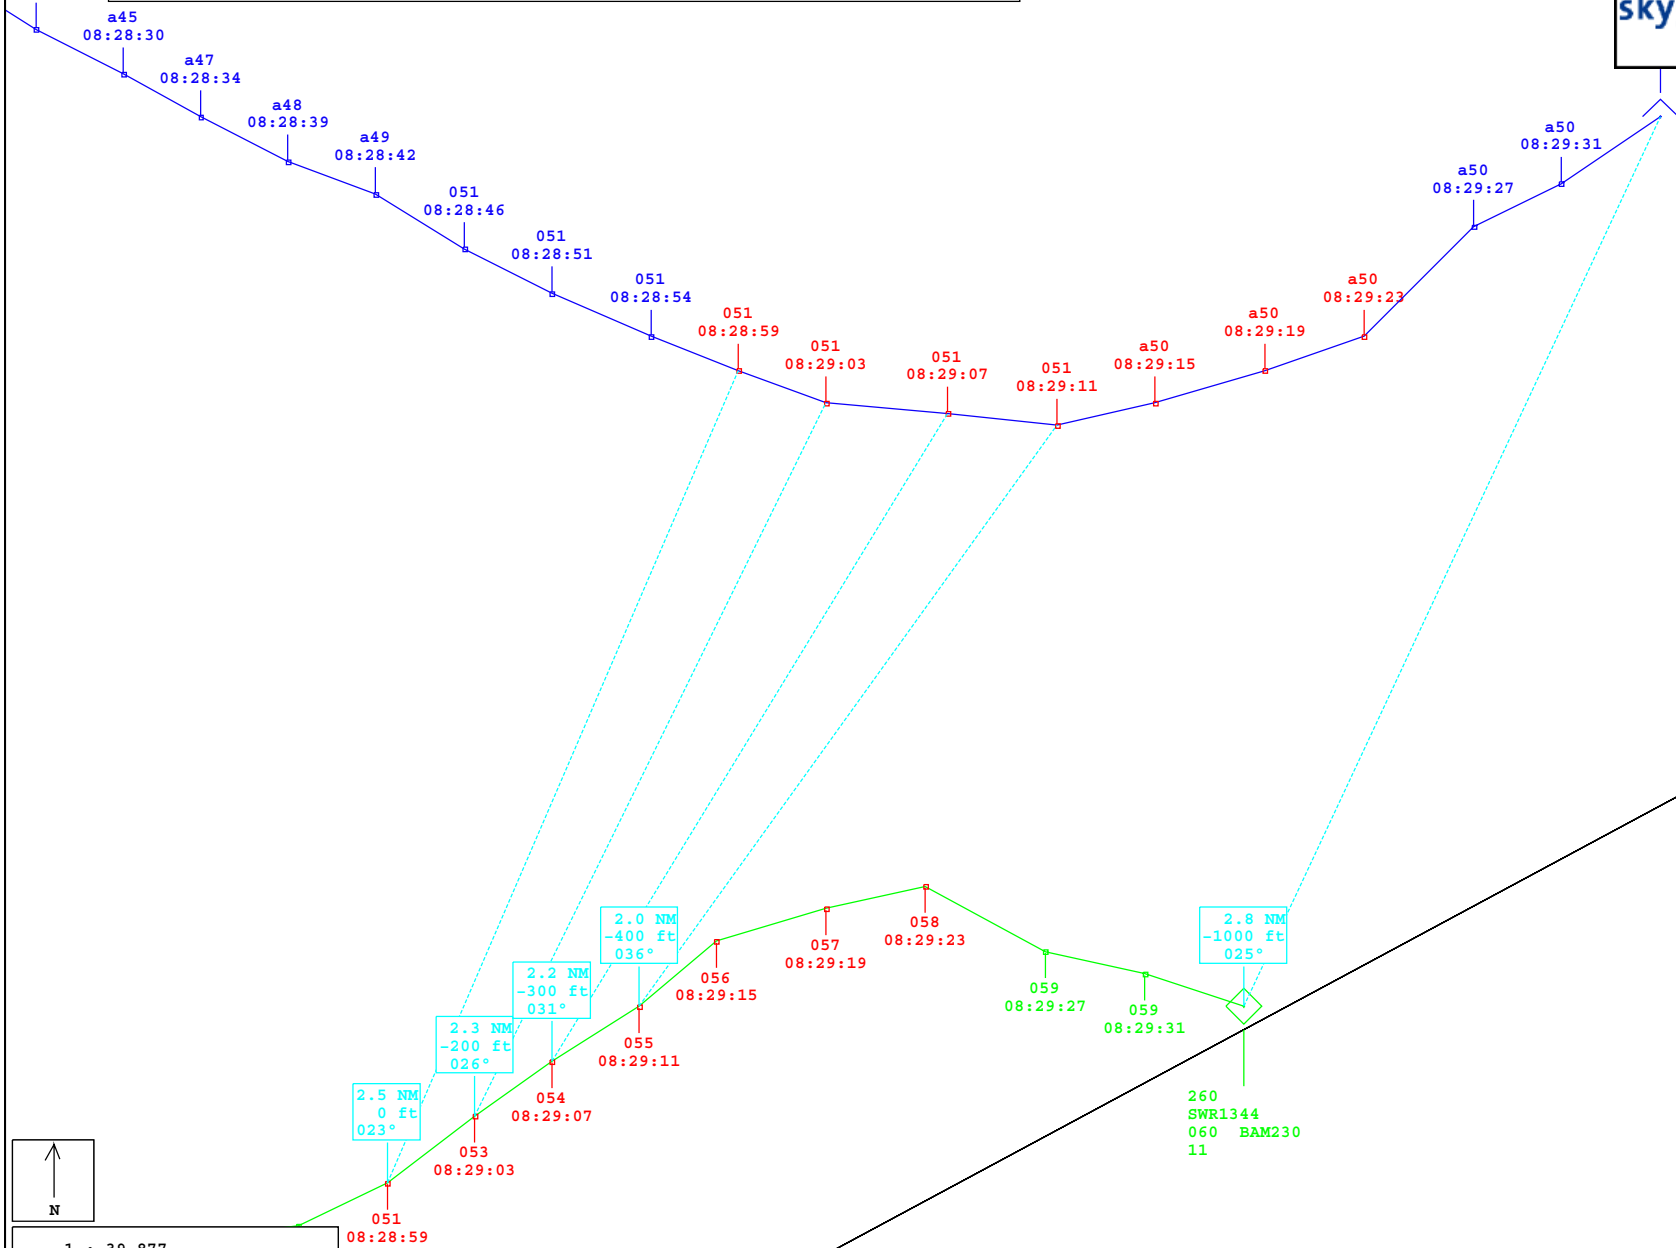
Analysis: airprox ezs932/swr1344 of august 30,2003 Time [UTC]: 30.08.2003 08:29:36

The two aircraft subsequently closed to a point with a lateral separation of 2 NM and an altitude difference of 0 (zero) ft for a time.
