# **Final Report No. 1877 by the Aircraft Accident Investigation Bureau**

to Cessna aircraft R182RG, N6412T

on 13 July 2003

in Pianello, municipality S. Antonio / TI

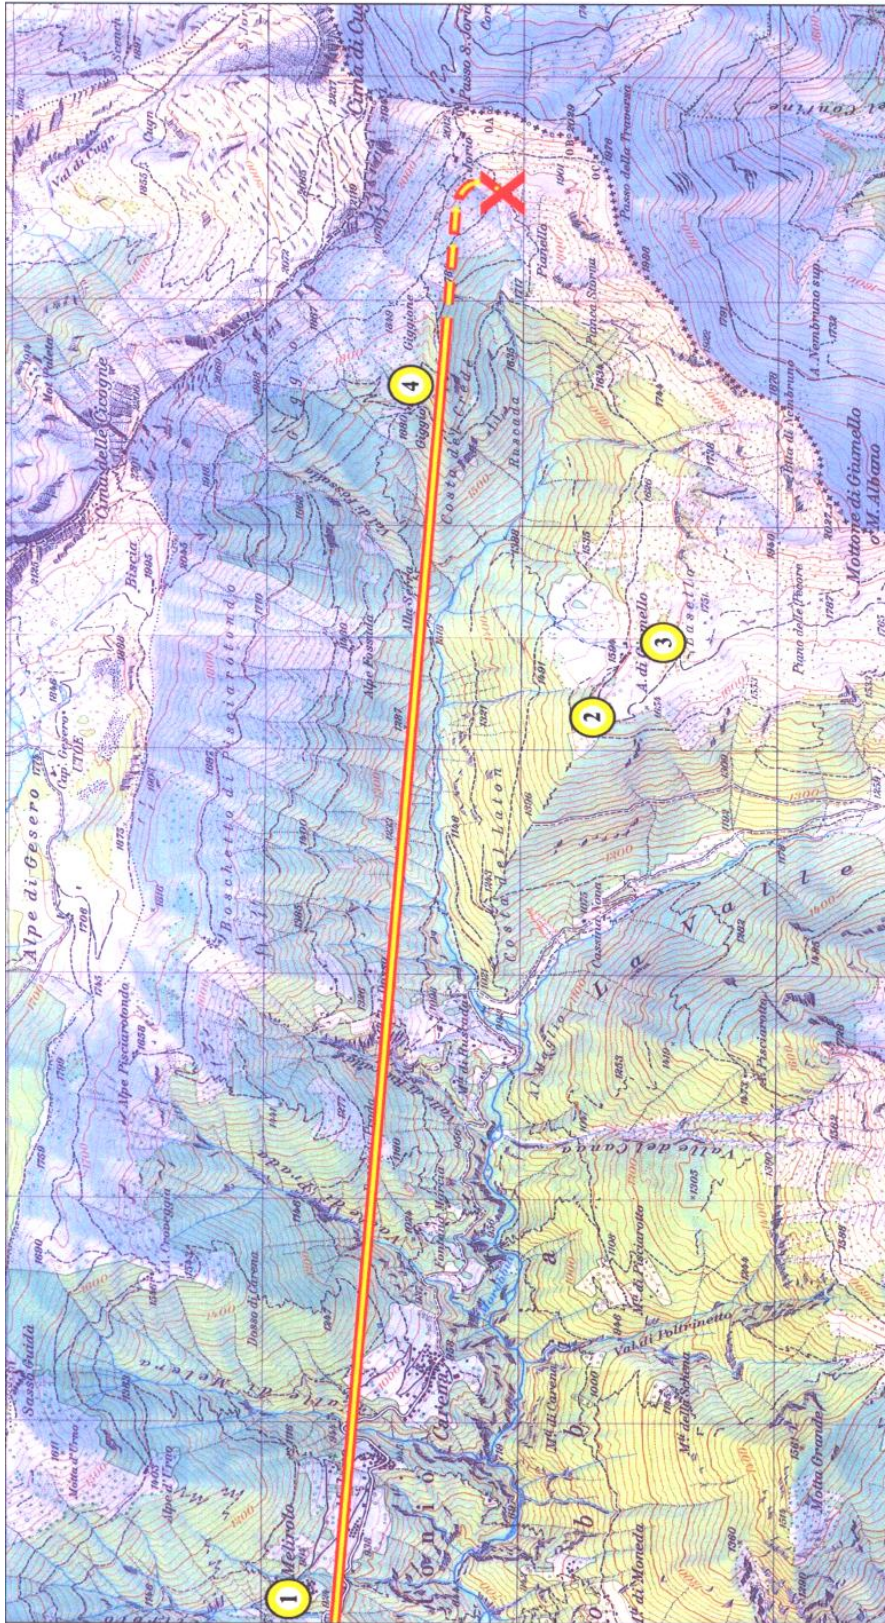
Appendix 1

The Passo del San Jorio is at an altitude of 2012 m/AMSL (6600 ft), 1.3 km from the point at which the aircraft was last seen (Appendix 1 and 2).

Over the last 1500 metres the valley climbs, in the form of a steep rock face, by a further 500 metres (Appendix 1 + 2).

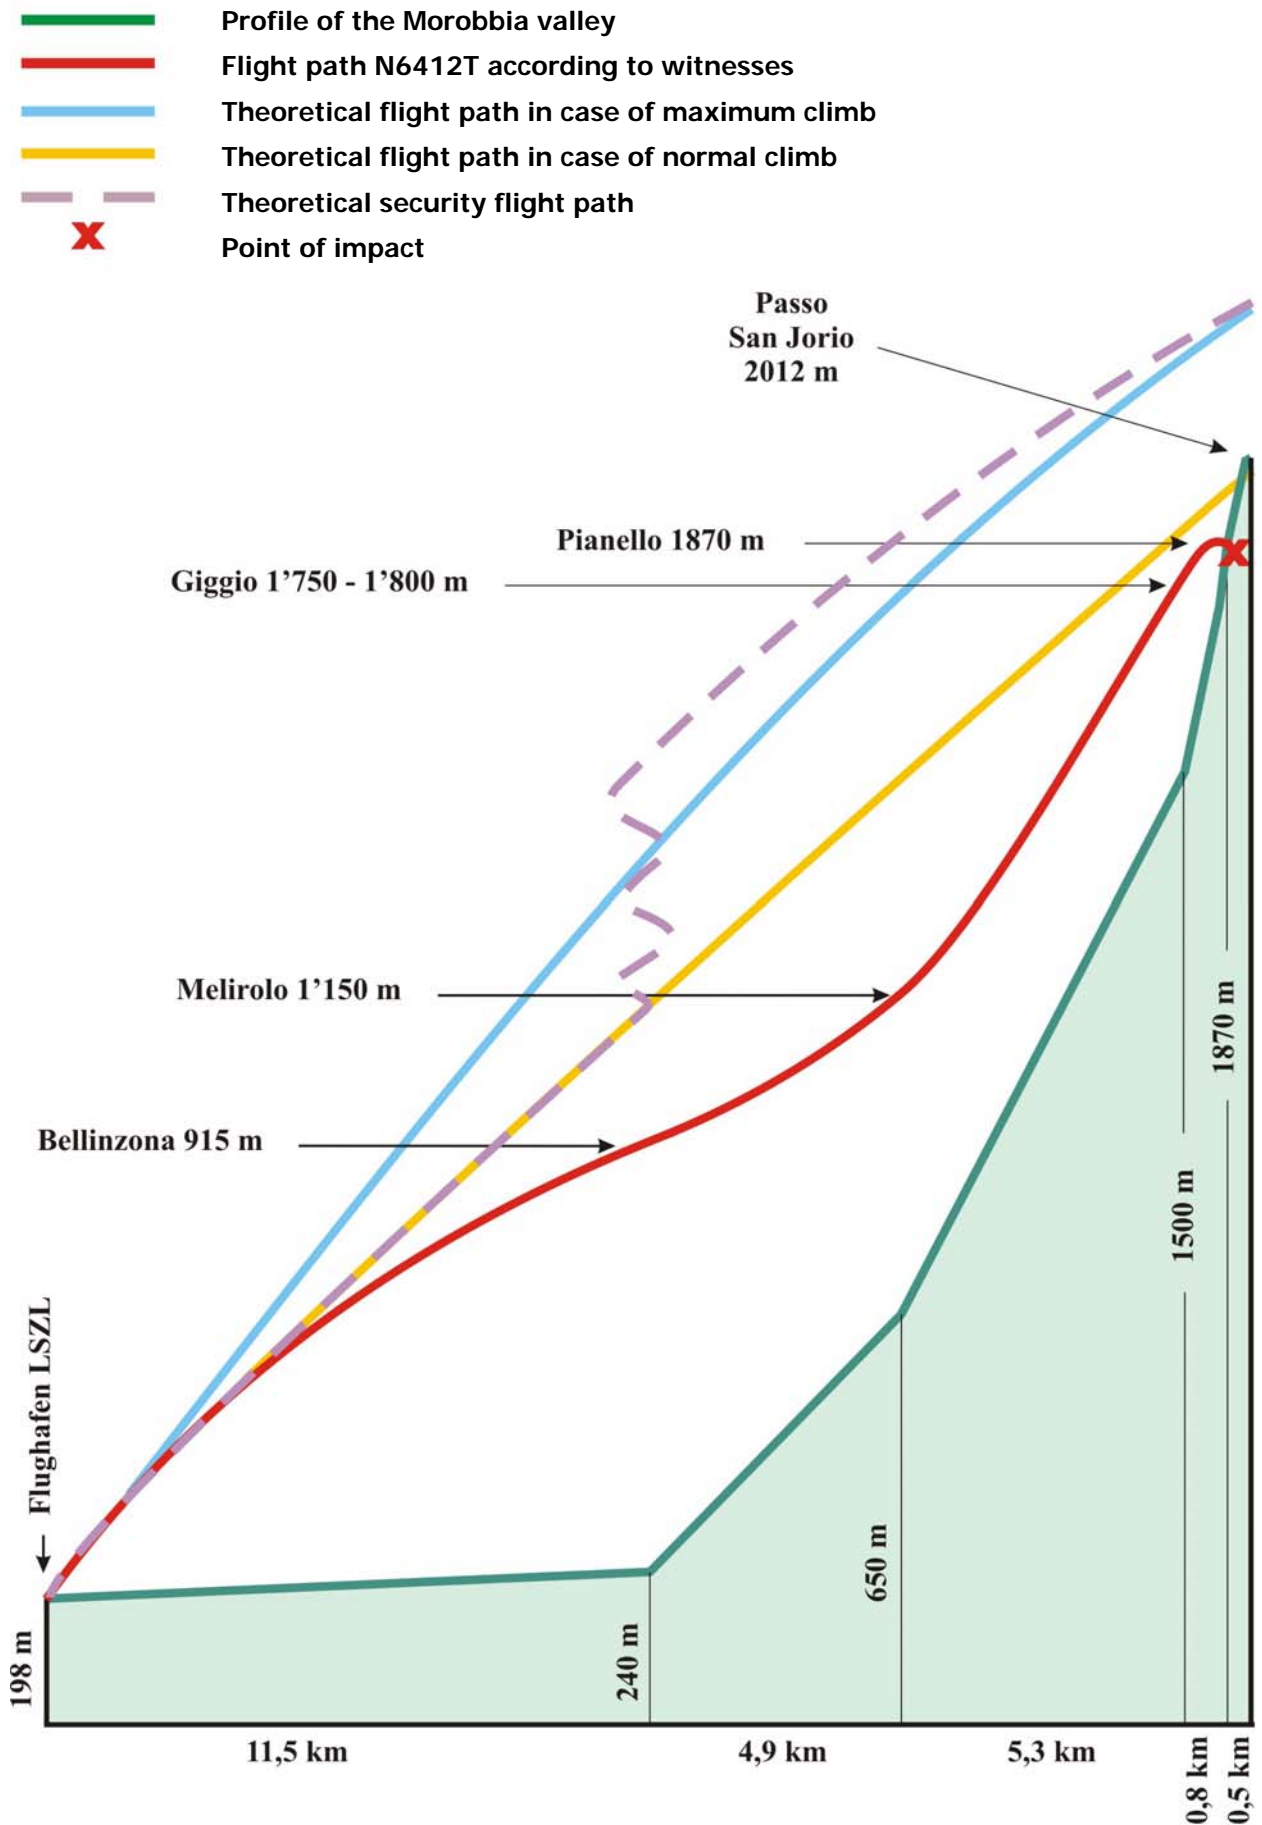
# Appendix 2

The San Jorio pass is at 2012 m/AMSL, approximately 11 km from Giubiasco. The recommended clearance for crossing a pass is at least 300 m (1000 ft). To cross the San Jorio pass, therefore, an initial altitude of 2312 m/AMSL would be appropriate (Appendix 2). In the prevailing north-easterly wind, downdraughts would be expected at the north face and in the centre of the valley. Under these conditions it would have been necessary to fly into the valley at an altitude of at least 1500 m/AMSL, in order to obtain the necessary altitude along the southern flank to clear the pass.

At an outside temperature of 18 °C, with a mass virtually equal to or above the maximum take-off mass and along the flight path chosen by the pilot, it would only have been possible to clear the pass by flying continuously at full power (2400 rpm, full throttle, mixture full rich, cowl flaps open) and at the maximum rate of climb (Appendix 2).

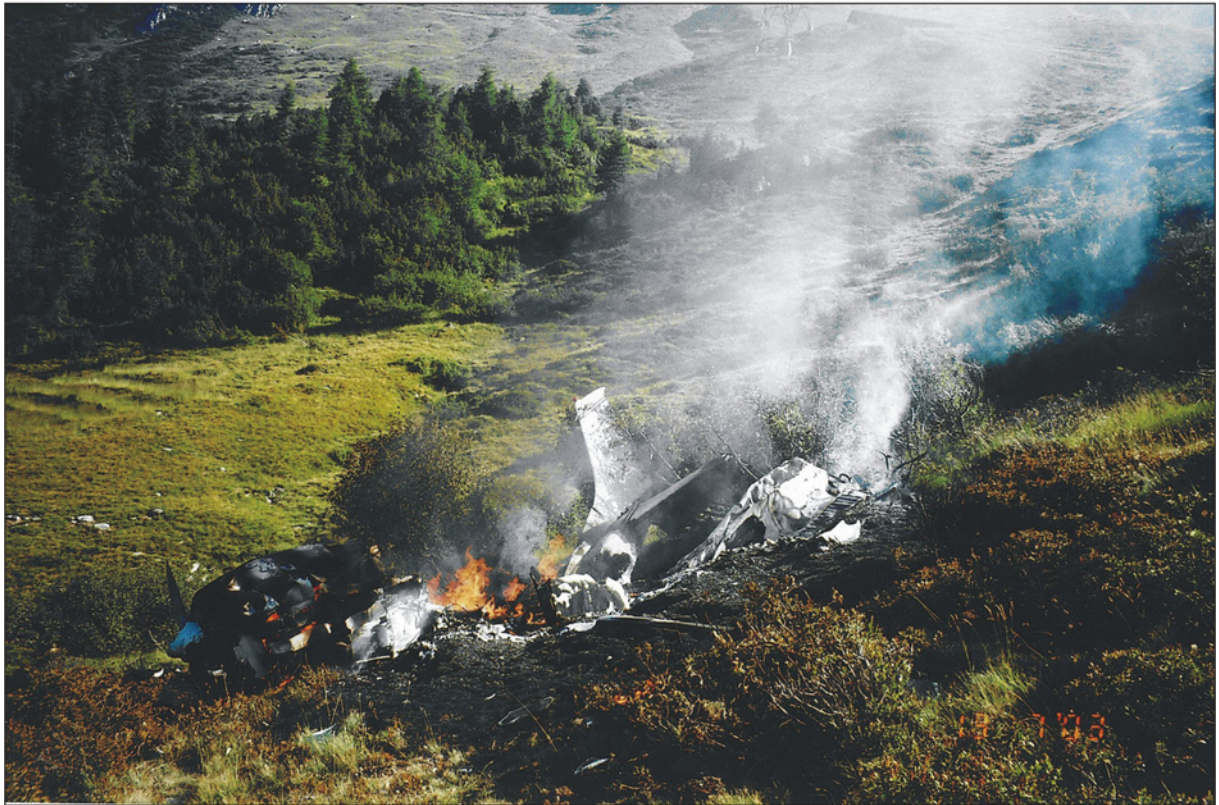
### Appendix 3

The wreck was at the foot of the last rock face, just to the south of the valley with its nose to the west.

The aircraft was almost completely burned. Only the tail, with the elevators and rudder and the remains of the engine with the propeller, were still recognizable.

From the deformation of the remains it can be concluded that the aircraft impacted into the ground following a vertical trajectory, with a virtually horizontal attitude, inclined slightly to the left and forwards.

Site of impact and wreckage

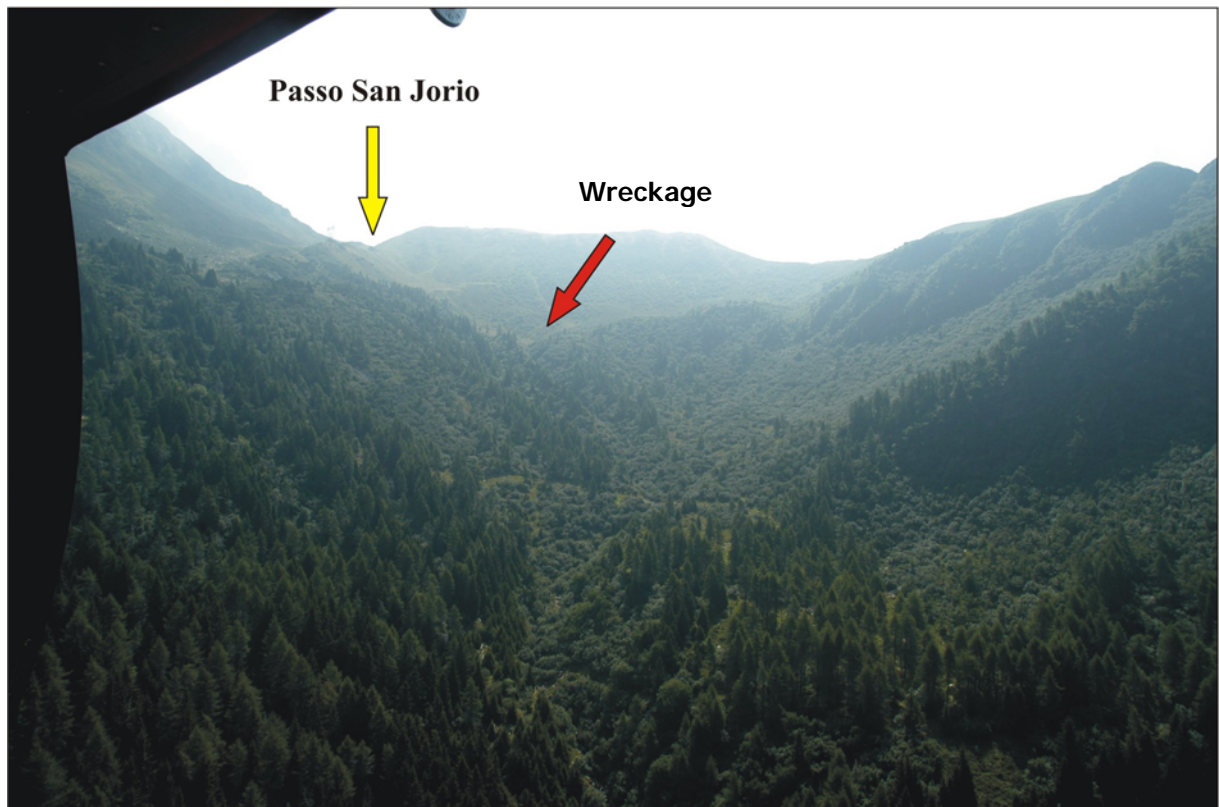
In a climb in an easterly direction, persons unacquainted with the locality might get the incorrect impression that it is possible to fly out of the valley to the left and right respectively (Appendix 3).

Morobbia valley, sight in direction east
