# Final Report No. 1882 by the Aircraft Accident Investigation Bureau

to the aircraft Piper Cheyenne PA-42, D-IFSH

Cirrus scheduled flight RUS 1050

on 28 October 2003

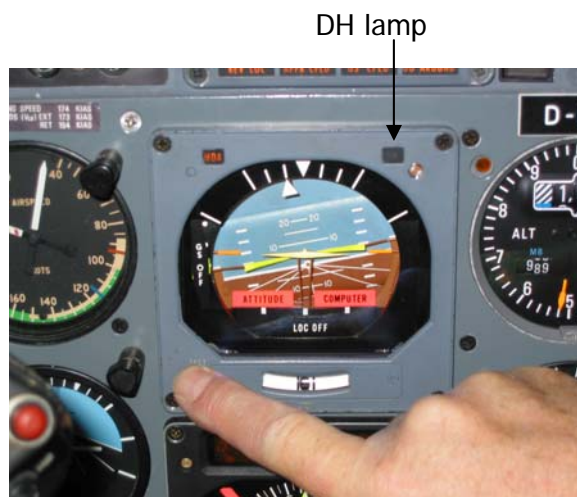
### 1.6.5.5 DH lamp on the flight command indicator

During a self-test on the Flight Command Indicator (FCI) after the accident it was found that the DH lamp on the FCI did not light up. It cannot be excluded that the filament of this lamp was destroyed in the accident. However, this appears improbable, given the relatively mild impact.

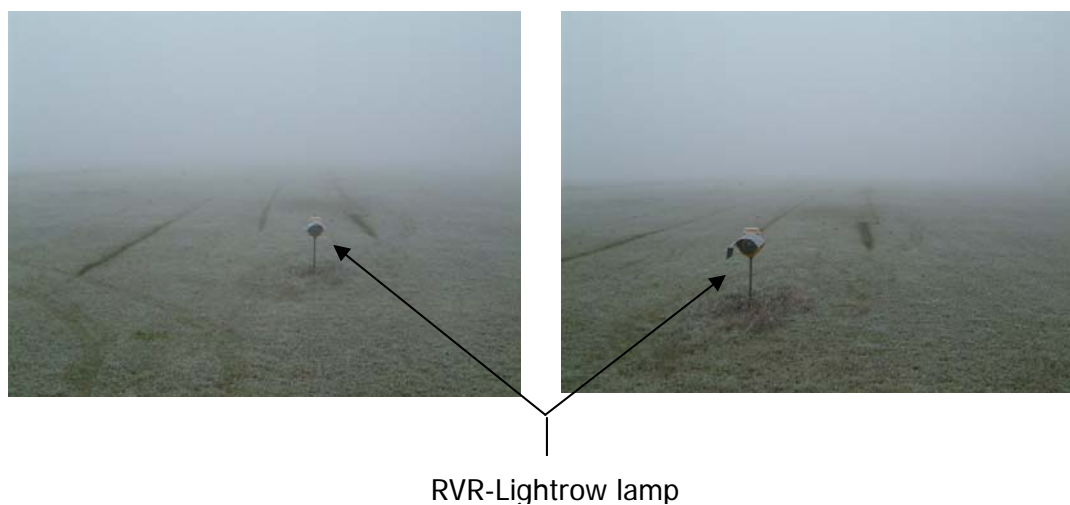
The aircraft touched down immediately after a lamp of the RVR-Lightrow, approximately 770m after the runway threshold. The RVR-Lightrow runs parallel to the runway and approximately 15 m from the right-hand edge and is used to monitor runway visual ranges (RVR). These lamps are equipped with a hood so that they cannot be seen by pilots, in order to avoid confusion with the runway lights. The investigation found that at the time of the accident the RVR-Lightrow was not illuminated.

View in the direction of flight, i.e. in the south-east direction:

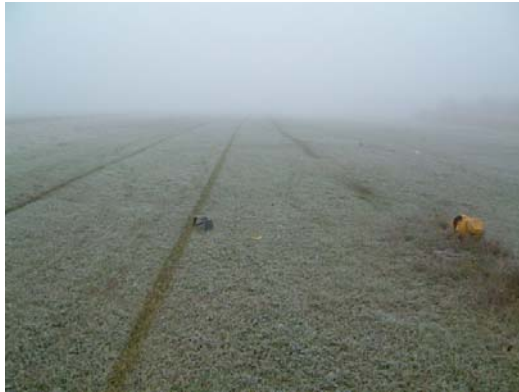
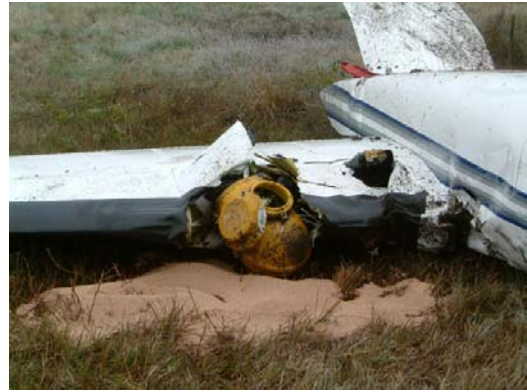
### 1.12.3 Aircraft roll-out

The aircraft initially rolled approximately parallel to the centreline of runway 14. After approx. 100 m the right wing collided with a lamp of the RVR-Lightrow; this wedged itself in the wing and the right main landing gear wheel was torn off by the concrete base of this lamp. From this point the aircraft was deflected slightly to the right, continued to slide for some 300 m and came to a standstill approx. 90 m west of the centreline of runway 14 and some 1200 m after the runway threshold.

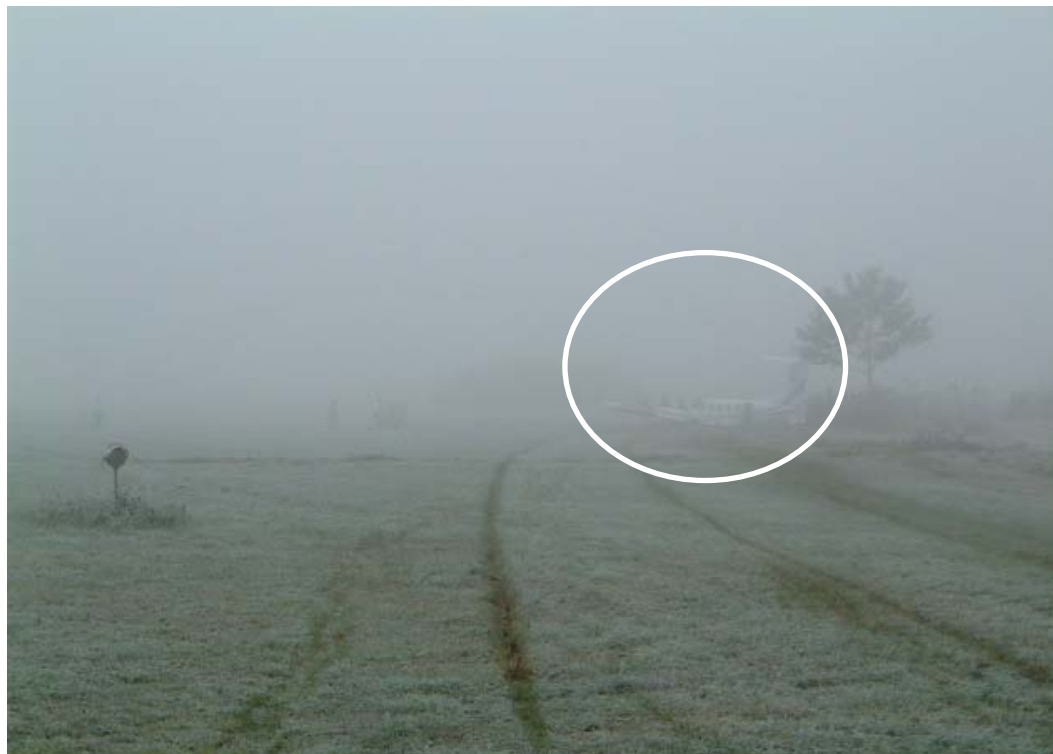
Final position of the wreck of the aircraft between taxiway G and the satellite road (cf. Appendix 3).

Initial findings at the wreck of the aircraft indicated massive damage to the fuselage and propellers.

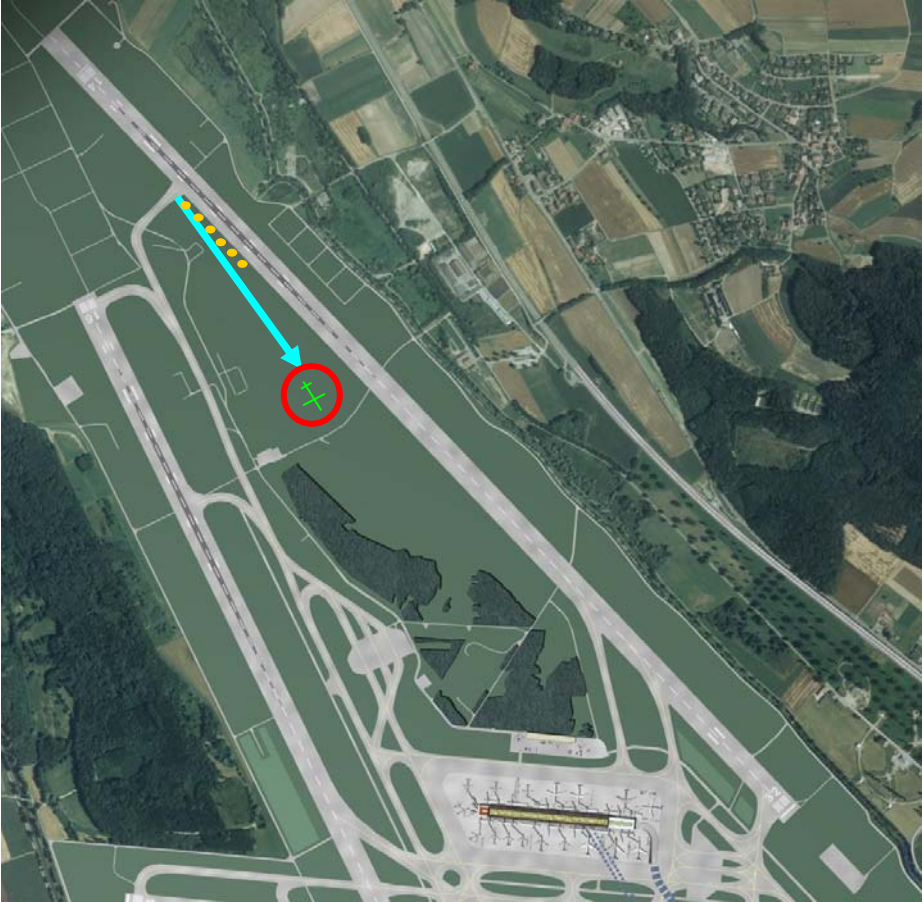
Appendix 3: General overview of the accident site

- RVR-Lightrow
- Approximate ground track and final wreck position
