Final Report No. 1883

concerning the accident
to the aircraft Velocity 173 RG, registration HB-YHB,
in the special self-build category
on 10 July 2003
near Würenlingen AG, approx. 40 km west of Zurich

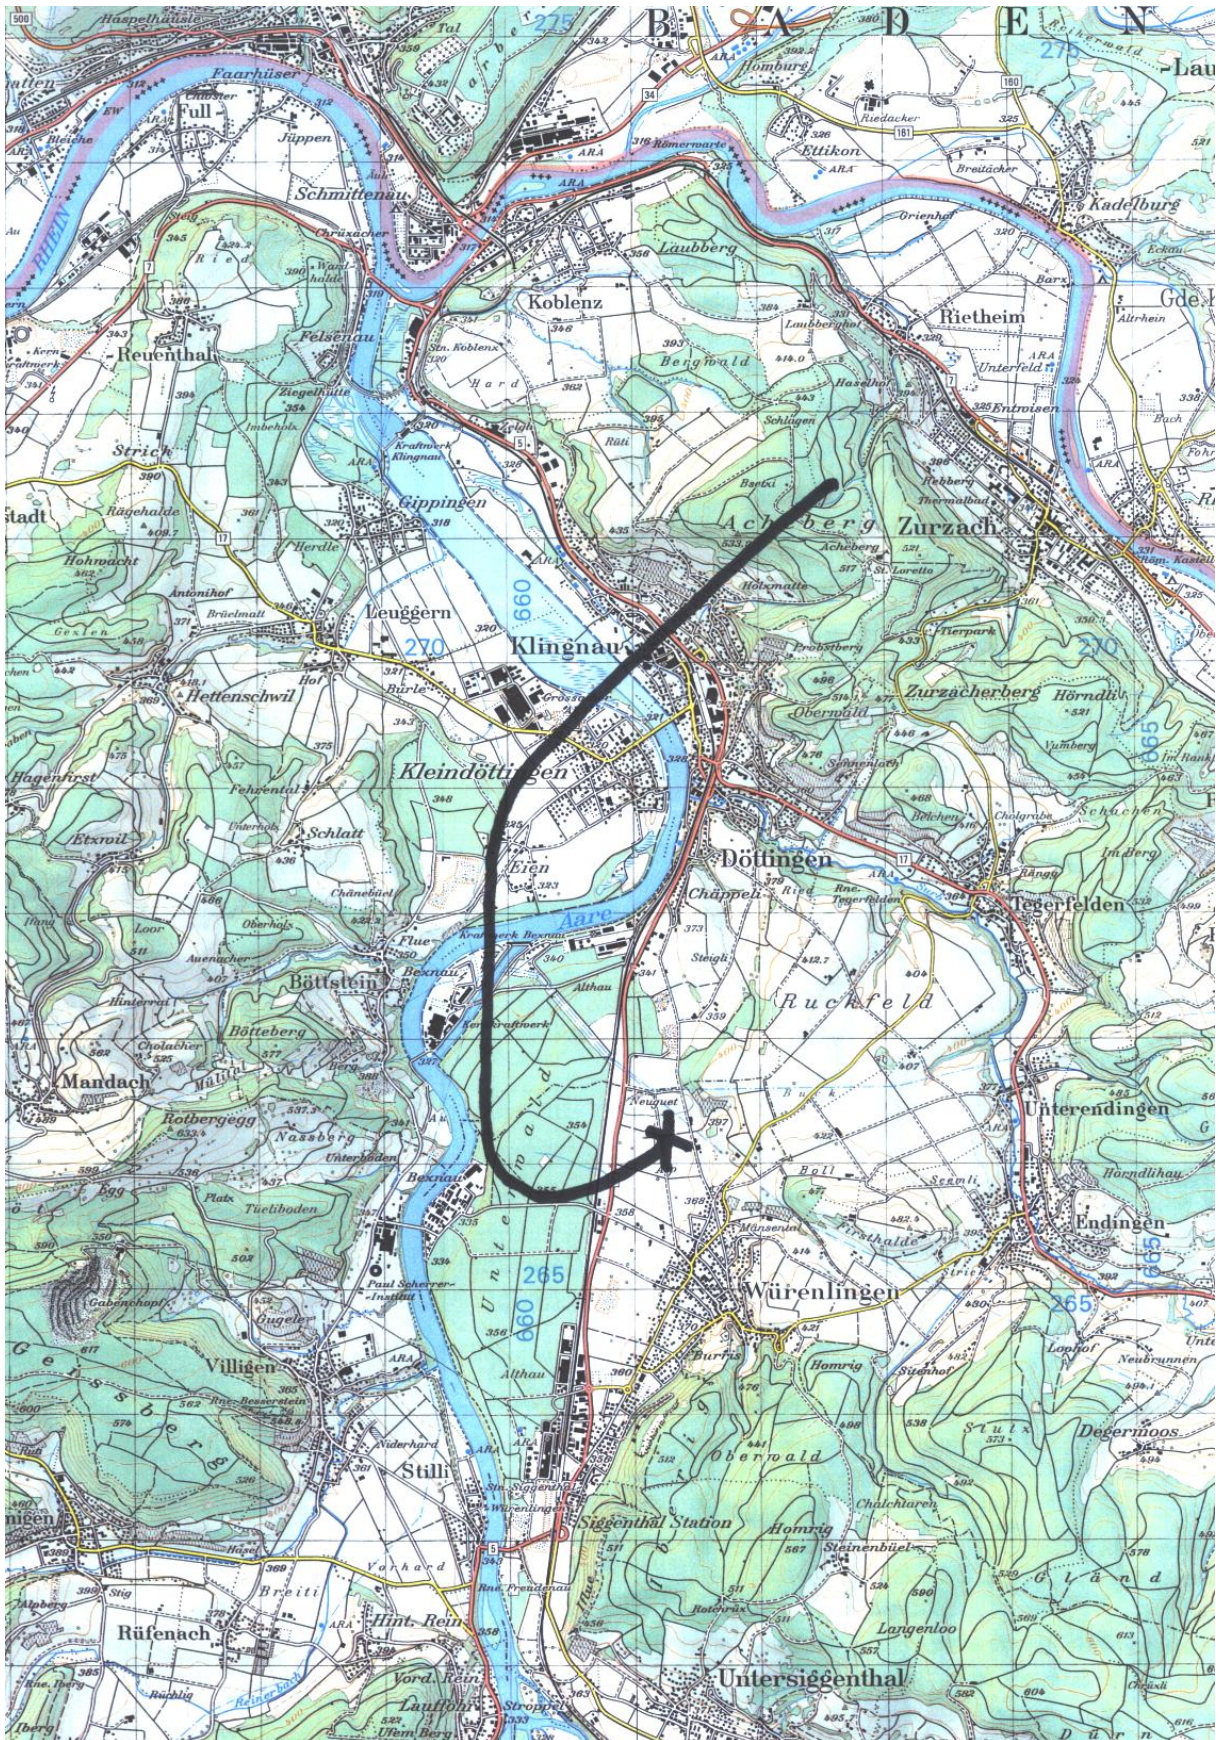
Annex 5.1

Eye witnesses observed the course of events of the accident from various positions around the site of the crash. The statements permit a relatively accurate reconstruction of the flight path and events immediately before the crash (cf. Annex 1).

Flight path

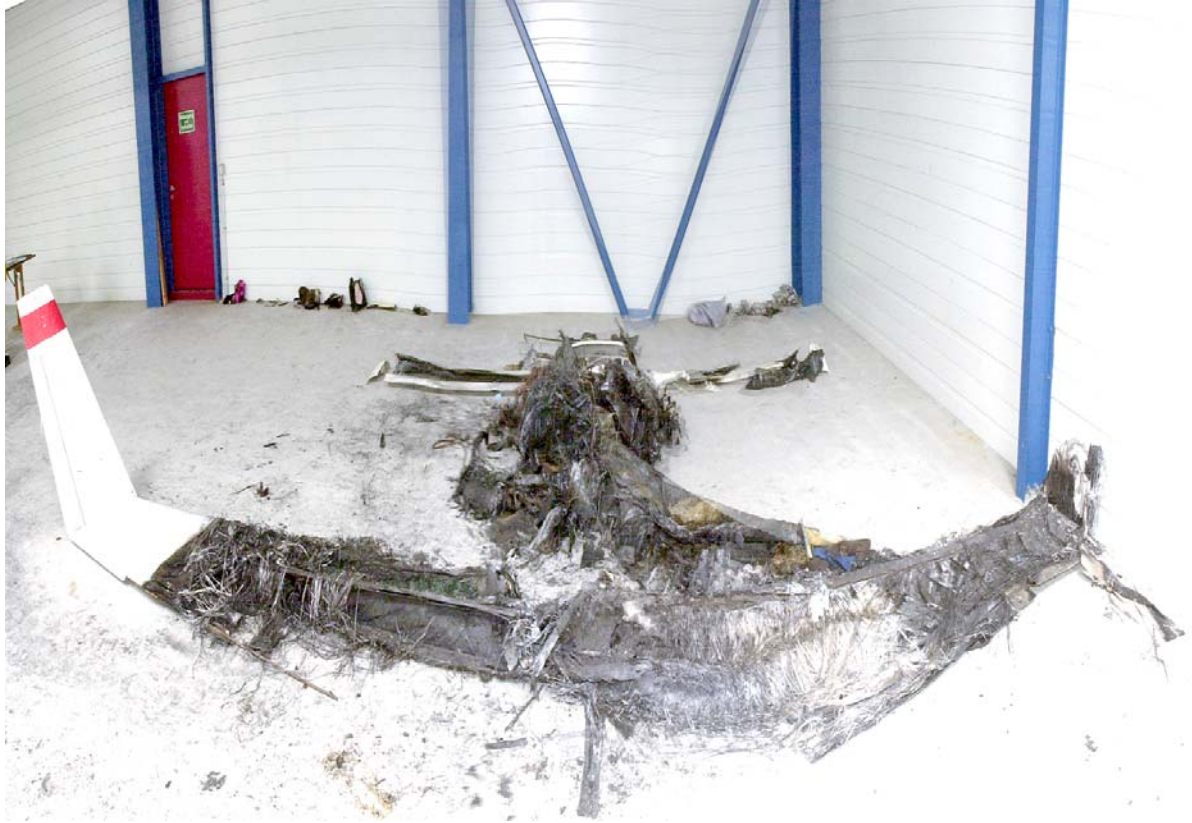
Annex 5.2

The structure was badly damaged by fire. The fireproof bulkhead and the main landing gear components were still attached to the engine, which was separated from the fuselage. The fuselage itself burned out with all of the interior and with the entire cockpit, so practically only the laminate fabric remained. The canard wing pair was largely preserved in its structure, but also exhibited traces of fire (cf. Annex 2).

Aircraft wreck

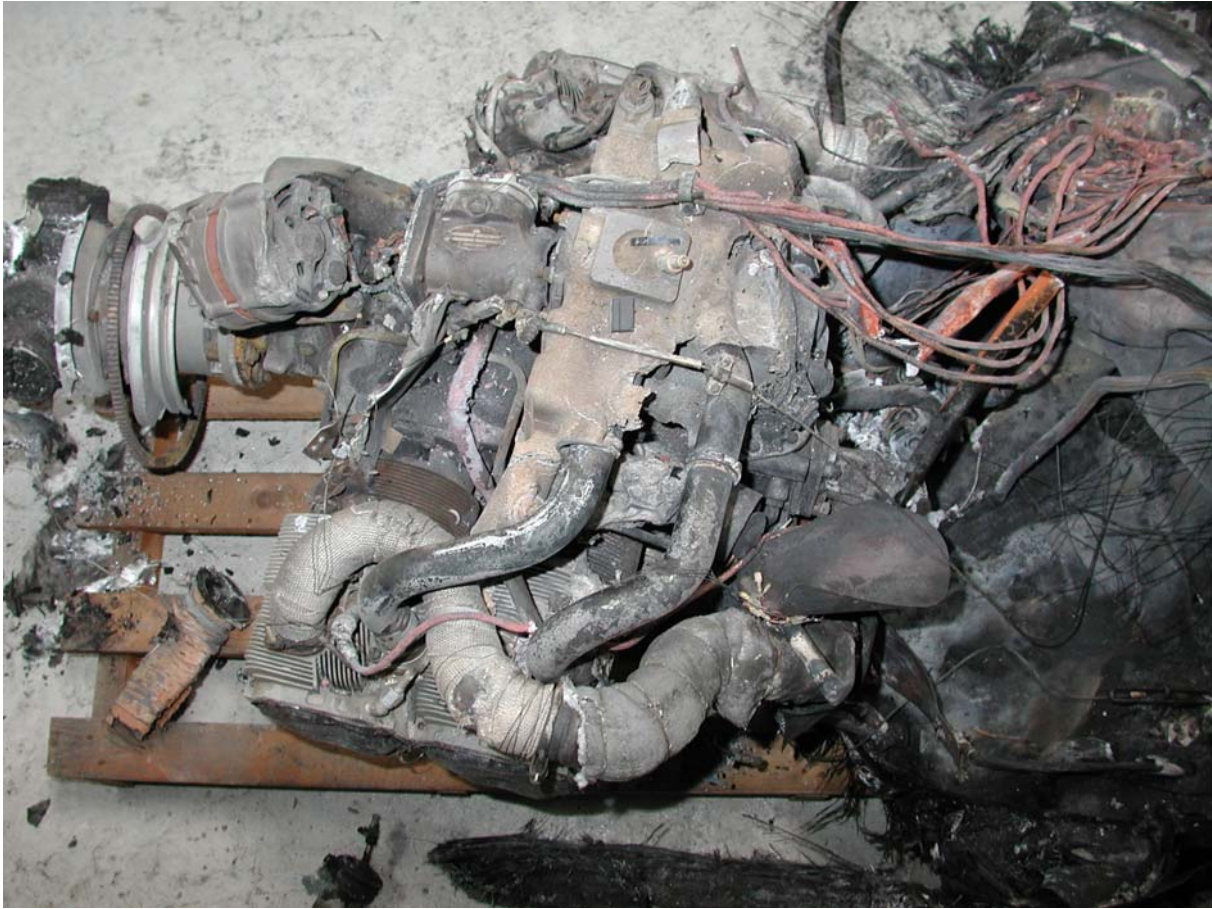
Annex 5.3

From the molten aluminium parts found on the engine, it was possible to determine that the engine finally came to rest bottom up. All combustible material around the engine had been burned away (cf. Annex 3).

A large part of the sump under the engine had melted, causing all the engine oil to leak out and combust. The oil lines mounted on the engine in the factory were all screwed on tight.

Engine

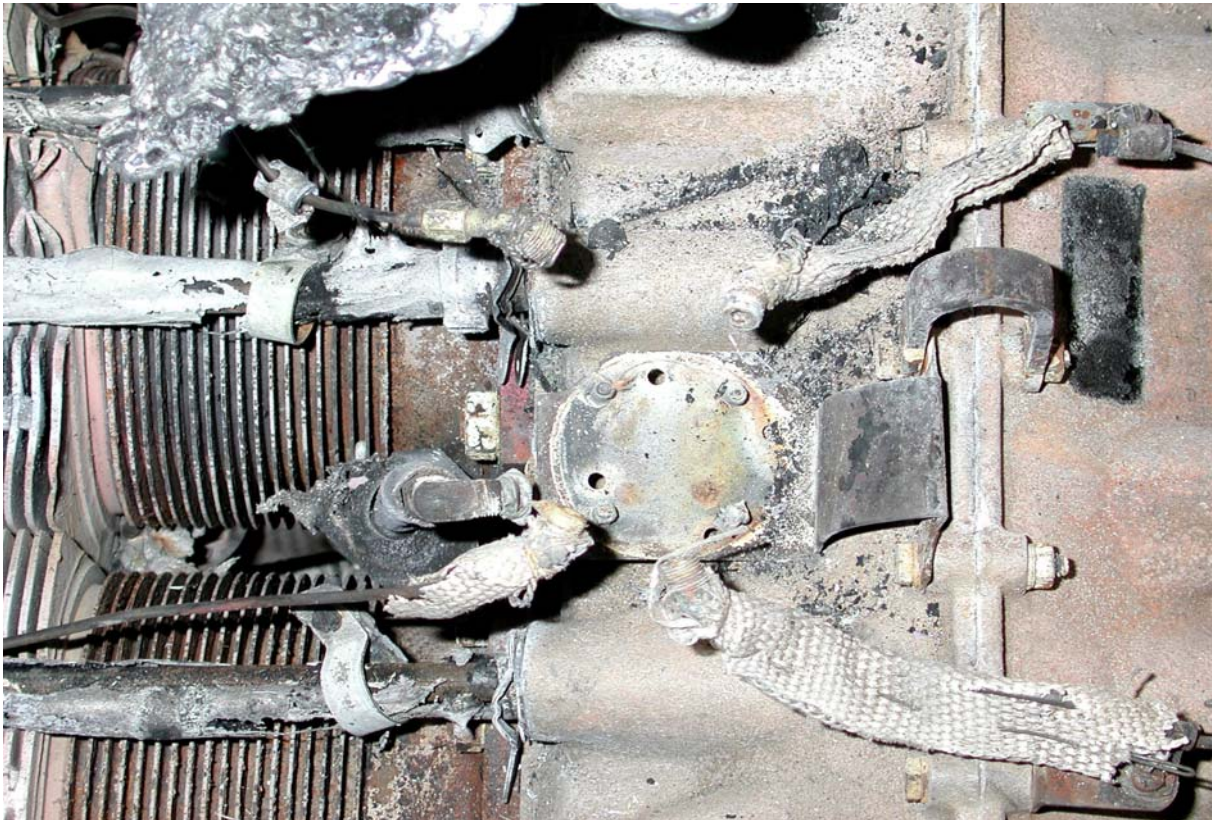
On the top of the engine, the fuel pipe to the divider was still present, as were the four pipes leading from the divider to the cylinders. The latter were covered with fire sleeves. The divider itself had melted. Stereomicroscopic examination of the fuel pipes revealed no indications of damaged areas. No conclusive statements can be made about how sound the unions were. It can be assumed that these were checked at the time of the 100 hour check two months prior to the accident.

Top of engine
