# **Final Report No. 1885 by the Aircraft Accident Investigation Bureau**

concerning the serious incident  
to the Dassault Falcon 2000 aircraft, N105LF  
on 24 October 2004  
at airway position BAMUR

## Final Report

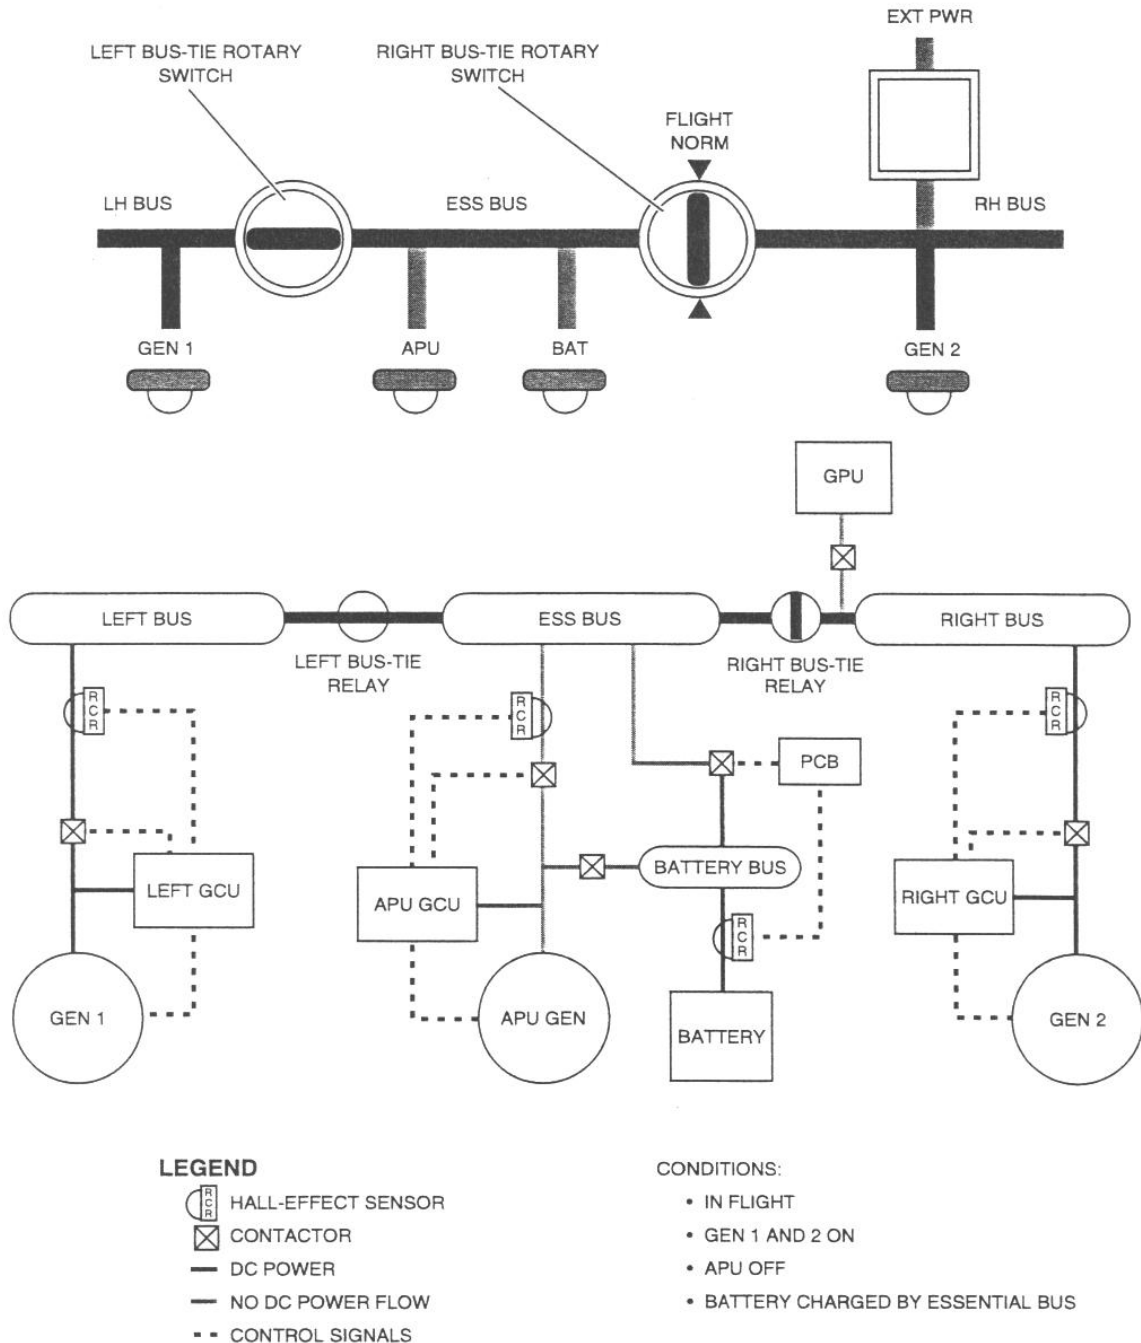
**Figure 2-8. DC Electrical System**

In case of a generator 1 fault, the checklist provides for the right bus tie rotary switch to be selected to the TIED position in order for the essential bus to be supplied by the generator 2 and consequently the battery being charged. If the left bus tie rotary switch stays closed, the left bus will be powered by the generator 2 (Annex 1).
