Final Report No. 1894 by the Aircraft Accident Investigation Bureau

concerning the serious incident
to aircraft AVRO 146-RJ100, HB-IYX
operated by Crossair under flight number SWR 3513
on 13 July 2000
on the ground at Zurich-Kloten airport

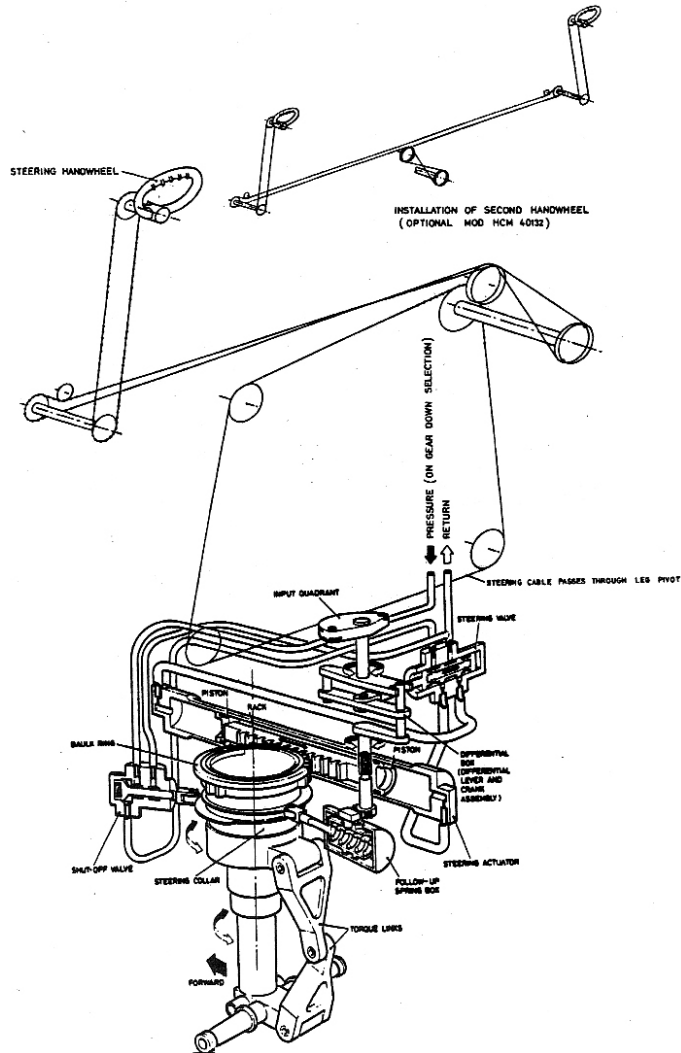
fig. 1

The basic nosewheel steering system on the BAe146/RJ consists of either a single (left side Captain's console only) or double tiller (both sides). The tiller drives a cable/chain circuit to the differential box at the rear of the noseleg. See Fig 1 (Appendix 5.1)

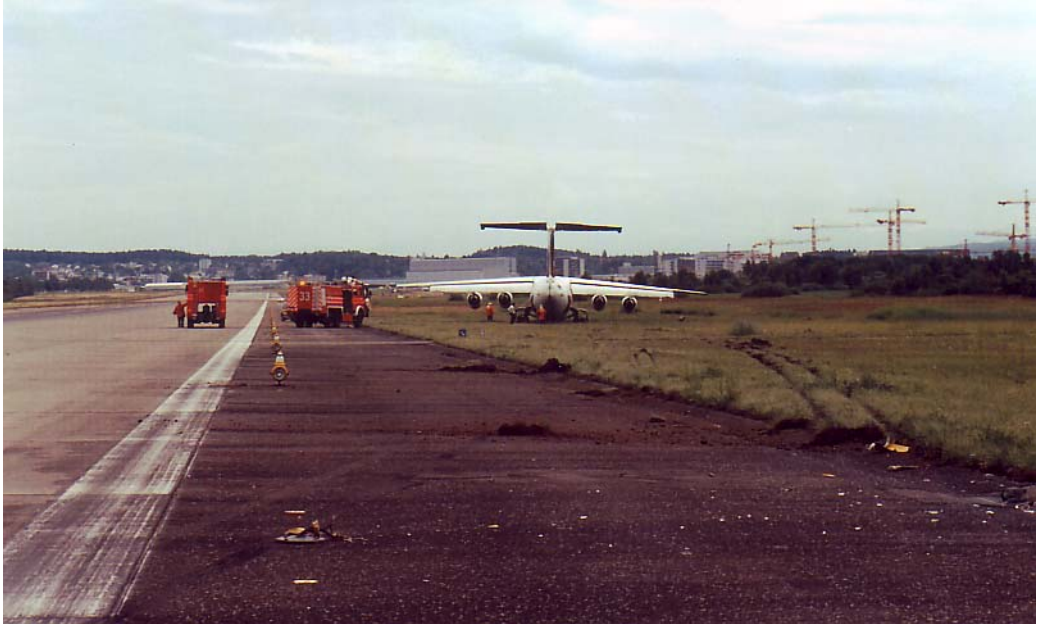
Zurich-Kloten airport, runway 14, approximately 700 m after the touchdown zone on the grass, approximately 20 m to the right of the runway. The aircraft came to a stop approximately parallel to the centre line of the runway (Appendix 5.2).

Position of HB-IYX after the serious incident

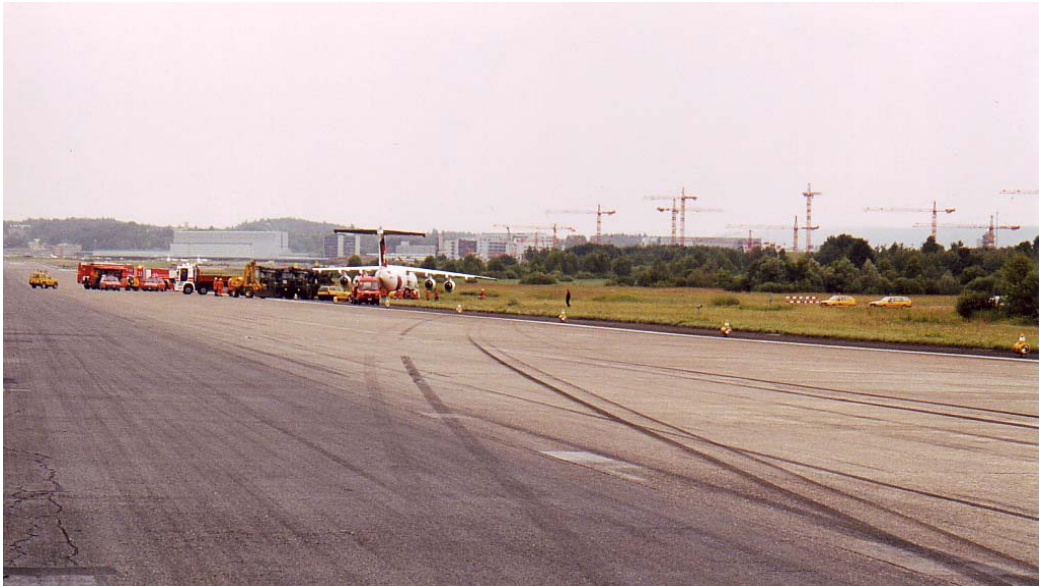
Tyre traces of HB-IYX on runway 14

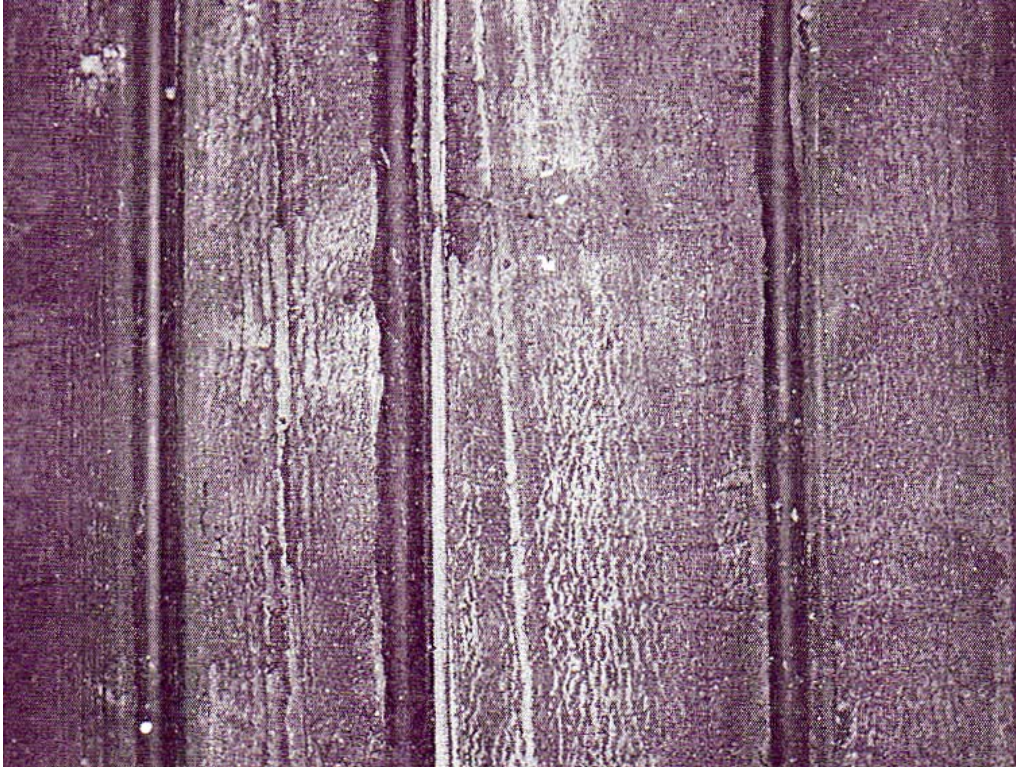
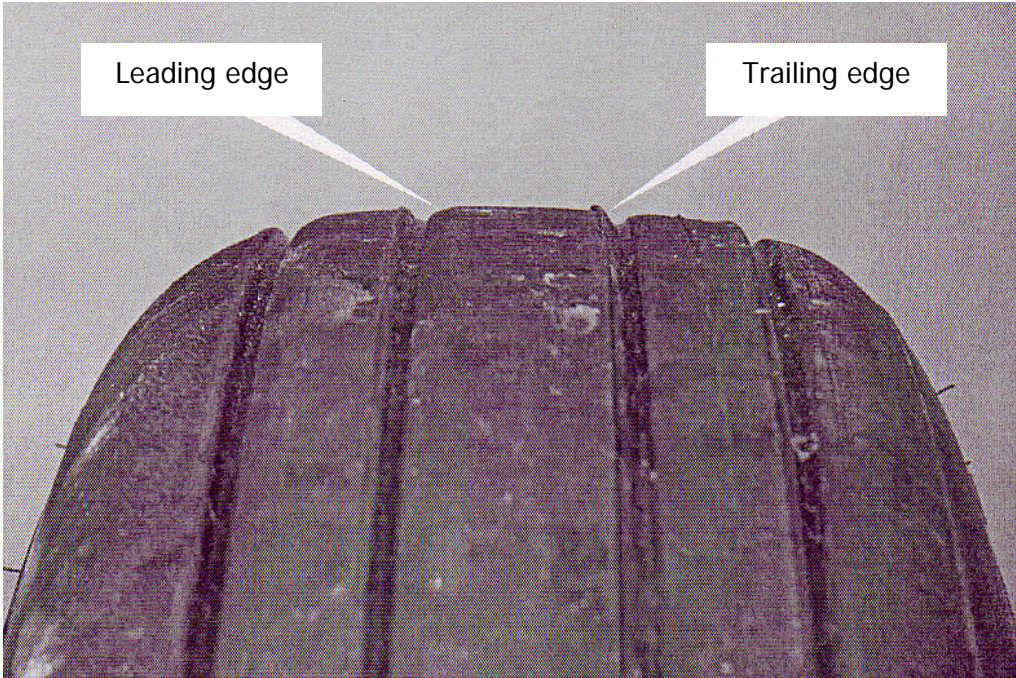
5.3 Pictures on the investigation of the nosewheel tyres

"(...) During the analysis we found scratches running under an angle of approximately 5° and some other ones in an almost radial direction. We did not find any skid marks so the tire did not stop rotating during landing. Due to the rotation, the angle of none of the scratches found in the tread surface will match the angle between the wheel and the direction under which the aircraft was travelling. (...) Review of the tread shows an abnormal tread wear, confirming the presence of such angle. On one side of the each rib, the edge shows wear while there is a ridge on the other side of the ribs. Due to the angle between the wheel and the travelling direction, the leading edges of the ribs started to wear faster while the trailing side the edge was pushed down into the groove. (...)"
