# **Final report No 1896**

# **Australian Transport Safety Bureau**

to the Cessna 421C aircraft, HB-LRW

### Cessna Aircraft Company 421C, HB-LRW

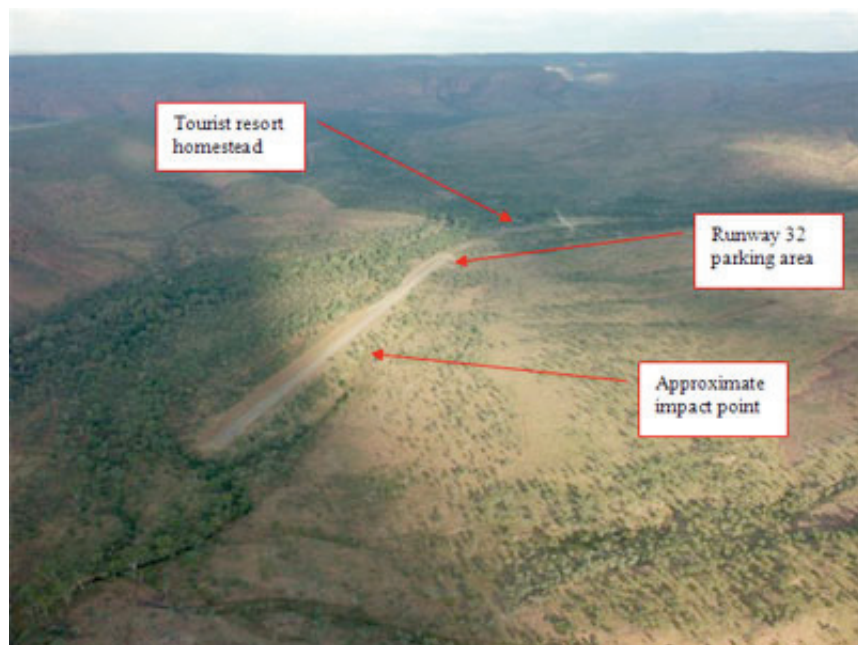
**Figure 1: General location of the accident site**

The accident site was located on level ground, alongside a dry creek bed about 106 m to the left of the runway centreline and abeam a point on the runway about 888 m from the runway 32 threshold. A photograph of the general location of the accident site is at Figure 1. Groupings of rocks were located about the site and the surrounding light scrub was interspersed with isolated larger Boab and other trees.

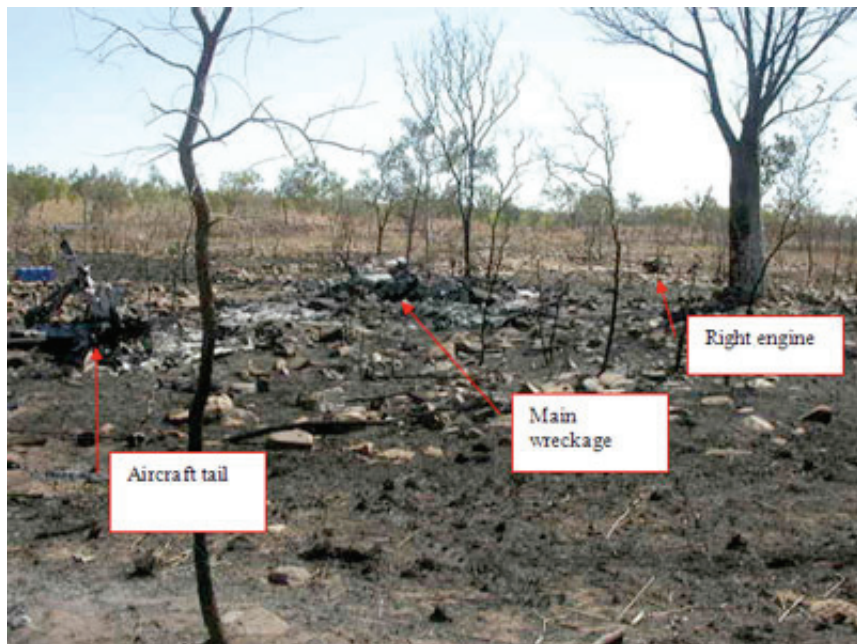
**Figure 2: Aircraft wreckage**

The aircraft impacted the ground about 33 m beyond the last tree, in a left wing low attitude and cartwheeled counter-clockwise. The right wing and tail then struck the ground. During the impact sequence, the right engine separated from the airframe mounts and was thrown about 26 m from the main wreckage and the tail section separated from the aircraft. The main wreckage came to rest upright, with the nose of the aircraft facing south-east. All structural components and flight control surfaces were accounted for in the vicinity of the impact point. A severe post-impact fire destroyed the majority of the aircraft's fuselage, wings, tail section, cockpit and cabin, and damaged the left engine. The right engine sustained minor fire damage from a scrub fire that was started by the aircraft fire. A photograph of the aircraft wreckage is shown at Figure 2.

Both wing structures were destroyed by the fire. The right wing forward attachment point was intact and the aft spar was fractured in overload consistent with upward loads in excess of design limits. The left wing structure had separated at the wing spar outboard of the engine nacelle, having also failed in overload due to the ground impact.
