# **Final Report No. 1901 by the Aircraft Accident Investigation Bureau**

concerning the serious incident  
to the aircraft Embraer 145 LR, I-EXME  
operated by Alitalia Express under flight number AZA 568  
on 3 August 2001  
at Zurich Airport

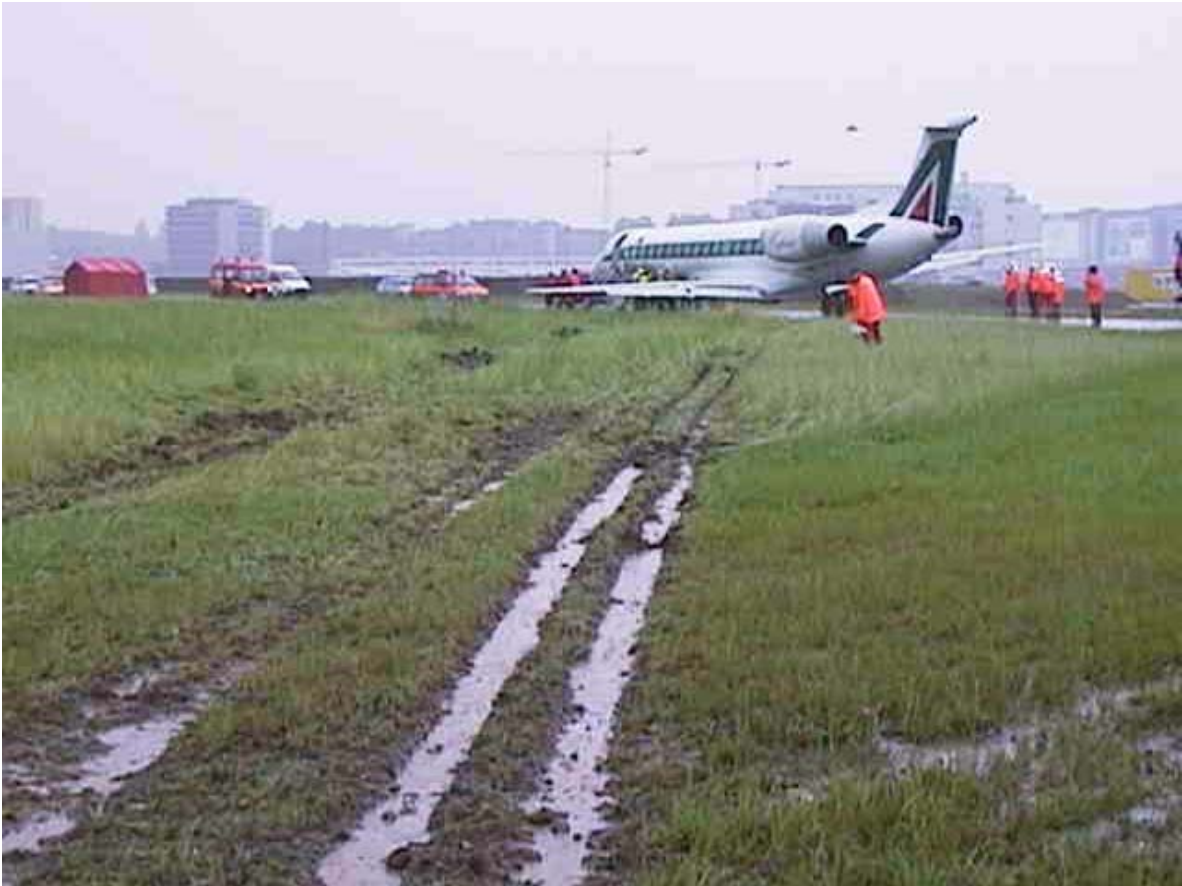
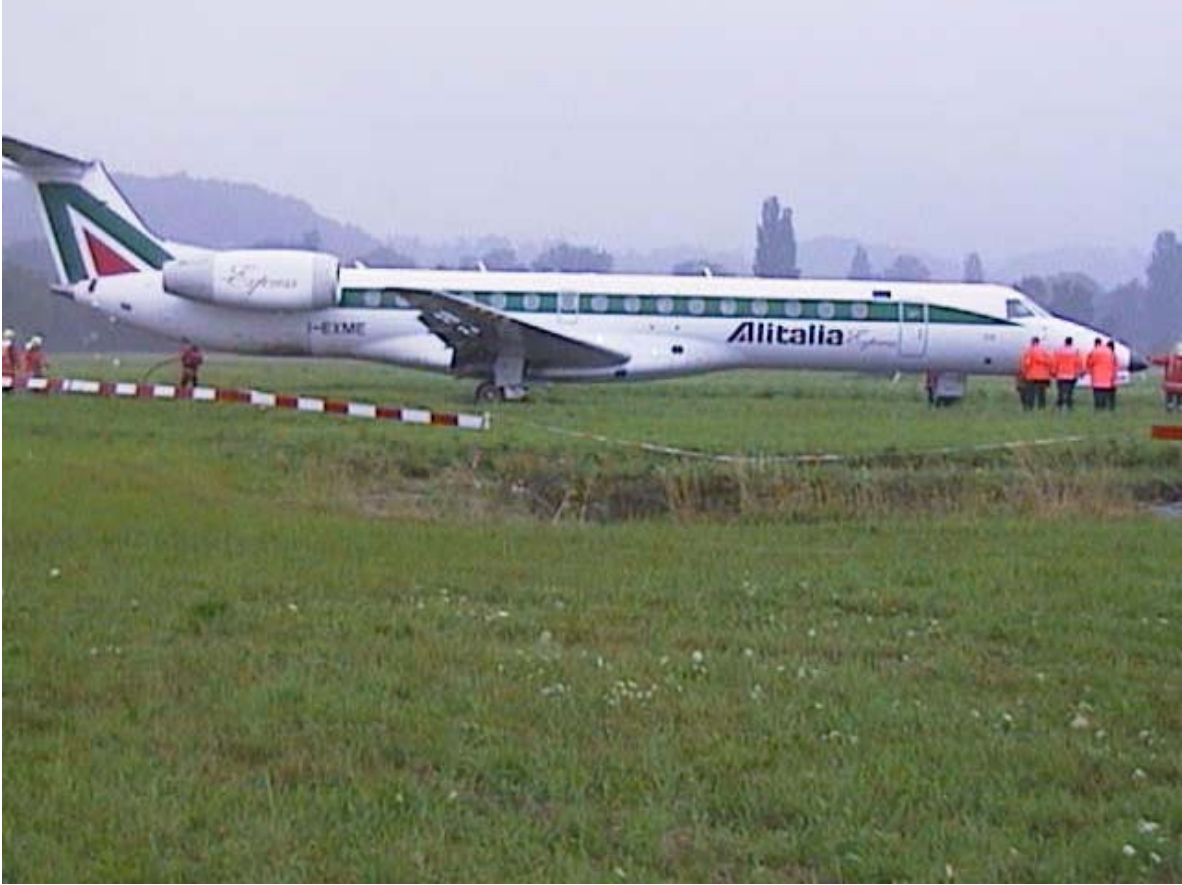
### Appendix 3: The site of the incident

Eighteen seconds after flying over the landing threshold and between 1500 and 1700 m before the end of the runway, I-EXME touched down on the wet runway 14 with flaps set in the 22° position and at a speed of 167 KIAS. The crew tried to bring the aircraft to a halt on the remaining section of runway using the wheel brakes. The reversers could not be used for technical reasons. Finally, the aircraft was still travelling too fast to be able to vacate the runway via taxiway H3. On a heading of about 170° and a track of approximately 160° I-EXME skidded over the southern shoulder of taxiway H3 onto the grass and came to rest after approximately 150 m on a road within the aerodrome perimeter.

There was minor damage to the ground.

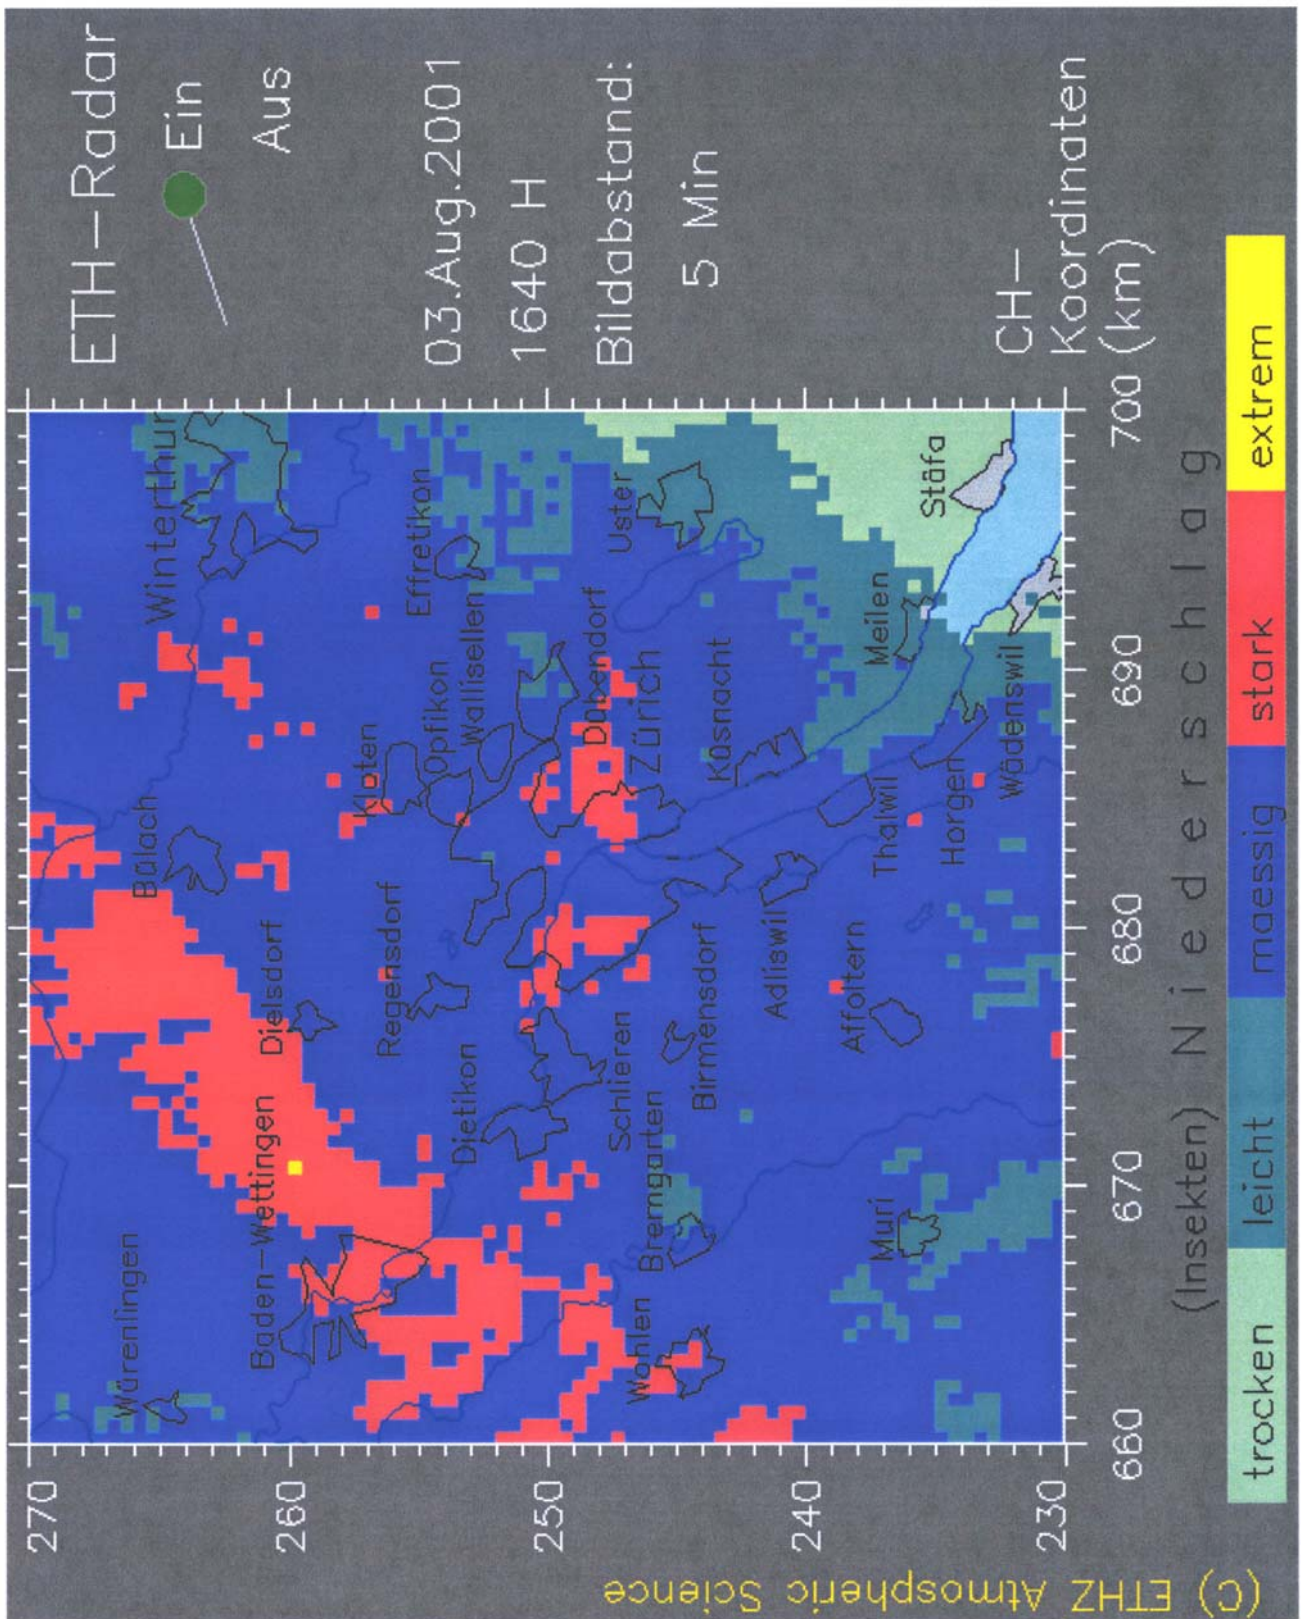
### Appendix 4: Plot of Doppler weather radar of the FIT for 14:40 UTC

During the last 8 NM of the final approach, the ground speed averaged 227 kt. Between 6 and 2 NM ILS-DME distance, I-EXME flew through a zone of heavy rain (cf. Appendix 4). At the edge of this rain zone, the DFDR briefly indicated a maximum tailwind component of approximately 40 kt. This tailwind component reduced to zero over the remaining flight path to the landing threshold.
