Final Report No. 1902 by the Aircraft Accident Investigation Bureau

to the helicopter, Eurocopter France/Aerospatiale AS350B2, HB-XJC

on 30 April 2002

Zermatt Heliport, Zermatt Municipality / VS

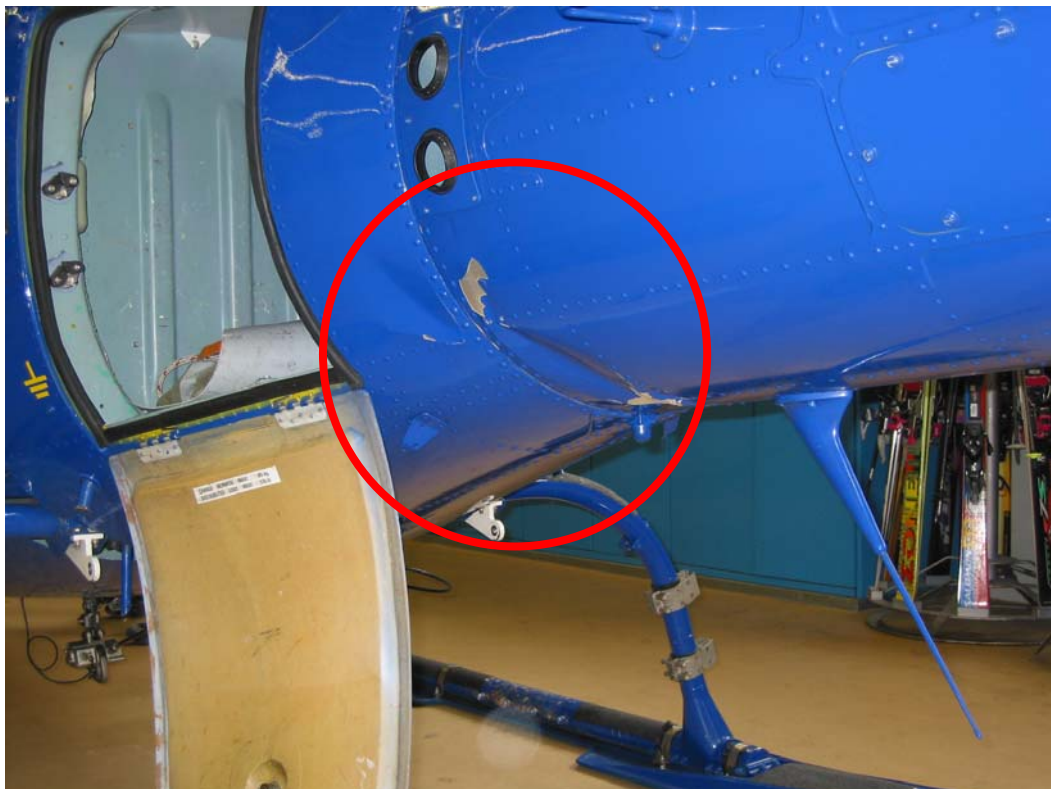
After taking over the helicopter at Zermatt Heliport, the pilot started the engine. After the start-up procedure had been completed and the pilot prepared for take-off, he felt strong vibrations with ground resonance. Eye witnesses heard a howling noise. The helicopter lifted off, in an uncontrolled manner. At approximately 1 m above the ground, the pilot reduced power and the aircraft fell back to the ground. As it did so, the helicopter rotated about 90° around its vertical axis and landed hard on the skids. Visible damage was found at the joint between the fuselage and the tail boom.

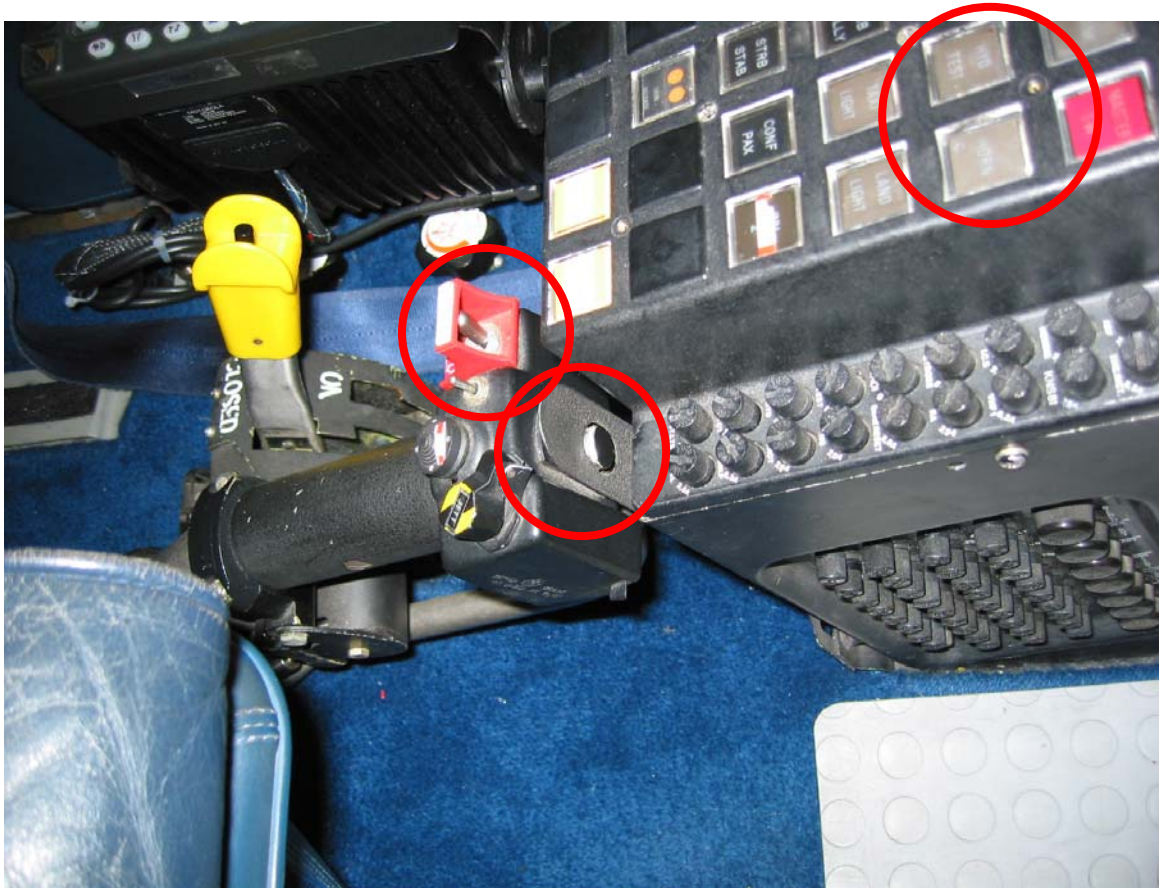
hyd press isolation switch, collective with the locking plate,
pushbutton hyd test and pushbutton horn

The hydraulic accumulator test (console pushbutton) and above all the hydraulic pressure isolation check (collective switch) generate pressure surges in the control system. In association with the general vibration of the helicopter, this may lead to an unnoticed release of the collective if the locking device is worn or not completely engaged respectively it may lead to a rapid, unnoticed increase of the pitch if the collective is not locked. If, during the hydraulic accumulator test, the accumulators are fully emptied as a result of too many major control movements, or if, during the hydraulic pressure isolation check, the collective is not additionally secured with the hand, this may cause an unintentional lift off.

The hyd test pushbutton is positioned on the console in the vicinity of the horn pushbutton of the aural warning system, which must be switched on at the latest before every take-off.

The manipulations in the area of the hydraulic system, hydraulic test pushbutton and hydraulic isolation switch demand a deliberate, controlled procedure in connection with the operation and control of the cyclic and collective.

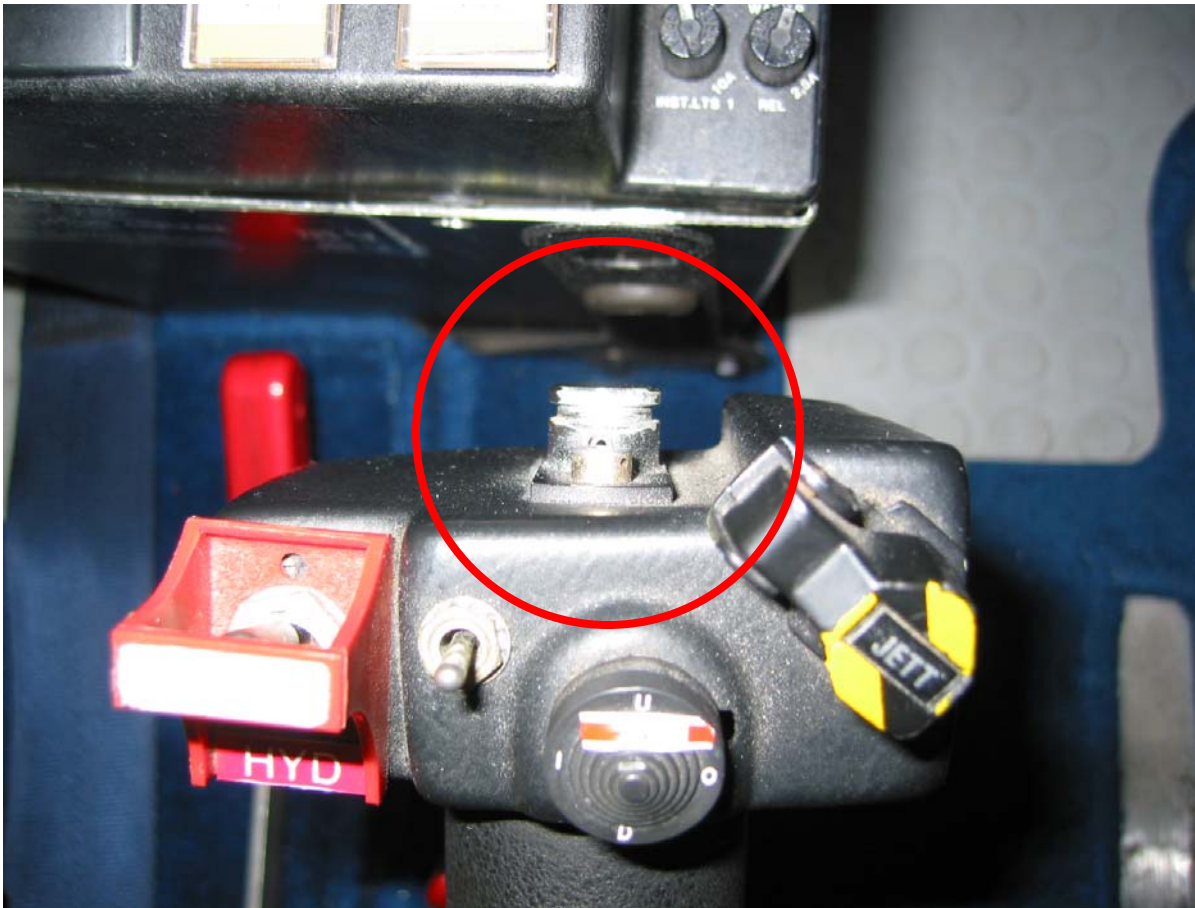
The dimensions of the engagement groove on the collective locking head and of the locking plate as a counter-piece were within the specified tolerances.

Engagement groove of the collective locking head
