# **Final Report No. 1909**

**concerning the accident**

of the aircraft Pilatus PC-21, HB-HZB, Prototype P02

on 13 January 2005

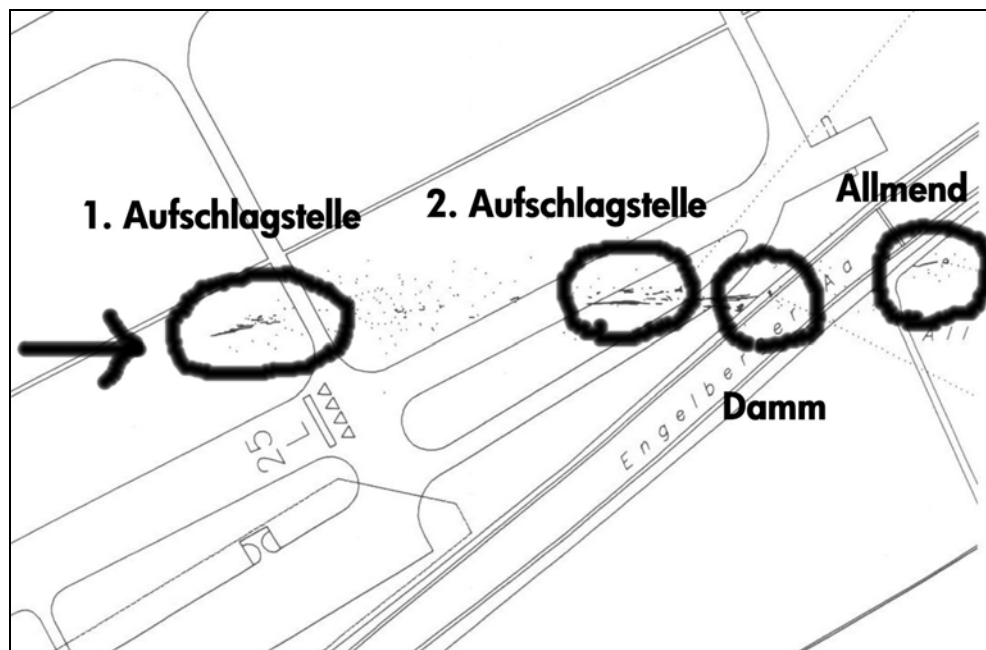
1<sup>st</sup> point of impact

2<sup>nd</sup> point of impact

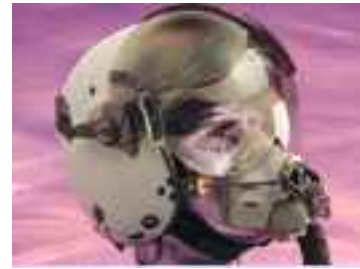
According to AFM 02 operating limitations, after arming the ejector seat one of the two helmet visors must be lowered and locked in this position. On the basis of indentations and deformations on the helmet and visors, and from the position of the visor mechanism, it was possible to establish that at the time of impact the position of the transparent visor was approximately 8 cm further down than the dark visor.

The dark visor (glare protection) was in the area of the upper locking position at this time. From this it can be concluded that the transparent visor had been used.

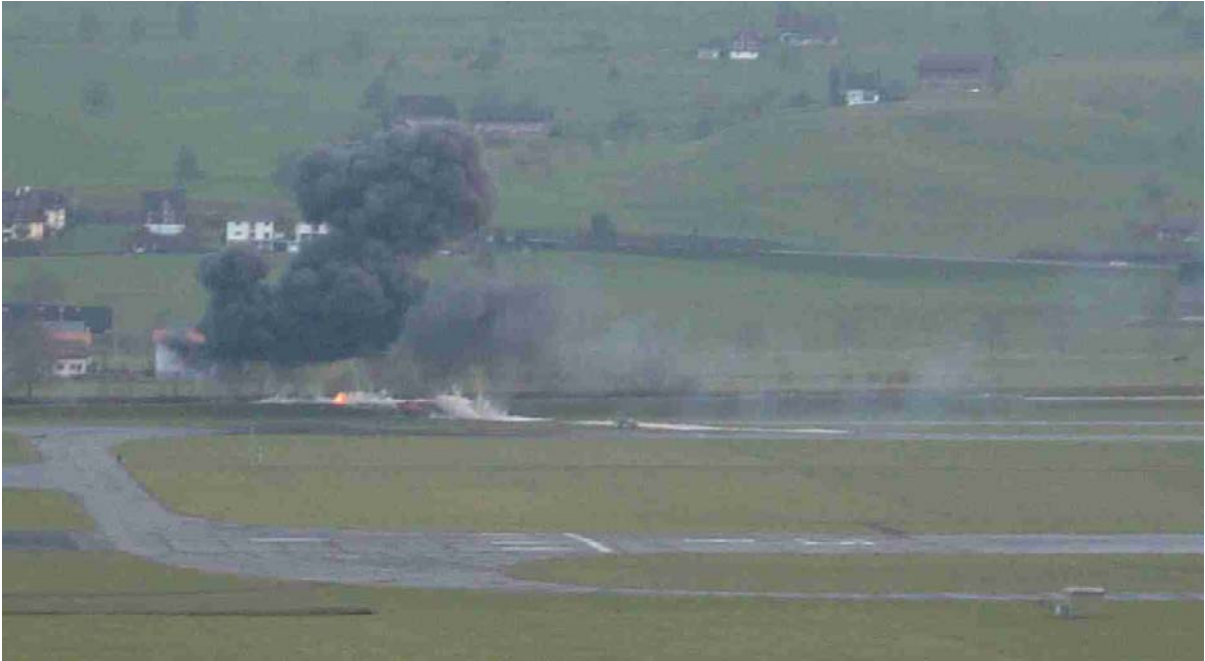
Smoke over the dam of the *Engelberger Aa*

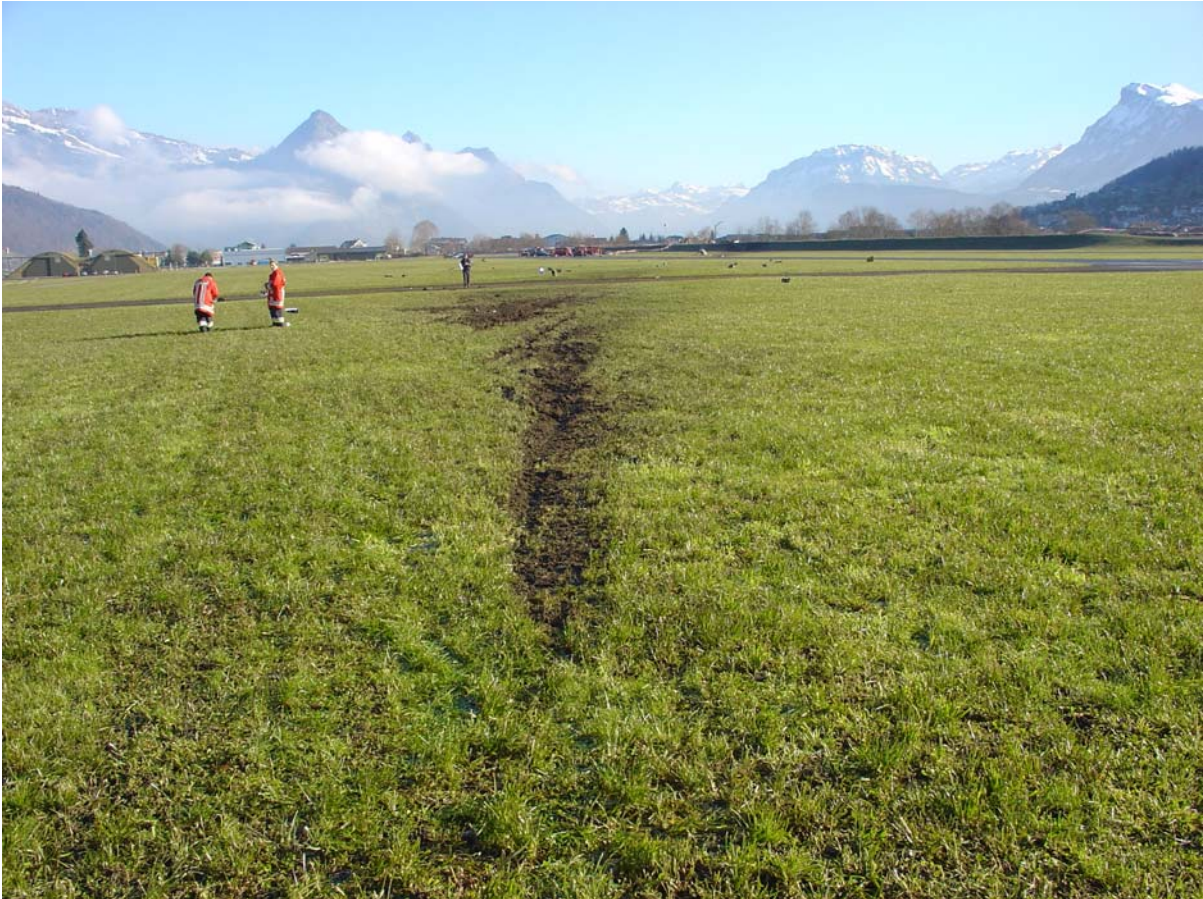
First traces of right wing impact

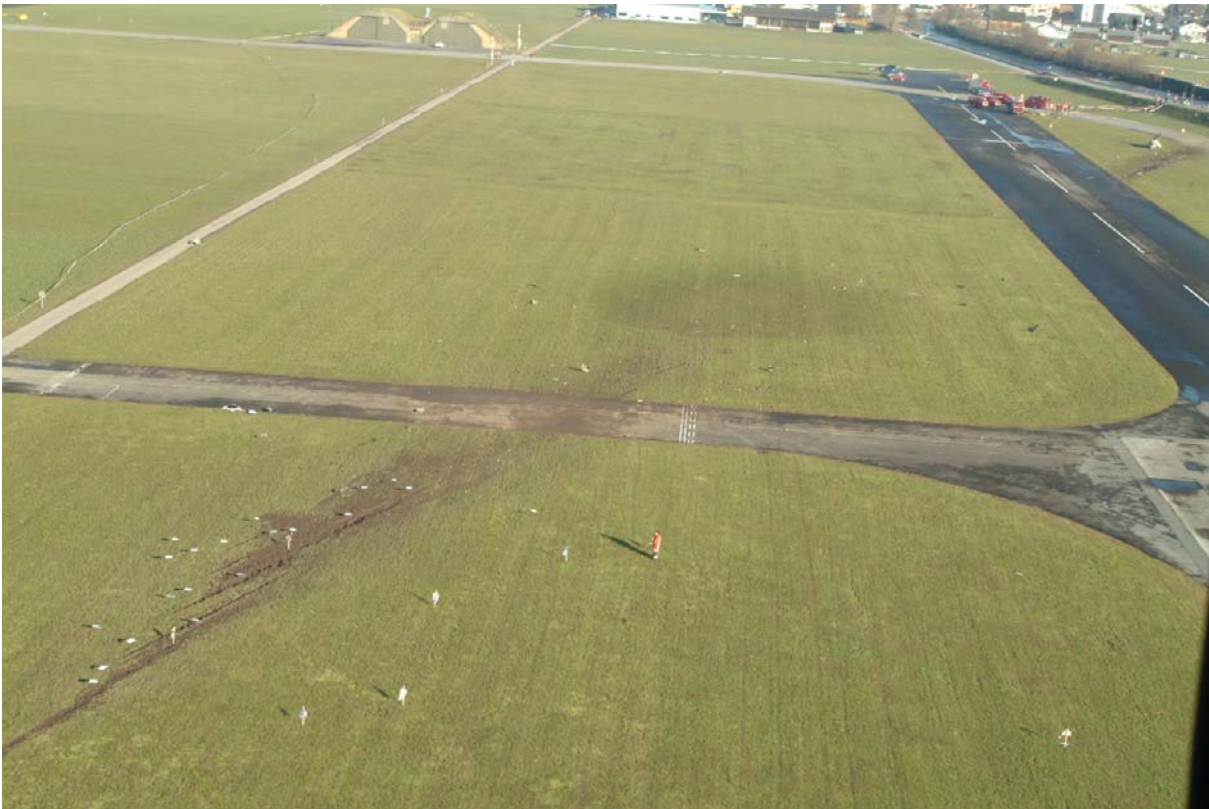
First point of impact and second point of impact plus detached tail in rear

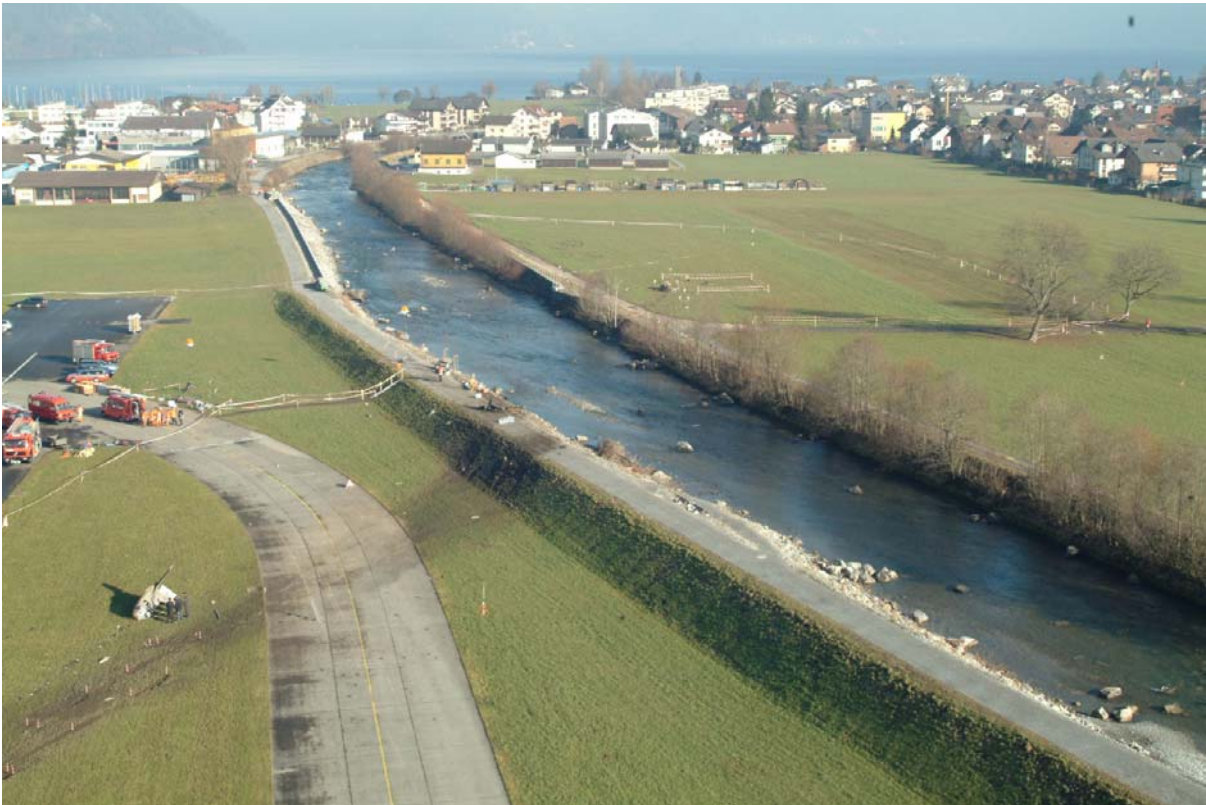
Tail and point of impact on the dam; behind the cockpit in the area of Buochs

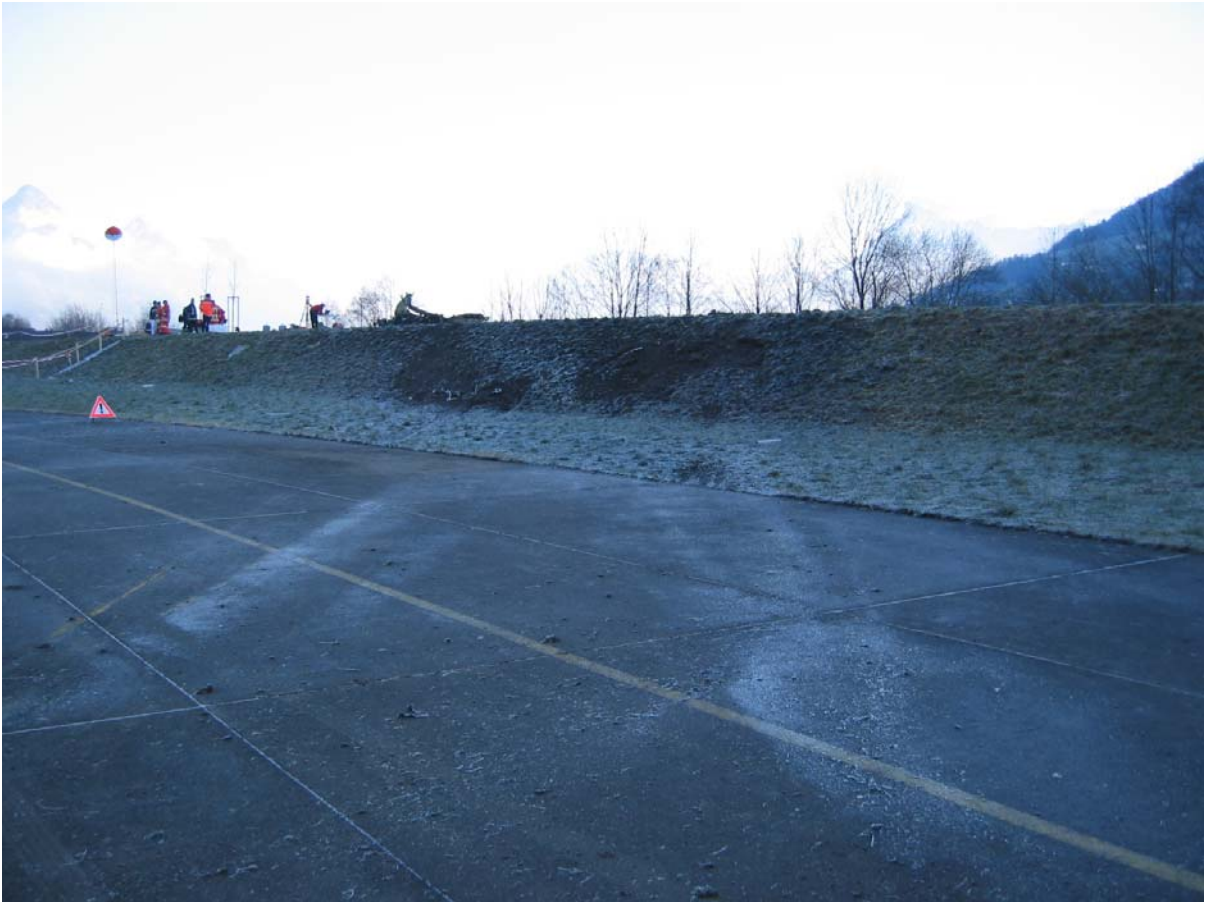
Point of impact on the dam of the *Engelberger Aa*

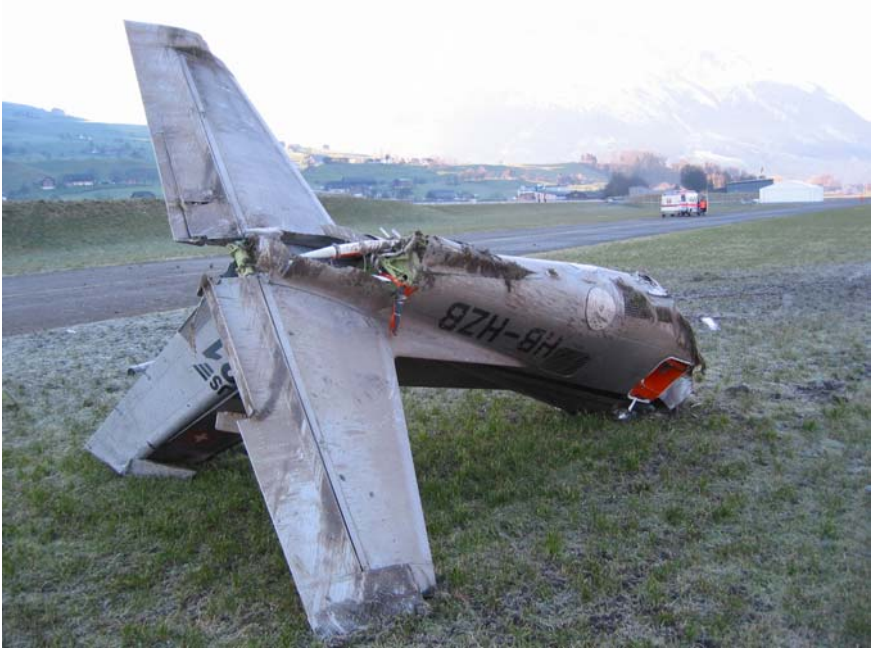
The rear section of the fuselage which had separated from the aircraft lay at the end of the second point of impact. The rudder and the two elevators together with the corresponding trim tabs were secured to the rear section of the fuselage, with minimal traces of impact. From the parts found it was not possible to draw any conclusions concerning the rudder/elevator settings and trim before the impact.

Final position of the tail

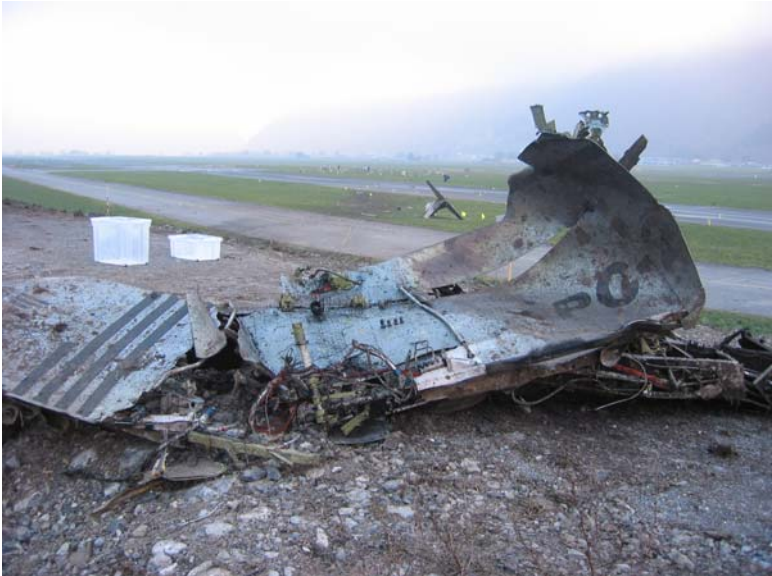
The central section of the wing with the main gear, severely damaged, lay on the embankment of the Engelberger Aa river.

Final position of wing main- spar / fuel tank section

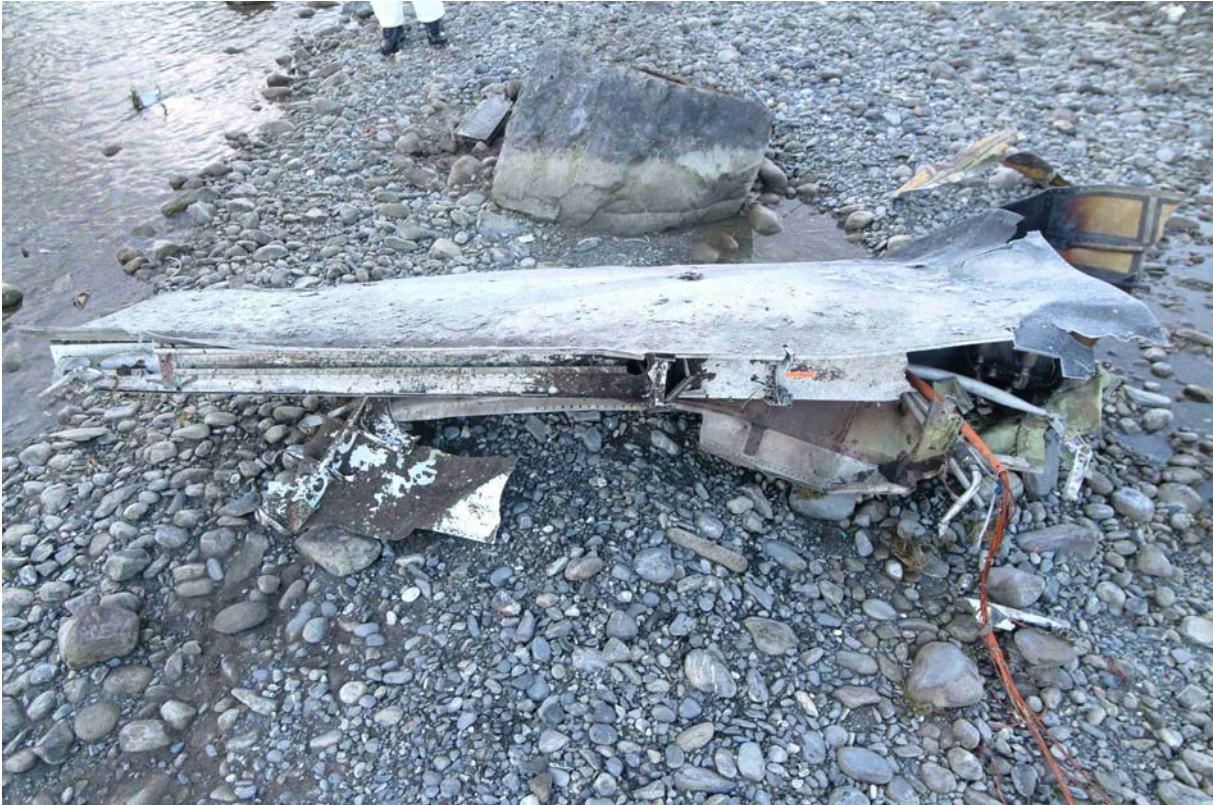
Skin of left wing on the board of the *Engelberger Aa*

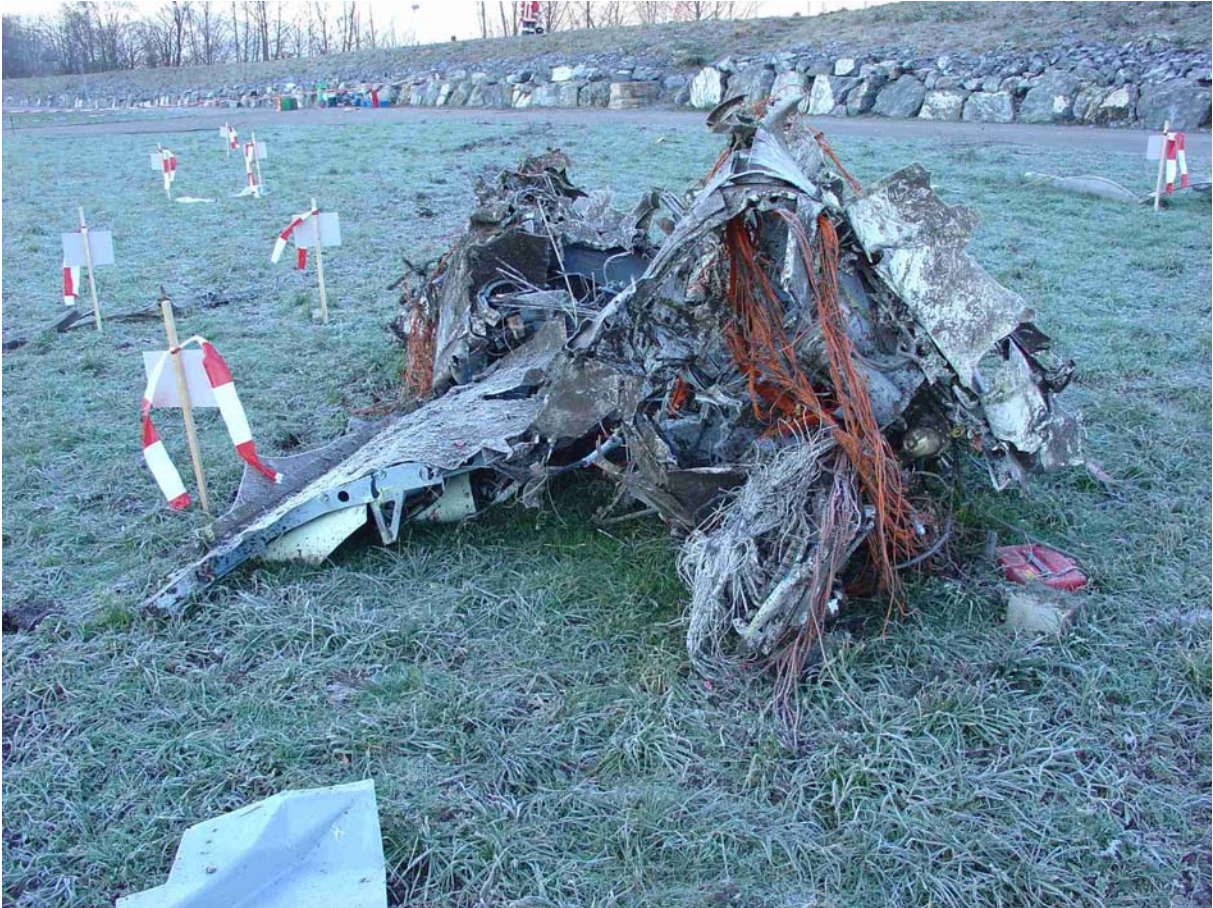
Cockpit on the Buochs side of the channel

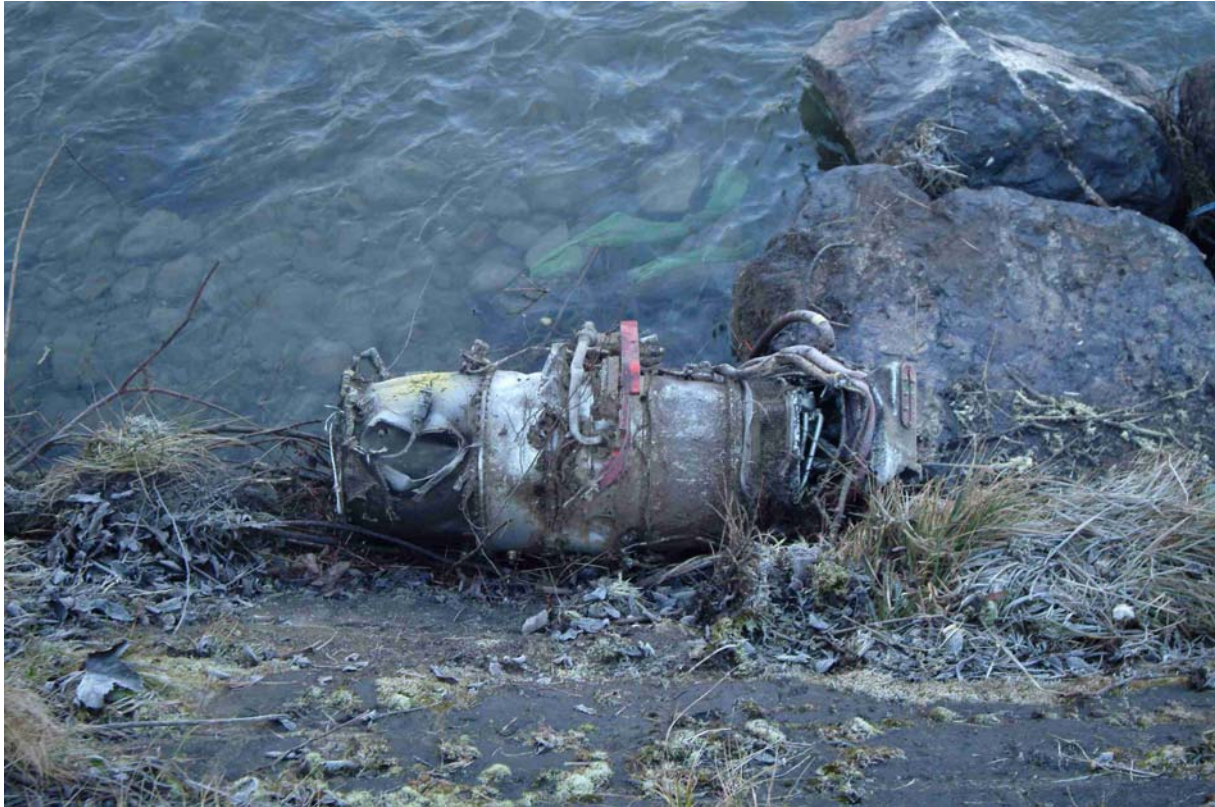
The engine exhibited severe impact damage.

Engine on the bank of the *Engelberger Aa*

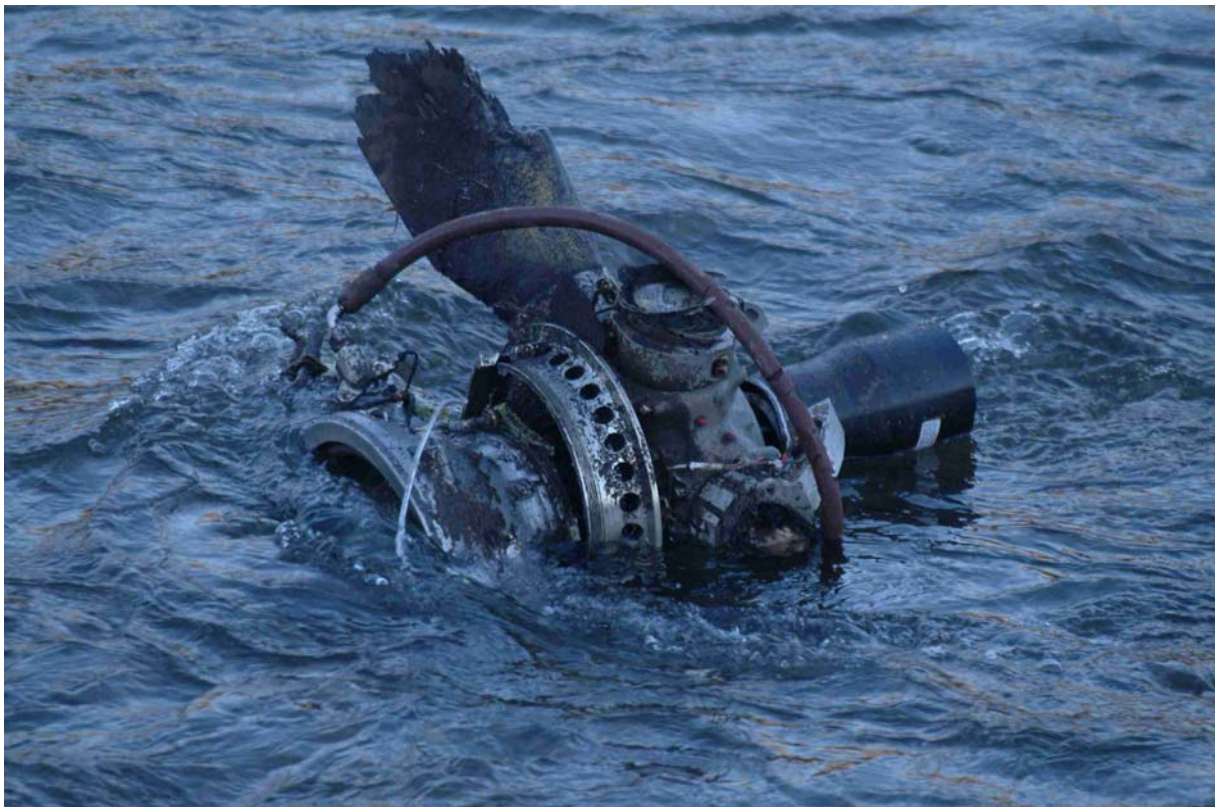
Propeller hub in the *Engelberger Aa*
