**Final Report No. 1910**  
**by the Hellenic Republic**  
**Ministry of**  
**Transport & Communications**  
**Air-Accident Investigation &**  
**Aviation Safety Board (AAIASB)**

to the Piper PA-24-250 aircraft, HB-OVR

on 30 May 2004

Corfu State Airport, Hellenic Republic

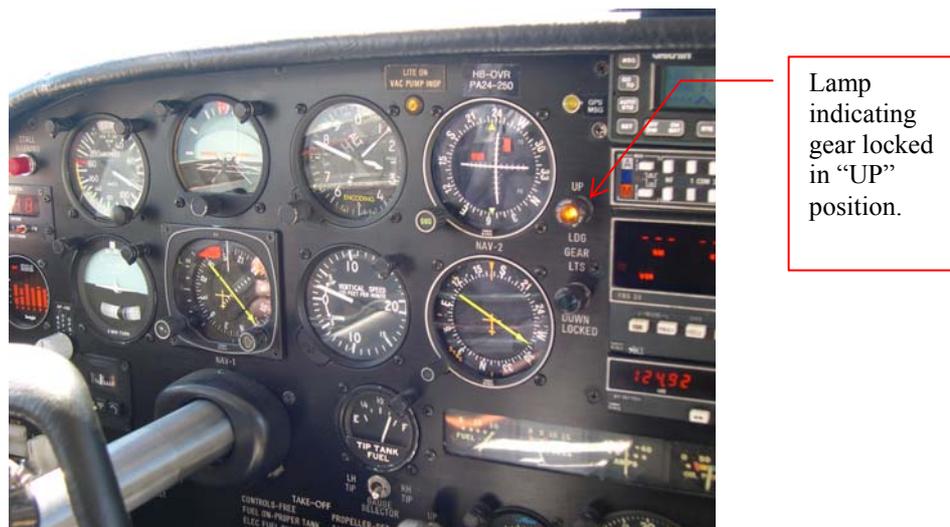
Picture 1

After the removal of the access door and the subsequent relief of the stresses on the gear retraction mechanism, the system operated normally. Moreover, the aforementioned malfunction was taking place during gear retraction only. In a picture, shot by the occupants in flight during the leg Propriano-Corfu, the yellow lamp indicating the position of the gear appears illuminated, which implies that the legs were up and locked (picture 1).

**3.1.4** During the flight, the landing gear was up and locked and the warning horn was activated before landing, for the landing gear was not extended.
