Final Report No. 1920 by the Aircraft Accident Investigation Bureau

to the helicopter Agusta Bell AB206B Jet Ranger III, HB-XUW

on 9 August 2003

in Rotgrueb/Chäshalten, municipality of Rümlang/ZH,

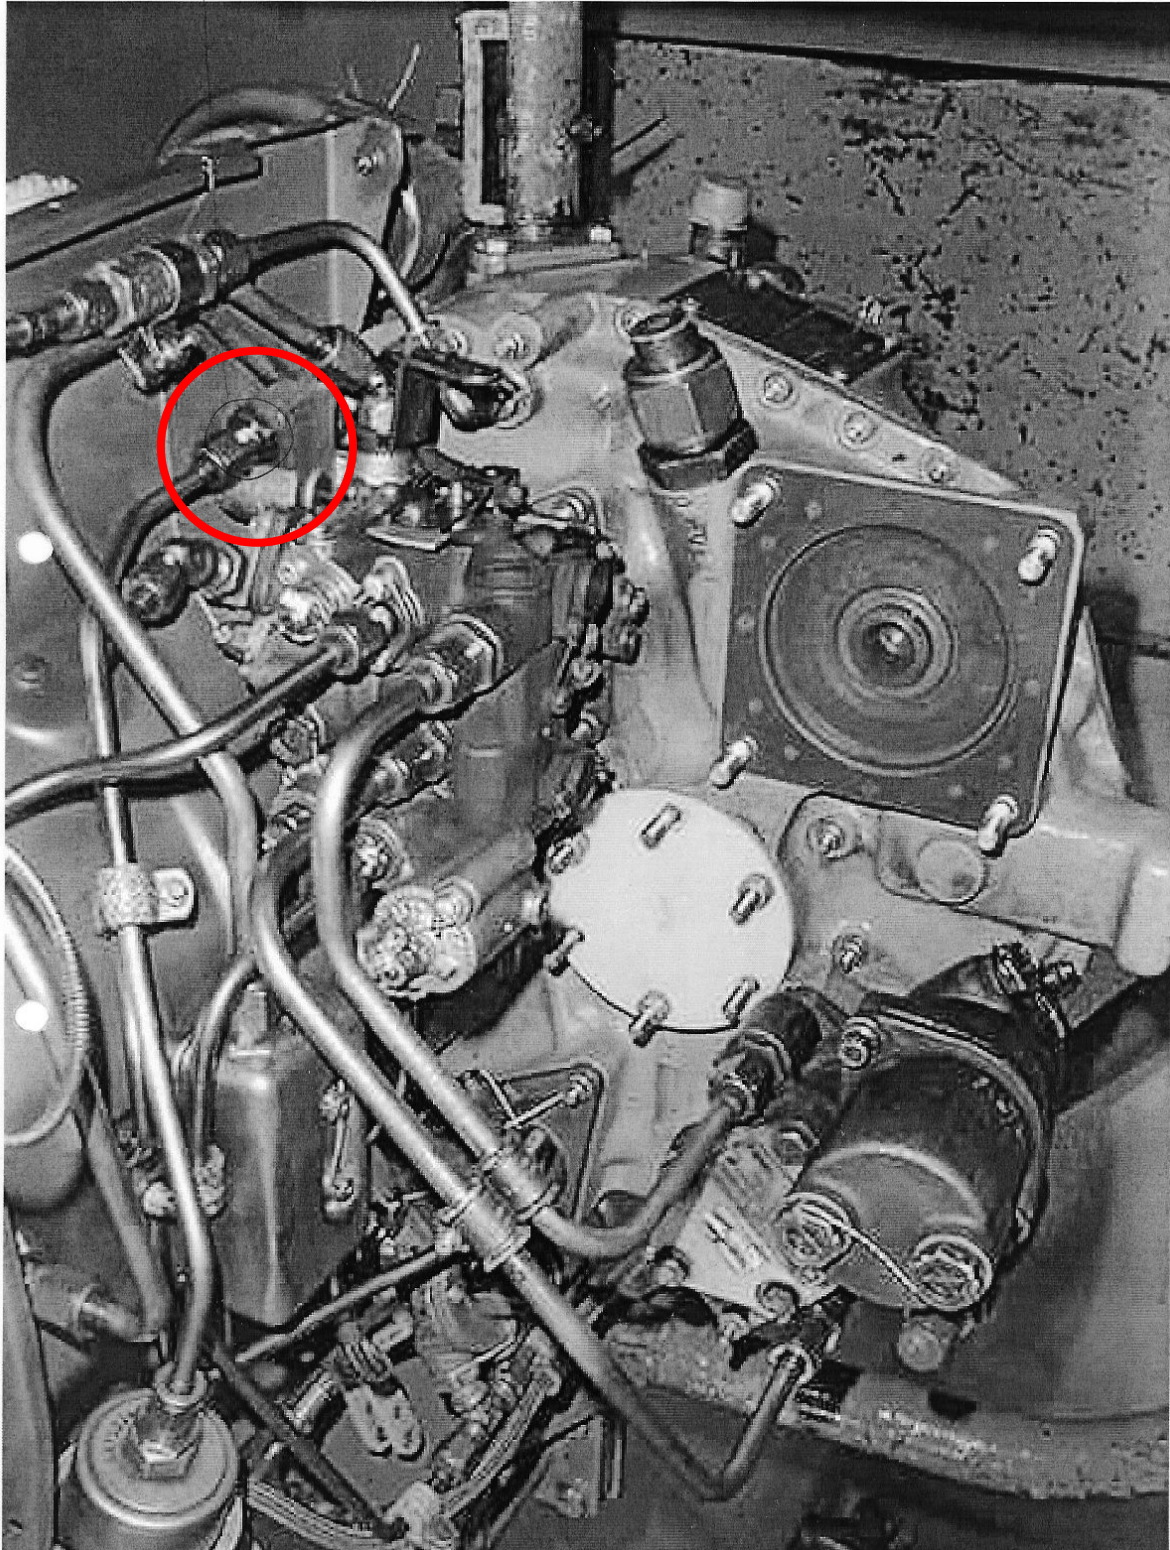
- Pneumatic air tube (Pt No 6877277) "B" nut (see Annex 1) between accumulator and Fuel Control Unit was found to be loose at the FCU connection. Air leak found at this point during receipt pneumatic test. Torque slippage paint previously applied to "B" nut found to be incorrect for torque loading required.*

When the engine was dismantled, it was found that the “B” nut on the control tube between the accumulator and the fuel control unit was not correctly tightened at the latter. The torque paint (slippage mark), which is applied after tightening to the correct torque, had shifted approximately 30° in the ‘loose’ direction. When installed correctly, this connection is airtight. A leak may occur at this connection under a corresponding mechanical load, such as occurs in turbulence or in alternating airflow conditions within the engine compartment. This leads to a reduced pneumatic signal to the fuel control unit and hence to a reduction in power.

Annex 1 "B" nut on the pneumatic tube between the accumulator and the fuel control unit, FCU side

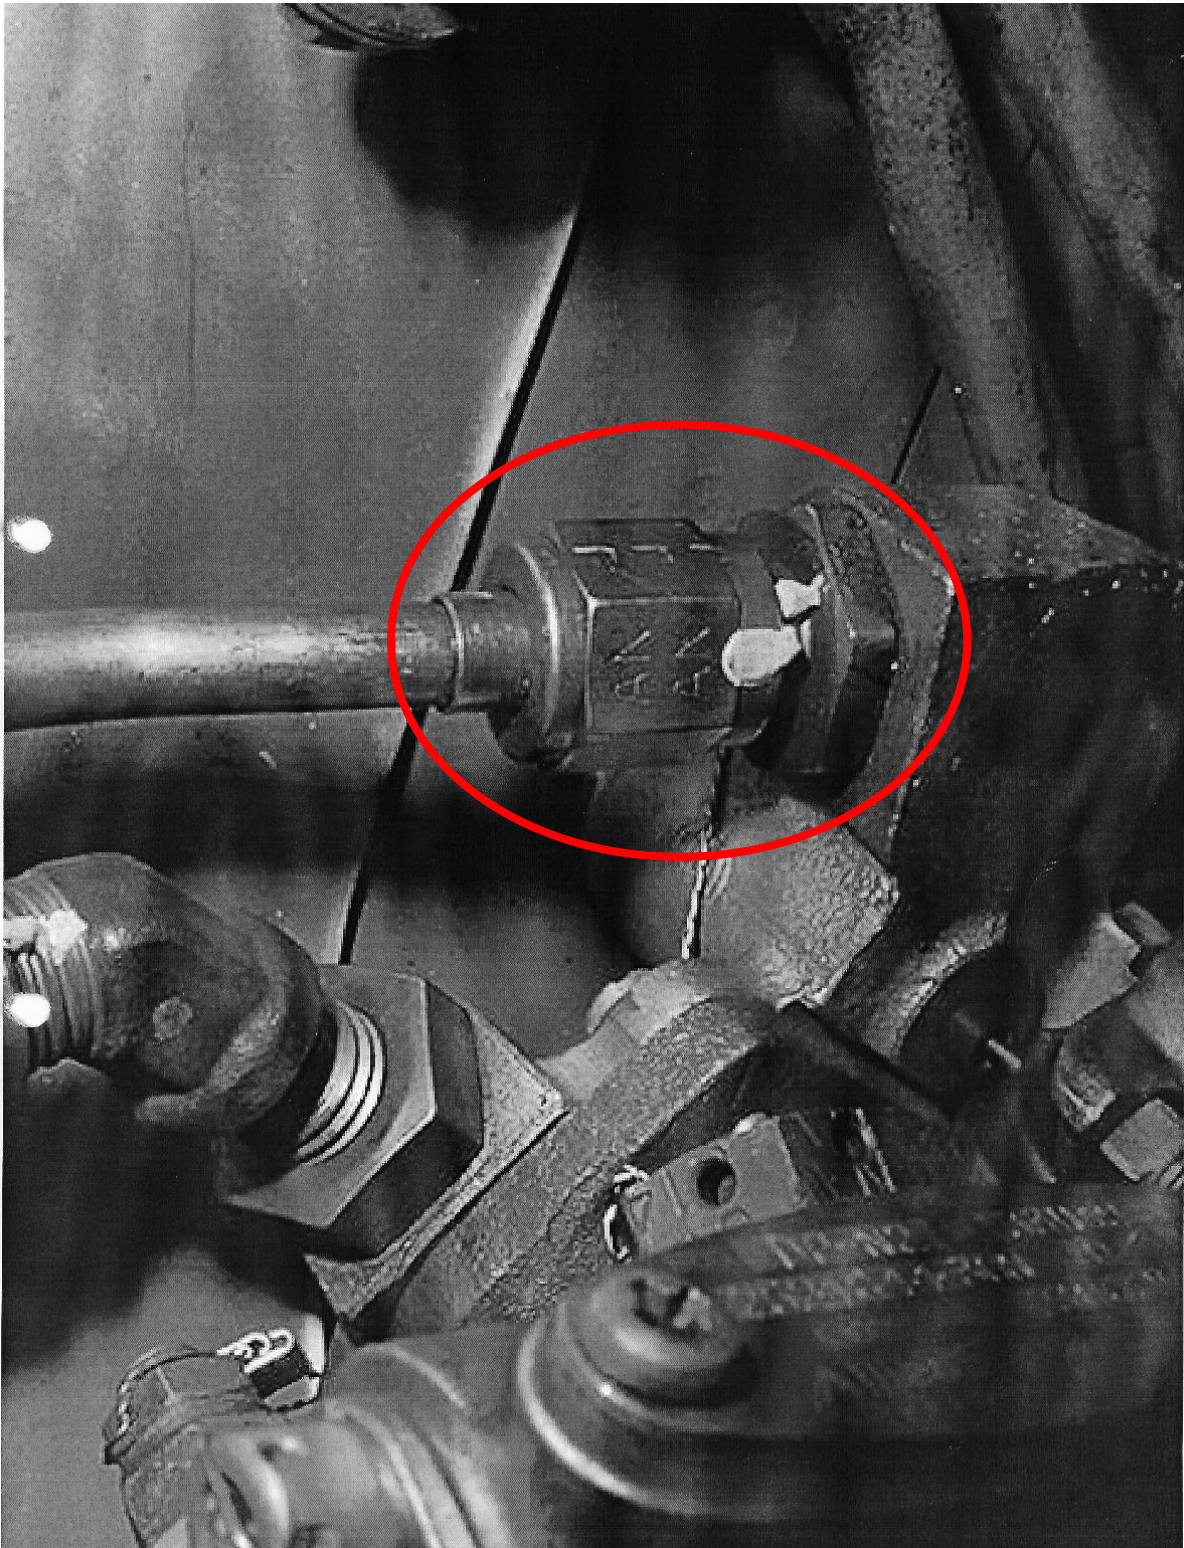
Annex 2 Torque paint (slippage marks) on the "B" nut after tightening to the correct torque value

Torque paint (slippage marks) shall be applied to all rigid tube B-nuts in accordance with rigid tube installation procedures. Torque paint shall be removed and reapplied anytime the B-nut is retightened.

In particular, the construction used on the Allison 250 engines, with the above-mentioned “B” nuts must not be fitted skewed, nor must the tube with the screwed connection be subjected to mechanical strain. In addition, the correct torque values must be applied for the installation of these “B” nuts. During each check, and whenever a tube is disturbed at one end, both ends of the tube as well as strain-free installation must be checked. New torque paint markings (slippage marks) is always required in such cases.
