# **Final Report No. 1921 by the Aircraft Accident Investigation Bureau**

involving helicopter K-1200 K-MAX, HB-ZEH

on 29 July 2003

"Trute", municipality of Frutigen/BE, approx. 45 km SSE of Berne

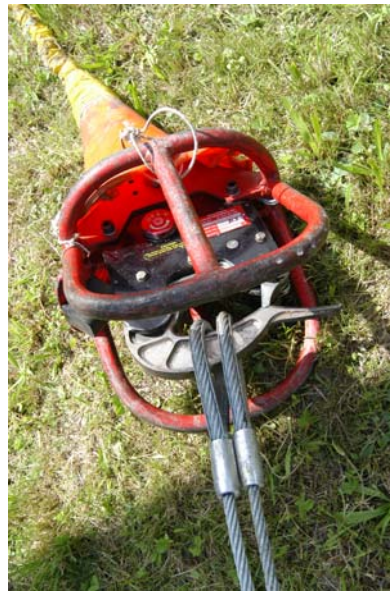
The product in question is a lower or remote cargo hook manufactured by Canam Aerospace Inc. in Canada. The Canam C60 type cargo hook was designed for use on the longline and was designed for loads up to 6000 lbs (2721 kg). The cargo hook can be released manually or electrically by means of a solenoid. The cargo hook was equipped with a protective cage (wrap around).

Figure: Lower cargo hook with two suspended “choker cables”

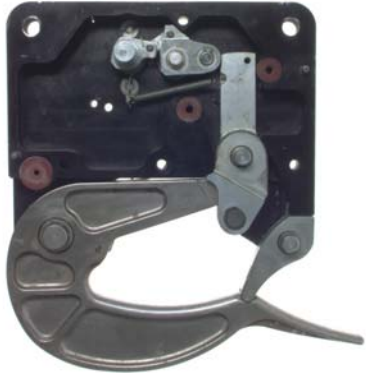
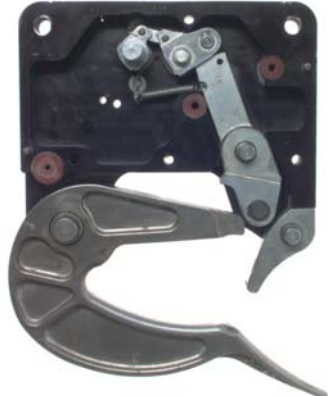
“Closed” mode	“Open” mode
<p>In this mode the load beam is locked in position by the safety catch. This in turn is locked by the hinged closure and secured by the leg spring.</p>	<p>By manually rotating the red knob on the catch housing or by means of electrical control of the solenoid, the release is rotated and the hinged closure is unlocked; as a result, the safety catch releases the load beam.</p>

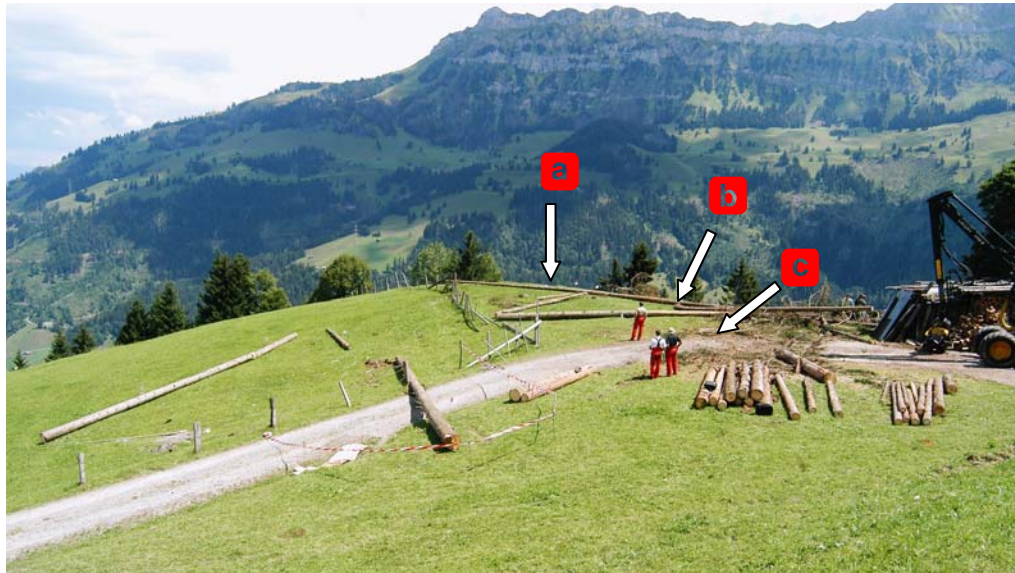
General view of the site of the accident

- a) Contact points of the trees
- b) Flight assistant
- c) Assistant (location of victim)

The tracks of tree trunks in the terrain, which were approximately 30 cm deep, indicate that the load was deposited at a high rate of descent. This high rate of descent and the resulting impact of the tree trunks caused breakages and led the trunks to collide subsequently, allowing the cargo hook to open.

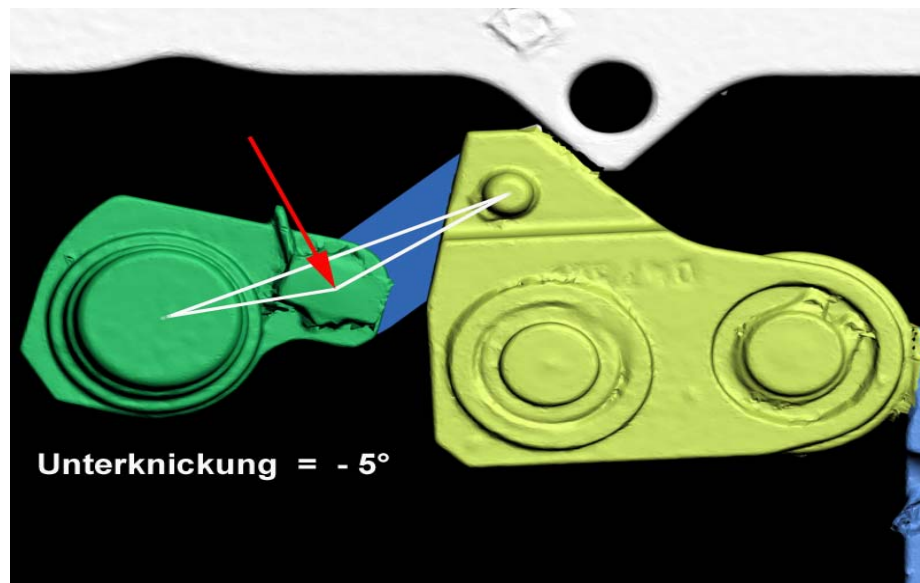
The partial risk analysis which was produced indicated the weaknesses of the design. A practical series of tests confirmed the hypothesis that the cargo hook opened "inadvertently" in all the tests. The tests also indicated a possible inspection procedure.

Figure: Hinged joint closure with deflection

Deflection = -5°

If the design solution of a "hinged joint closure with deflection" is retained, it is imperative to incorporate a mechanical safeguard which prevents the deflection from being overridden in the event of momentum due to the force of an impact. This means that the interlock mechanism must be additionally mechanically blocked to prevent rotation.

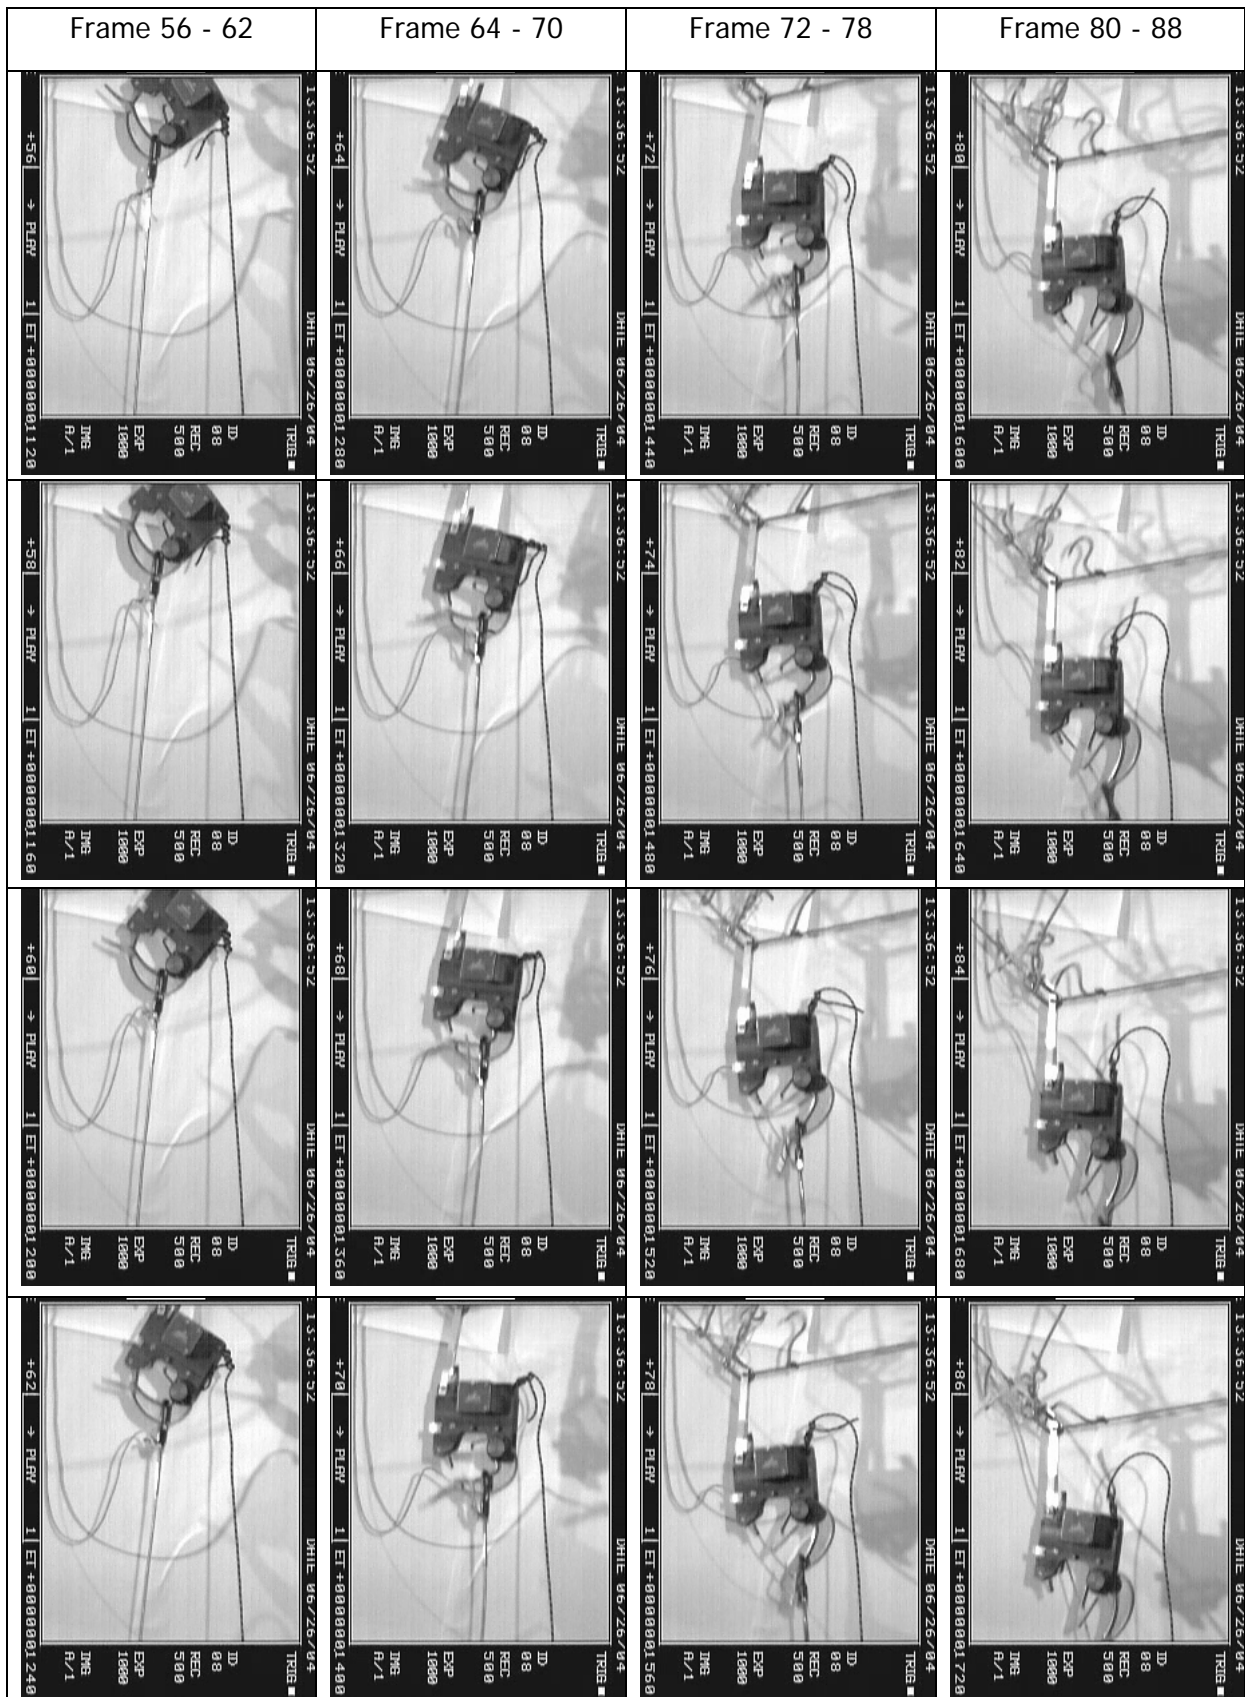
Annexe 1

Photographs of the test using a high-speed camera
