Final Report No. 1923 by the Aircraft Accident Investigation Bureau

to the aircraft Cessna C 500 Citation I/SP, EC-HFA

on 7 April 2003

at Zurich-Kloten Airport

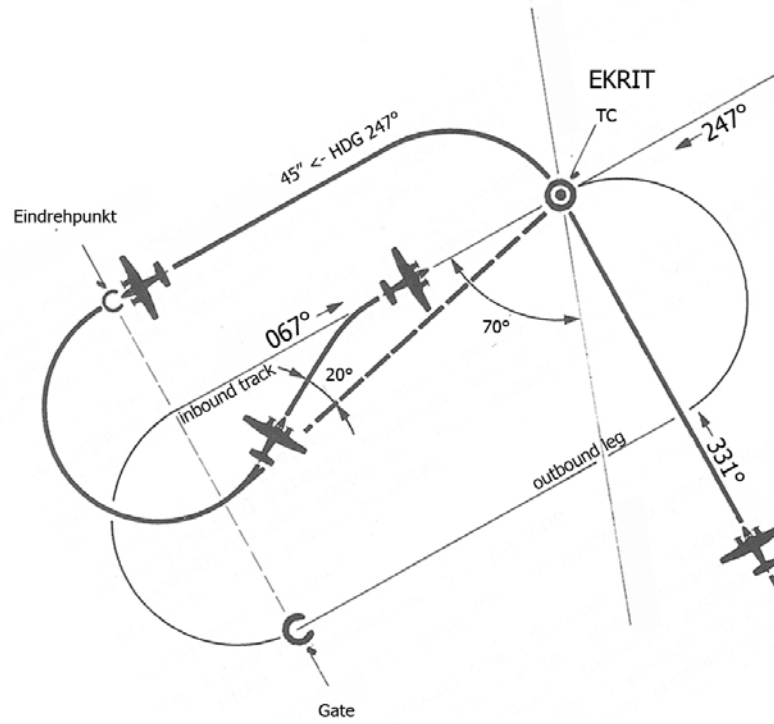
Annexe 2: Parallel entry procedure

From the position which the aircraft was in at this point, the pilot should have joined the EKRIT holding pattern in accordance with a so-called parallel entry procedure (cf. Annex 4.2). As the radar recordings show, EC-HFA continued to fly the outbound leg for approximately one and a half minutes instead of 45 seconds and turned right instead of left in order to follow the inbound track 067° to EKRIT (Annex 4.3). According to the cockpit voice recorder (CVR) recordings, it was precisely in this phase that the pilot explained to his passenger during approximately five minutes how to join the holding pattern correctly. The subsequent holding patterns were flown with major lateral deviations in comparison with the published procedure.

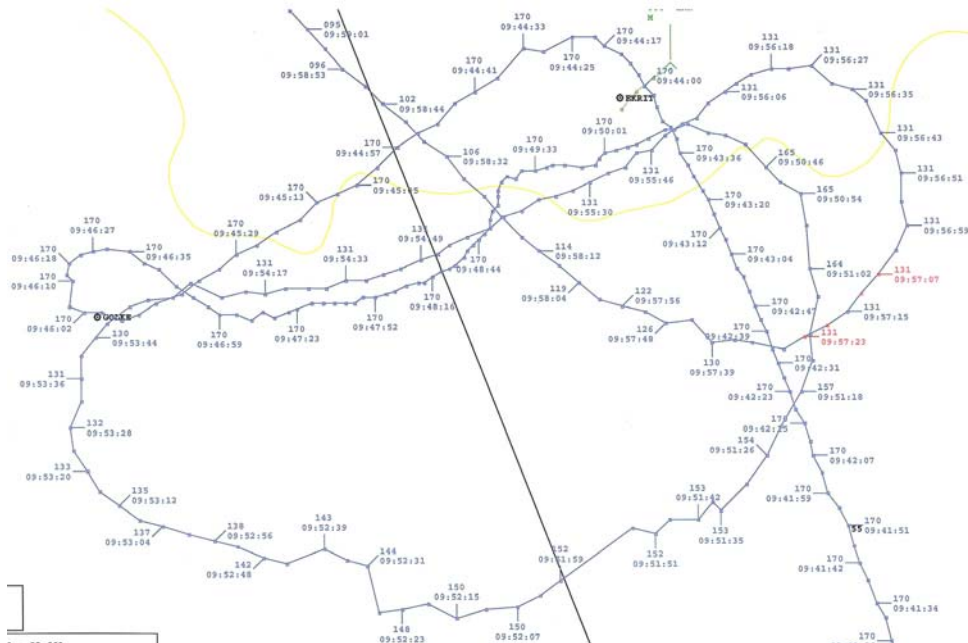
Annexe 3: EC-HFA radar recording, joining EKRIT

This assessment also finds fault with the pilot's general instrument flying skills. This finding is substantiated by the fact that during the 7 April 2003 flight involved in the accident the pilot was not able to correctly join the EKRIT holding (Annexes 4.2 and 4.3). Two possible reasons for this could be on the one hand his relative inexperience on the aircraft type involved in the accident and on the other hand his flying activity under Mediterranean conditions, limited to a few destinations.

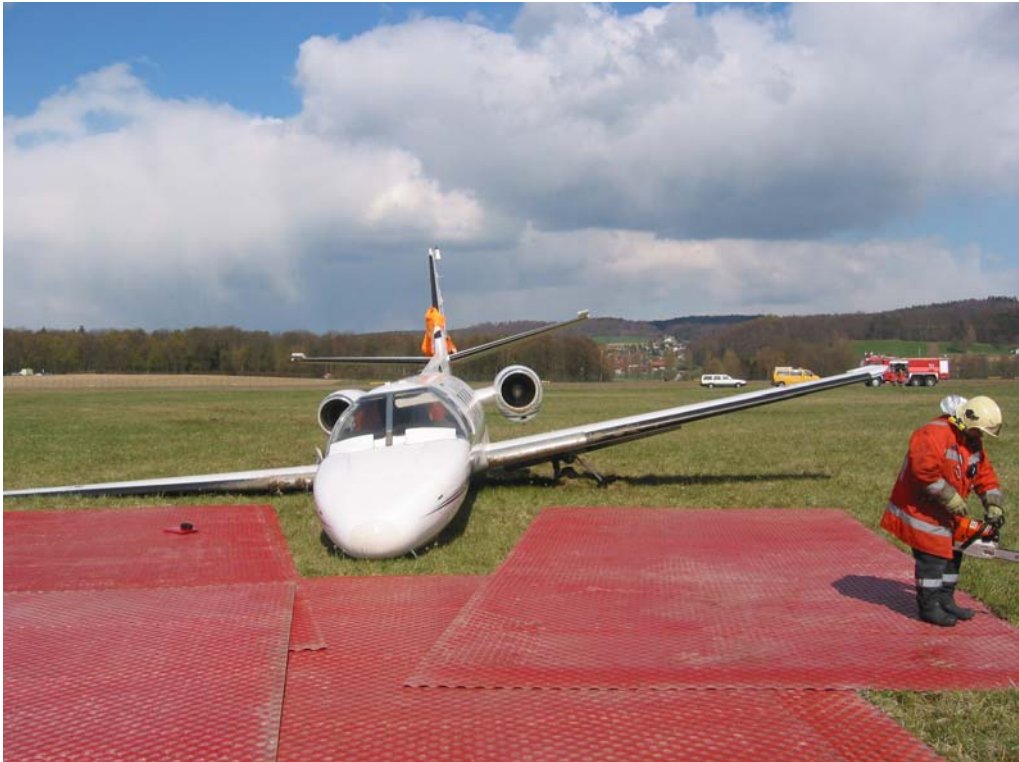
Annexe 5: Wreck of EC-HFA

The aircraft was badly damaged. The Cessna C 500 Citation I/SP touched down in landing configuration on the grass in front of runway 14. The aircraft veered to the right and crossed a minor road. In the process, the nosewheel and the right main landing gear were torn off. The aircraft then continued to skid over the ground on its right wing and the remaining left main landing gear and finally came to a standstill in front of the runway 16 PAPI (cf. Annex 4.5 and 4.6).
