Final Report No. 1925 by the Aircraft Accident Investigation Bureau

concerning the serious incident
to the aircraft AVRO 146-RJ100, HB-IXQ,
operated by Swiss European Air Lines
under flight number LX 778
on 5 December 2005
at Zurich-Kloten Airport

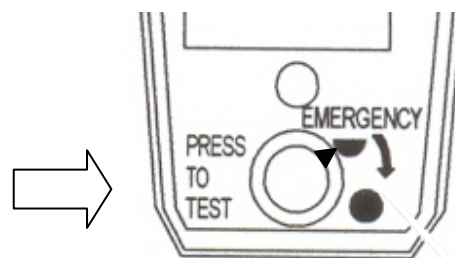
Mask EMERGENCY pressure knob in the normal position

In order to be able to press the Mask EMERGENCY pressure knob, it must be in the normal position (see Annex 1). If this pressure knob is in the “emergency” position, it cannot be pressed.

In the course of the investigation, various pilots stated that this Mask EMERGENCY pressure knob is turned to the “emergency” position by some pilots before a flight. The result is that when the mask is donned, a continuous oxygen flow is present. It was not possible to verify if this pressure knob was in the “emergency” position in the case of the present serious incident.

If the Mask EMERGENCY pressure knob is in the emergency position, there is a continuous flow of oxygen as soon as the mask is taken out of its box. The same effect occurs if, with the mask donned, the Mask EMERGENCY pressure knob is rotated to the emergency position. On the one hand, the continuous oxygen flow means that the available oxygen is used up more quickly. On the other hand, the continuous oxygen flow has the advantage that in extreme smoke conditions penetration of smoke to the inside of the mask through points which are not air-tight is prevented.
