# **Final Report No. 1926**

**concerning the serious incident (Airprox)**

involving Tupolev 154M

and Airbus 319

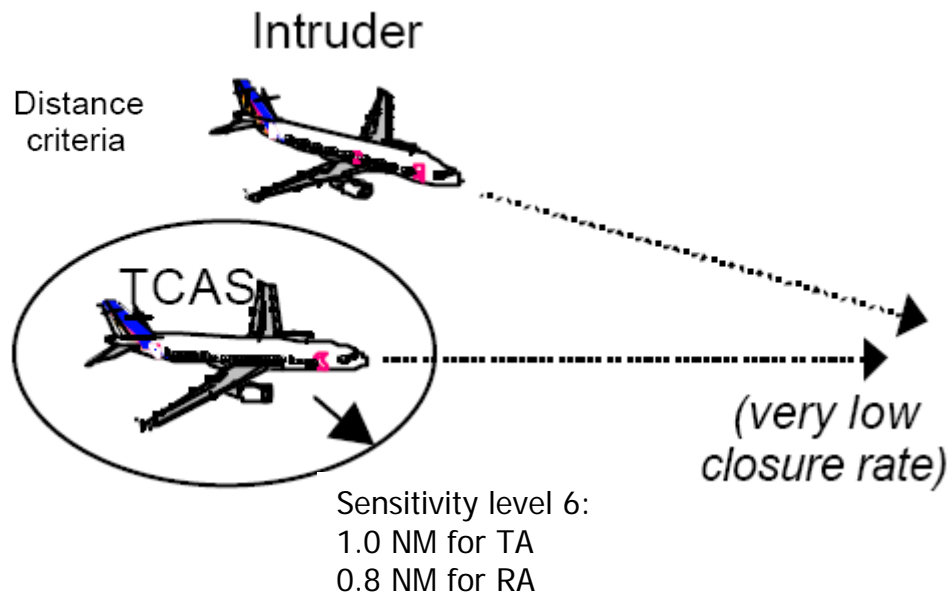
The A319 was in level flight at FL 130, whereas the Tu-154M was descending. At the time of the closest lateral convergence of the two aircraft at 06:58:52 UTC, the altitude difference was some 1,600 ft. The A319 was at this time already at FL 130 in level flight, and the rate of descent of the Tu-154M was approximately 1,500 ft/min. These values did not yet fulfil the requirements for triggering a traffic advisory. From this point in time, the lateral separation between the two aircraft began to increase again, until about 06:59:04 UTC, but at such a slow rate that an extrapolation of the flight path would have resulted in a convergence of less than 1.0 NM by the time they reached the same altitude (co-altitude). As the lateral separation between the aircraft was continuing to increase from 06:58:52 UTC, a special function of the TCAS logic was triggered. This function is provided for situations in which the horizontal closure rate is very low or the aircraft are even diverging, but the TCAS computer indicates that at the time when they reach the same altitude (co-altitude), a set lateral separation minima will be violated.

For the altitude band between 10,000 and 20,000 ft (sensitivity level 6) in which the incident took place this set lateral separation minima corresponds to 1.0 NM for the triggering of a TA (traffic advisory) and 0.8 NM for the triggering of an RA (resolution advisory).

According to TCAS logic, in the corresponding altitude band between 10,000 and 20,000 ft (sensitivity level 6) a traffic advisory (TA) is issued if the following two conditions are fulfilled simultaneously:

1. If the time to reach 'co-altitude', i.e. until the two aircraft are at the same altitude, is 45 seconds (TAU\_TA).
2. If the distance calculated by both TCAS on the basis of the current flight paths on reaching this co-altitude is 1.0 NM or less.

Because of the geometry of this serious incident, these conditions were fulfilled at the time at which the Tu-154M was executing a left turn onto a heading of 150°. Shortly thereafter, the flight paths of the two aircraft were again diverging as a result of this turn, which prevented further intensification of the conflict and the issuing of a resolution advisory.
