Final Report No. 1928 by the Aircraft Accident Investigation Bureau

to the Bell 407 Helicopter, HB-ZBA

on 2 September 2004

Steinweid-Gross Band, Bisistal, municipality of Muotathal/SZ

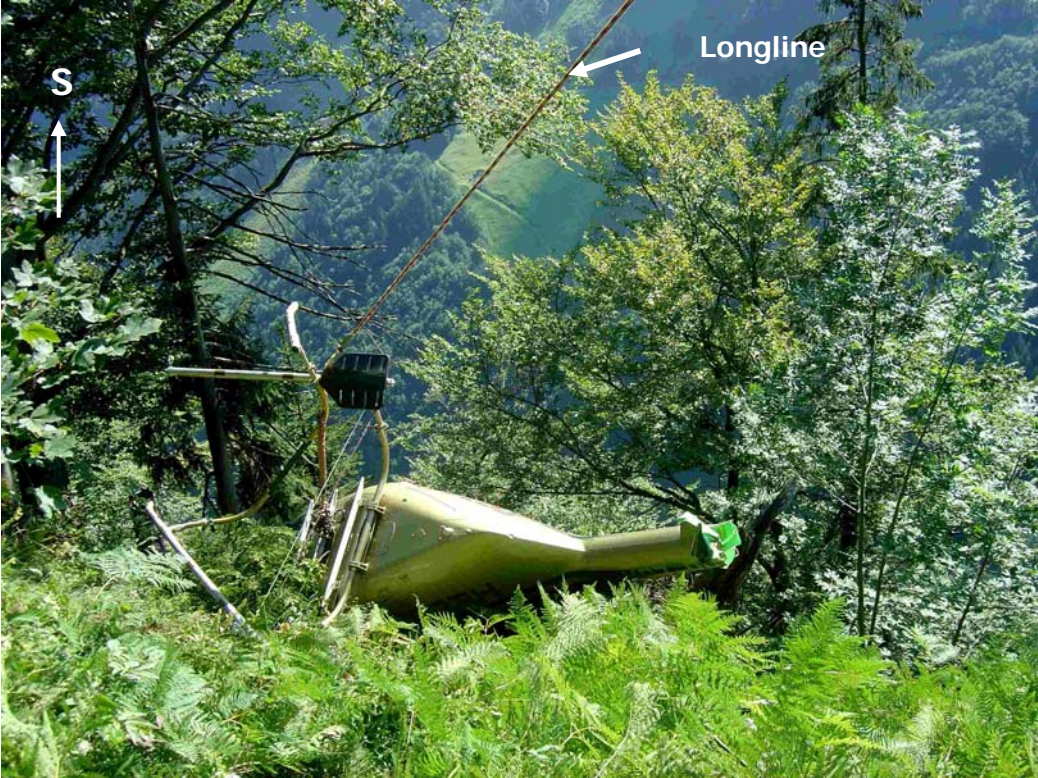
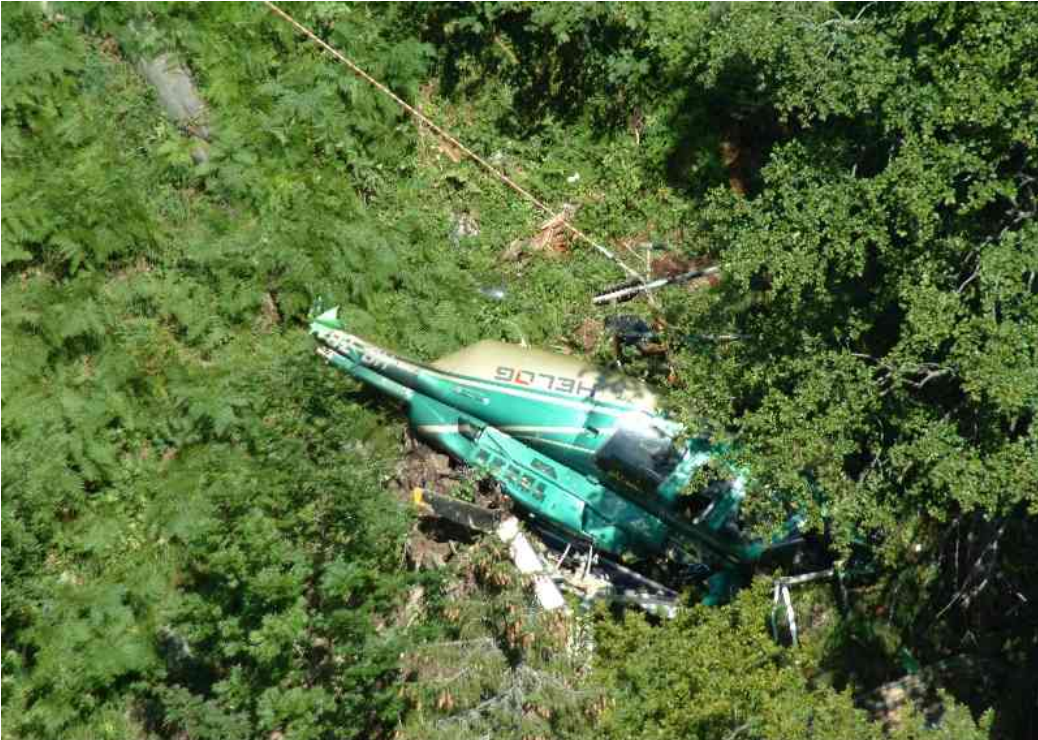
The wreck at the site of the accident appeared as follows:

Front of cabin, cockpit, airframe panelling, turbine and transmission panelling damaged; main rotor head, main rotor with various fractures and deformations, destroyed; tail destroyed with two main fractures, tail rotor shaft torn off, tail rotor blades damaged.

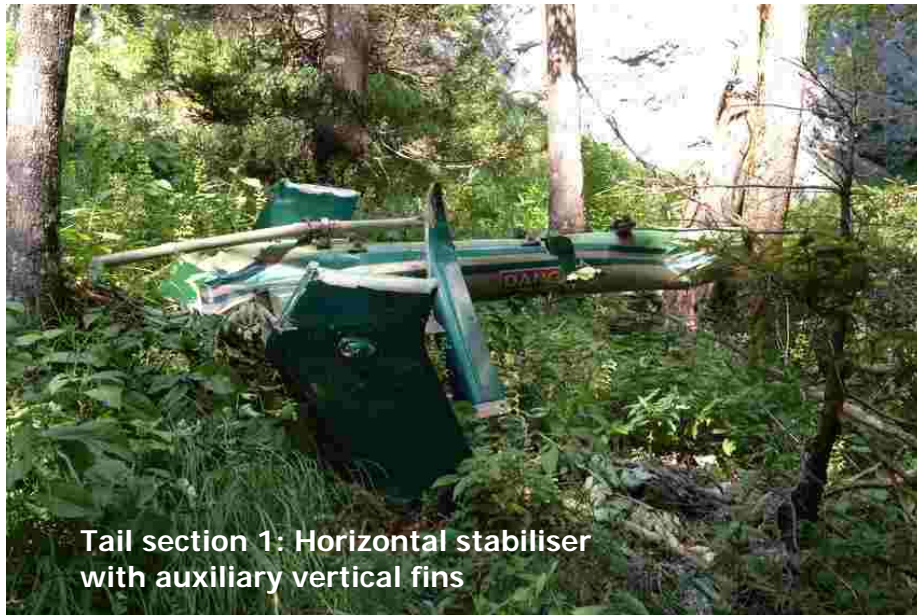
Tail section 1: Horizontal stabiliser with auxiliary vertical fins

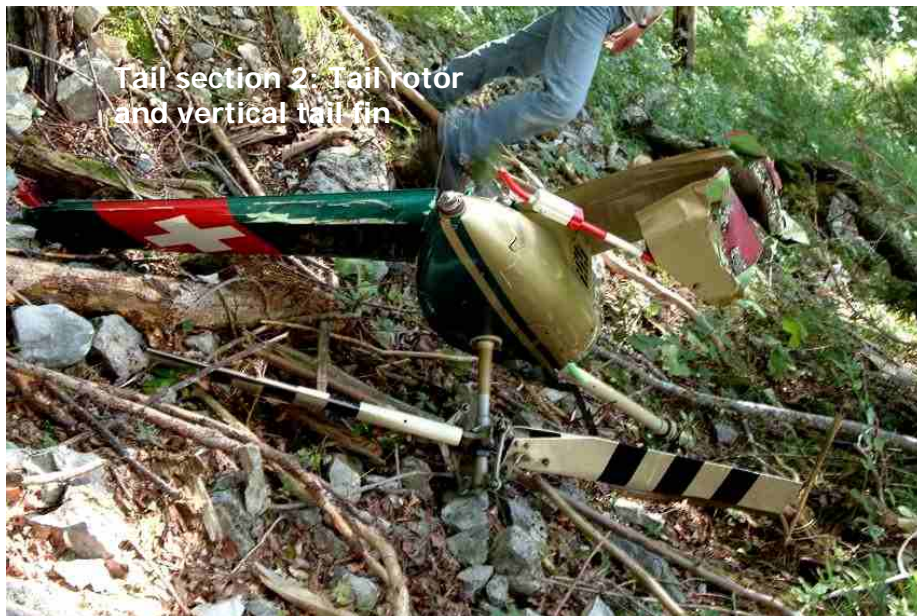
Tail section 2: Tail rotor and vertical tail fin

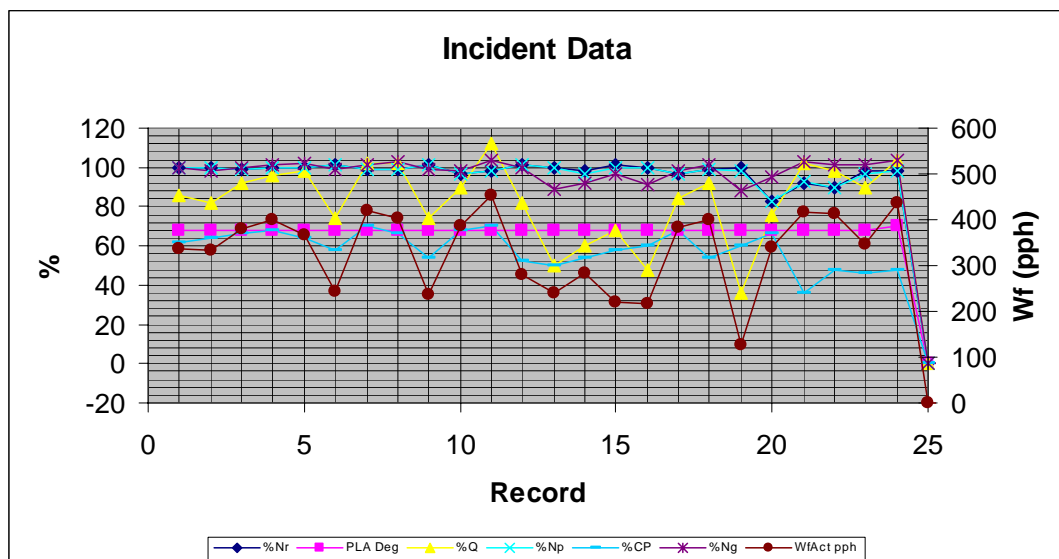
The interrogation of the Incident Recorder (IR) captured a torque exceedance. The data indicates the torque exceedance occurred between record 10 and 11 at time stamp 47:12:23.736 with a value of 110%. A rotor droop is also recorded at time stamp 47:14:34.128 with a value of 92%. There were no prior run faults recorded in the maintenance recorder.”

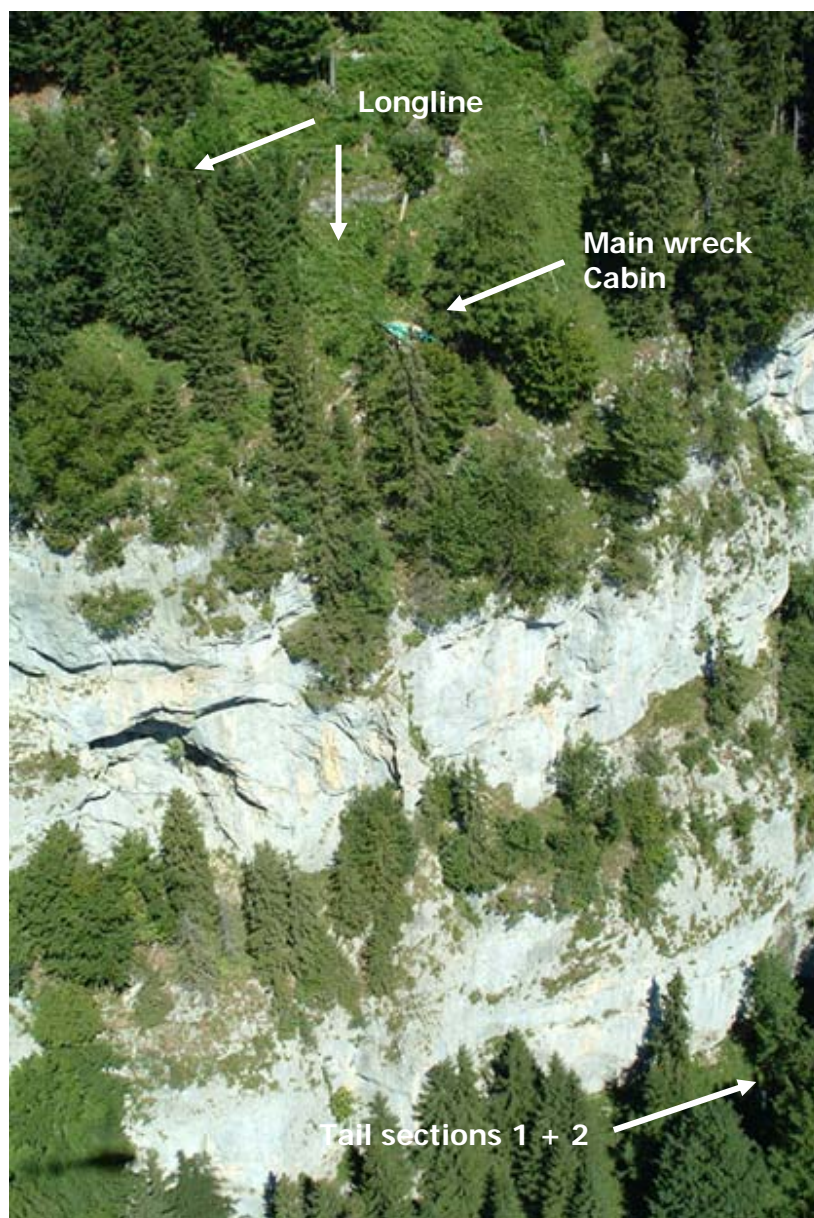
The tree damage a few metres above the final position of the main wreckage, the alignment of the longline, which was under great tension, the anchor-like position of the trunks which were still in the choker and therefore in the remote cargo hook, the lateral position of the main wreck, the position of the tail rotor and horizontal stabilizer show that in the final phase the helicopter, rotating and under the tension of the longline, crashed into steep terrain (approx. 35°) at an angle of about 30 degrees.

The two individual larger tail sections came to rest at the foot of a vertical cliff face approximately 60 high, beginning directly below the main wreck.

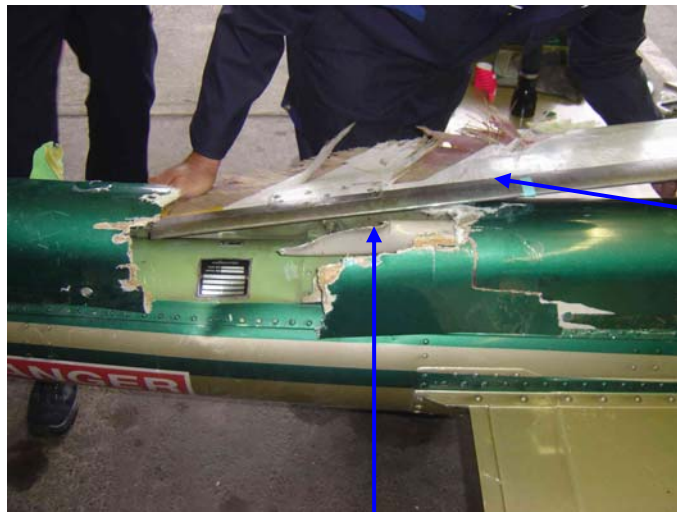
Main rotor blade leading edge

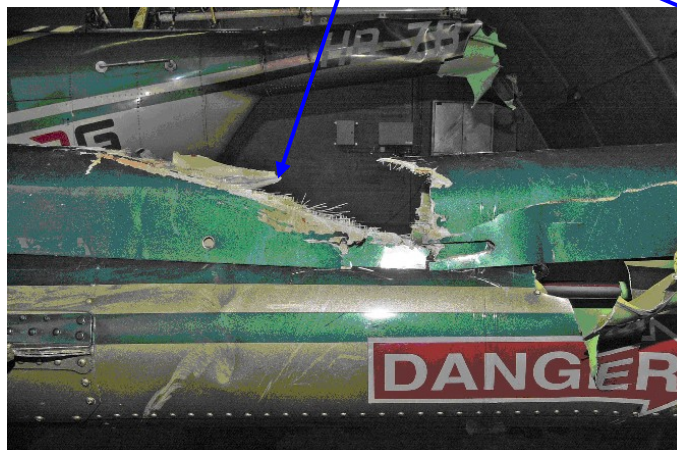
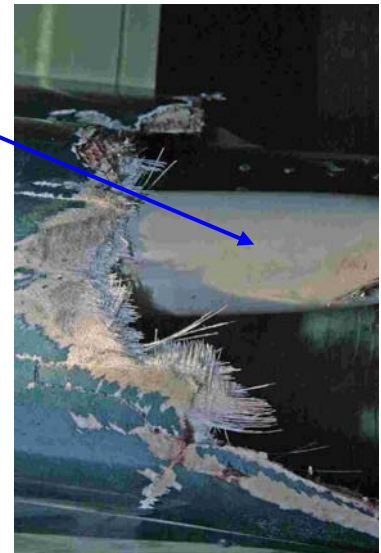
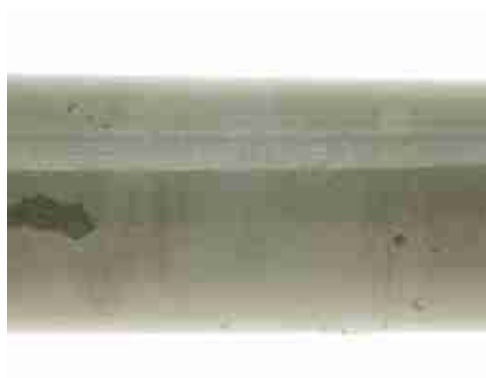
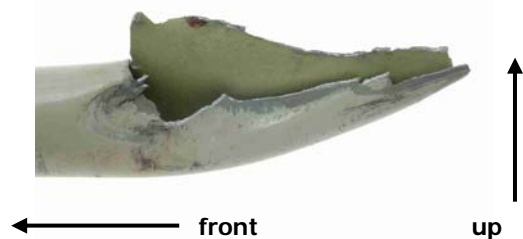
Tail rotor drive shaft

The entire area of damage, or rather the ruptured zone of the shaft, measures approximately 17 cm and starts with a dent, from which the wall of the tube is torn, on the one hand in the longitudinal direction and on the other hand along the circumference.

The damaged tube is compacted over the entire length of the defect, partly turned up and running conically to the rear. It is apparent that a substantial part of the shaft material is missing at this point.

In the damage complex, black adhesions are present.

Scratches in the beige paint are present immediately in front of the damage described, on approximately three quarters of the circumference of the shaft and over a length of approximately 20 cm.

The part of the shaft protruding from the sleeve, with the break, measures max. 43 mm and, viewed from above, is deformed with the flanged flexible coupling in an anti-clockwise direction.

Although a short piece of the tail rotor drive shaft is missing between the two breaks, it must be assumed that only one main rotor blade, the "blue" one, was involved in the separation process: this statement is based on the panel which is penetrated obliquely (approximately 10° - 12°); its fracture ran to the part of the shaft on the tail rotor side, or rather to the two notches present in it. Also, the imprint of the leading edge of the main rotor on the front part of the shaft break and the traces of paint on the inside of the tail rotor drive shaft panelling which were found only on the "blue" main rotor blade. Superimposed traces which would have been made by other main rotor blades were not found on the components examined.

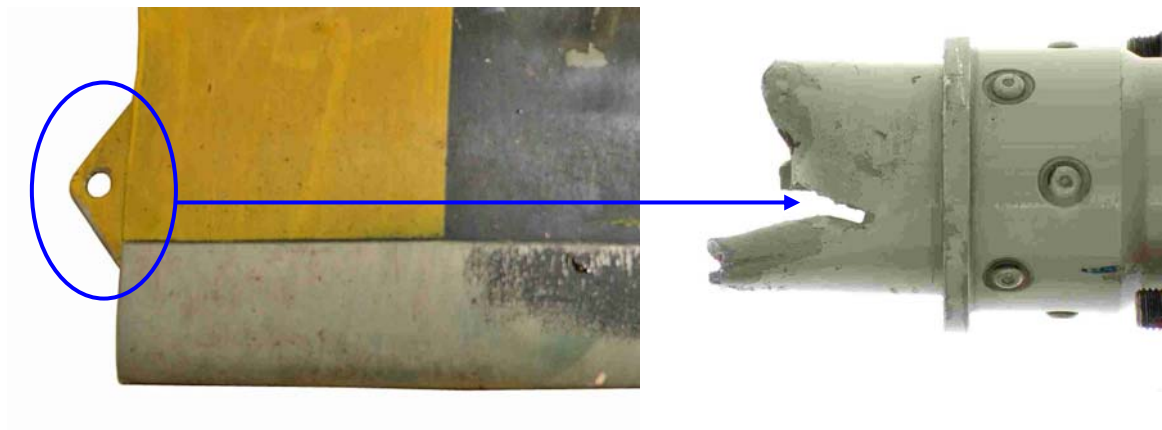
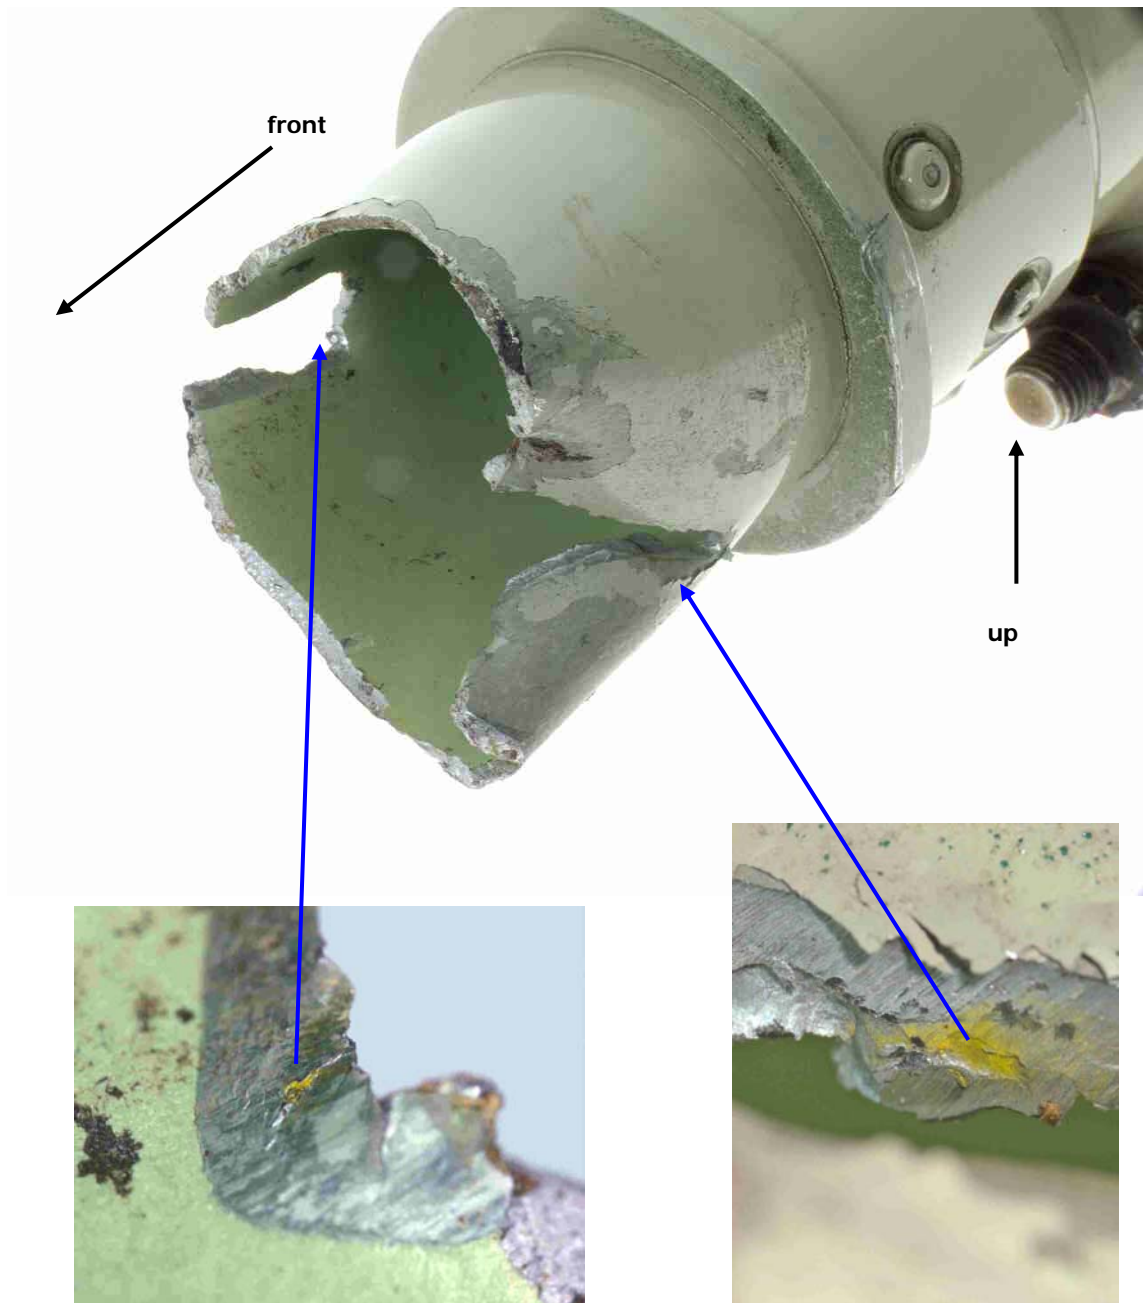
Two opposed nicks of 24 mm maximum length are present in the wall of the tube.

In the case of the "left" nick the force acted from the outside to the inside against the tube and vice versa in the case of the "right-hand" nick (viewing direction: cabin).

Traces of yellow paint could be detected in both nicks under the stereomicroscope.

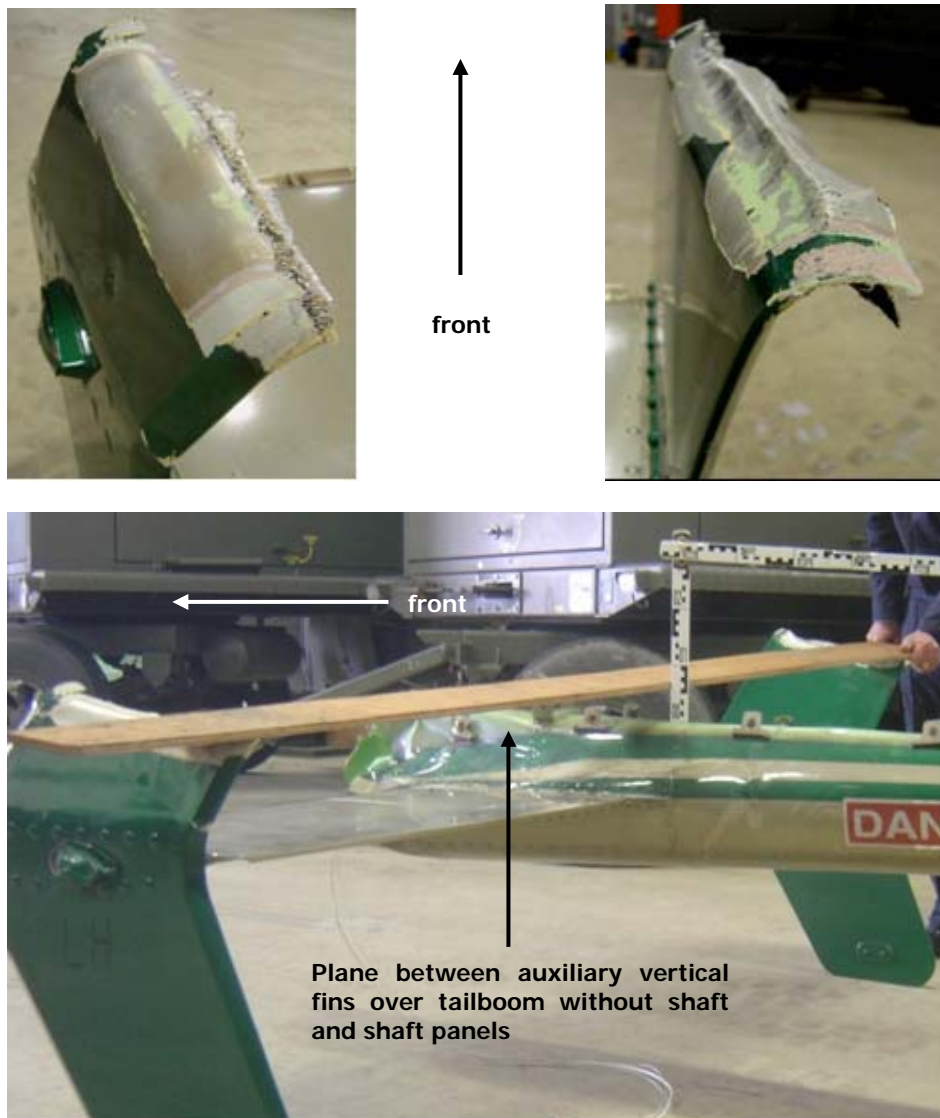
Auxiliary vertical fins:

The LH vertical fin is buckled inwards slightly above the fixing points on the horizontal stabilizer.

Over the entire width of the approximately 37 cm long rupture, a sharp-edged dark impact can be seen at the beginning of the structural plate which is deformed inwards. At the front, this trace is approximately 26 cm above the top of the horizontal stabilizer and at the rear it is approximately 17 cm above it.

Just below the rupture, there is a distinct dark trace of the shape of a main rotor blade leading edge over the entire width of approximately 36 cm. Above the rupture, the structural material is buckled outwards.

The various traces on the panels, on both breaks in the tail rotor drive shaft and on the "blue" main rotor blade allow the conclusion that the separation was caused by an impact.

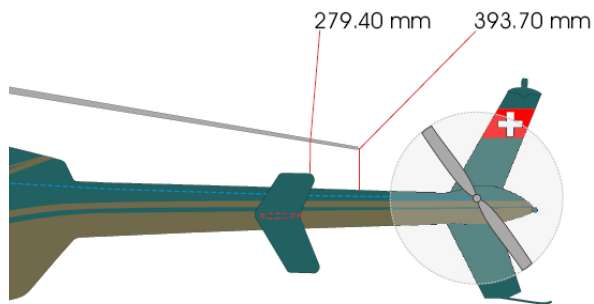
FULL CYCLIC BACK 4000LBS

The "blade clearance over tailboom" in the annex, for two weights particularly relevant for cargo flights, indicates the small residual clearance between the main rotor plane and the area of the tailboom concerned as long as the centre of gravity is within the permissible limits.

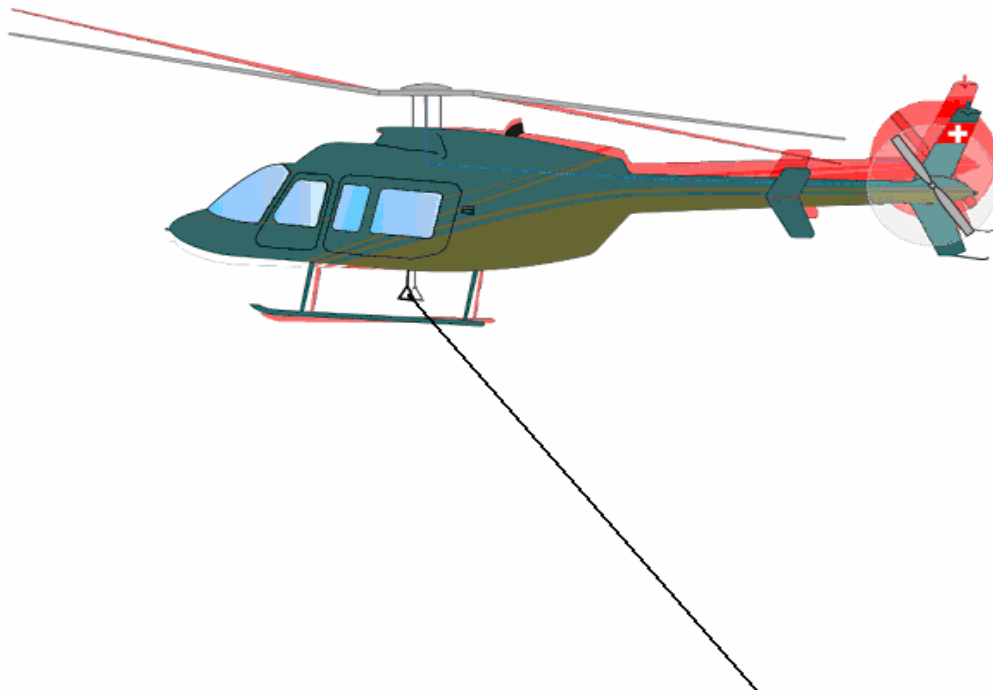
rot = verm. Unfallkonfiguration an Rotorachse ausgerichtet
