Final Report No. 1934

Federal Aircraft Accident Board

concerning the serious incident

to the aircraft AVRO 146-RJ100, HB-IXR,

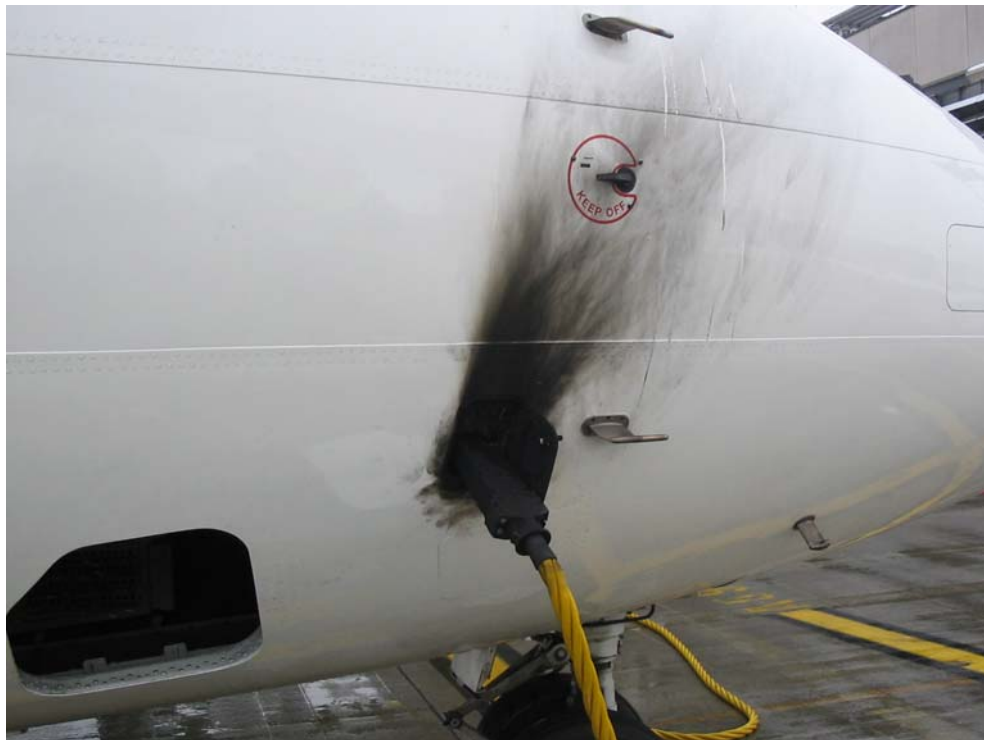
Annex 1: Traces of soot on the surface of the fuselage

On the aircraft, substantial damage was caused to the connector plate of the aircraft-side connection for the external power supply and in its immediate vicinity. Traces of black soot were deposited over the entire area of the connection and on the surface of the fuselage (see Annex 1).

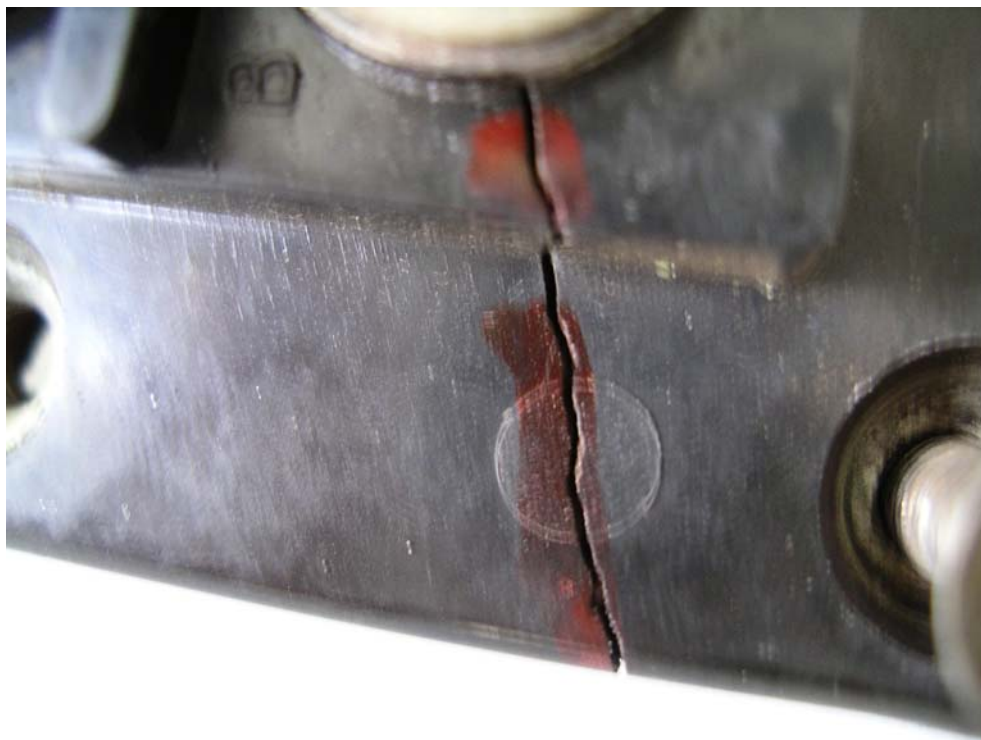
Annex 2: Crack from the contact pin to the edge of the connector plate

The surface of the connector plate itself was badly burnt. Three contact pins for transferring the three-phase alternating current had melted and were found in the dock-side plug. Moreover, the connector plate exhibited a fairly small crack between two contact pins and a larger crack from one contact pin to the edge of the plate (see Annex 2).

A crack was found (see Annex 2) in the aircraft-side connector plate which was removed after the serious incident; parts of it had been burned or had melted.

For the macroscopic examination, the crack in the connector plate was opened and one half of the fracture was spluttered with gold in order to increase contrast. The fracture surface was normal and macroscopically low in deformation. The fracture origin could be located in the inner area of the two holes. In the

centre of the connector plate, in the area of the two holes, about two thirds of the cross-sectional area of the plate had been burned by the short-circuit. The greater the distance from the centre, the less pronounced the thermal deformations.

Although it is not possible to answer with certainty the question of the origin of the crack, it can be assumed that the short-circuit was not caused by the crack.

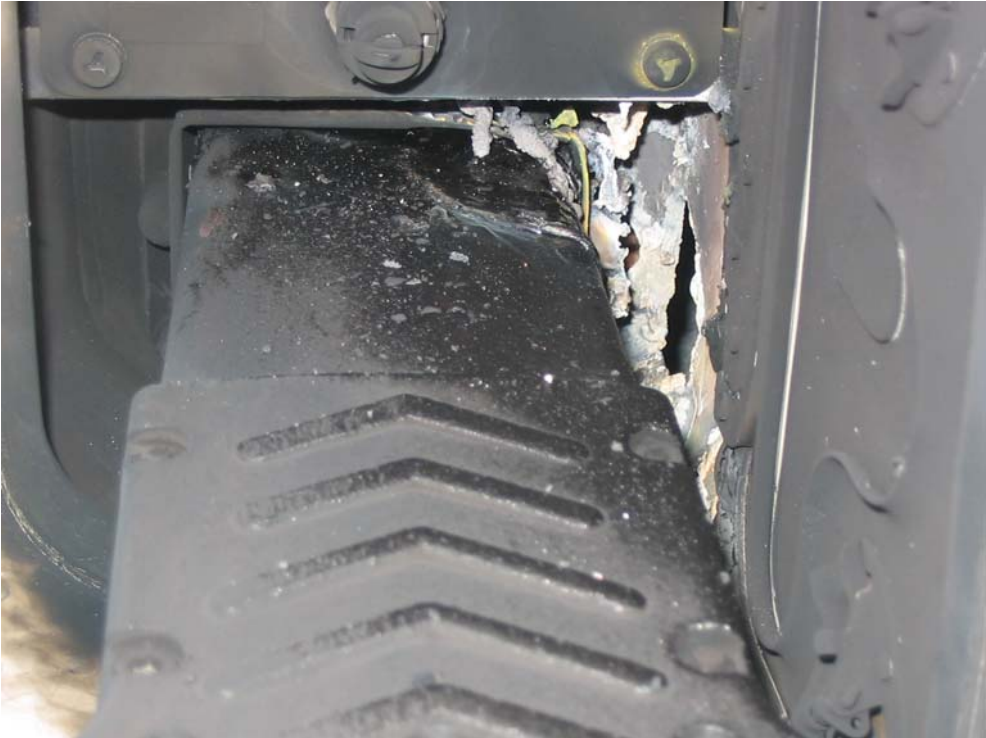
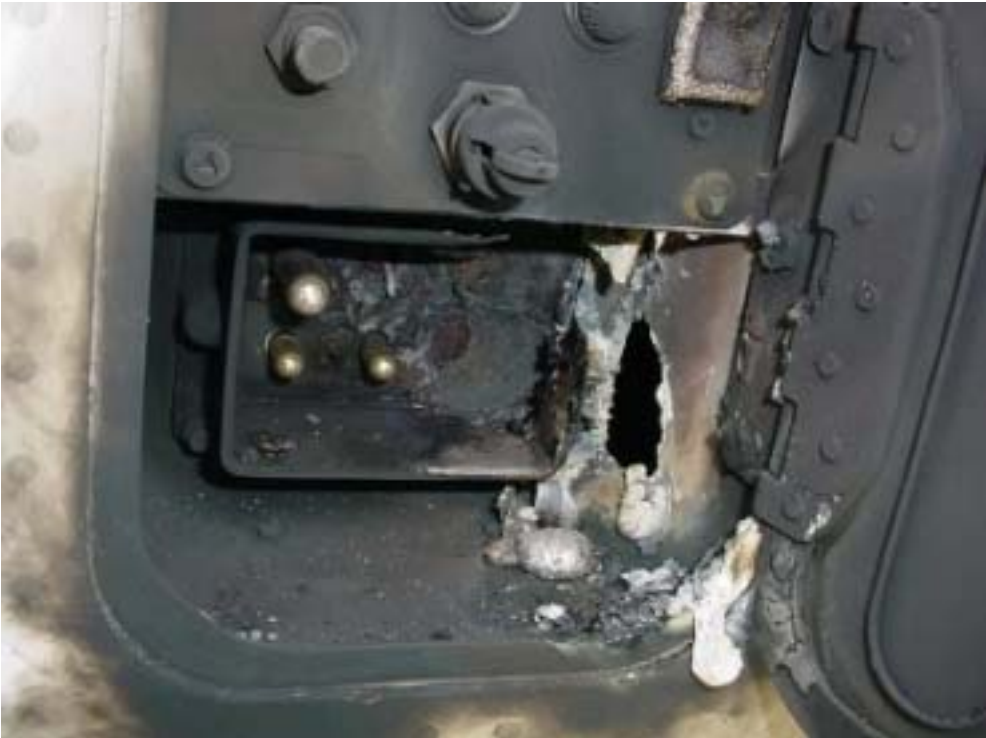
Annex 3: Hole in the fuselage

The connector plate was located in an externally accessible bay in the aircraft's fuselage. The wall of the bay had burned through at one point. This created an opening through which fire and smoke were able to penetrate into the cockpit (see Annex 3).

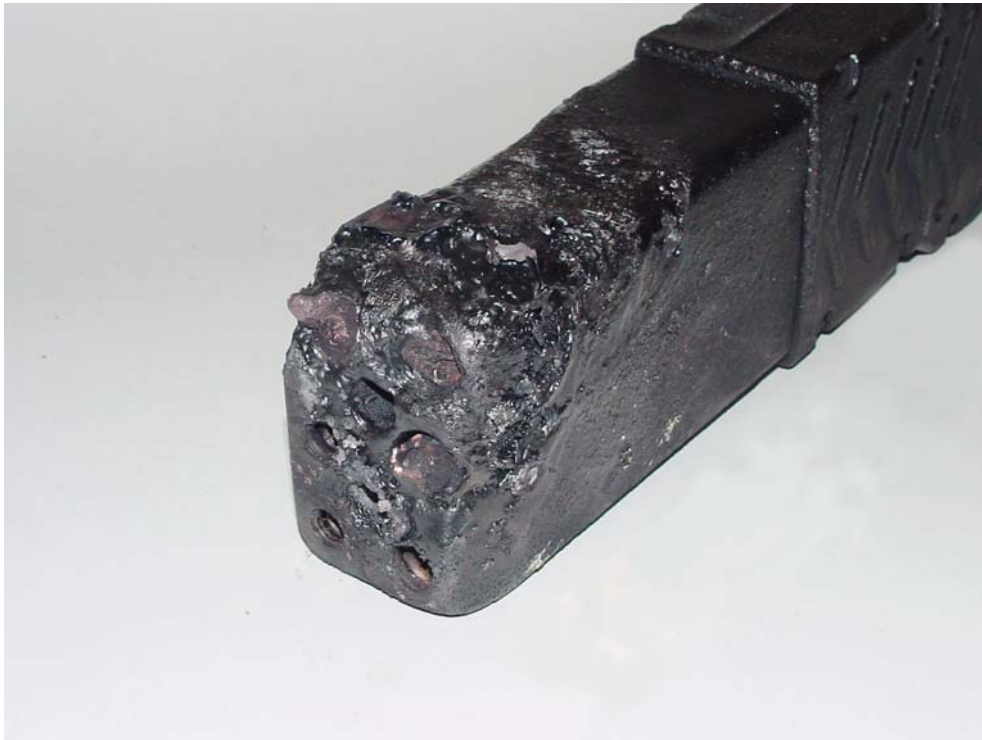
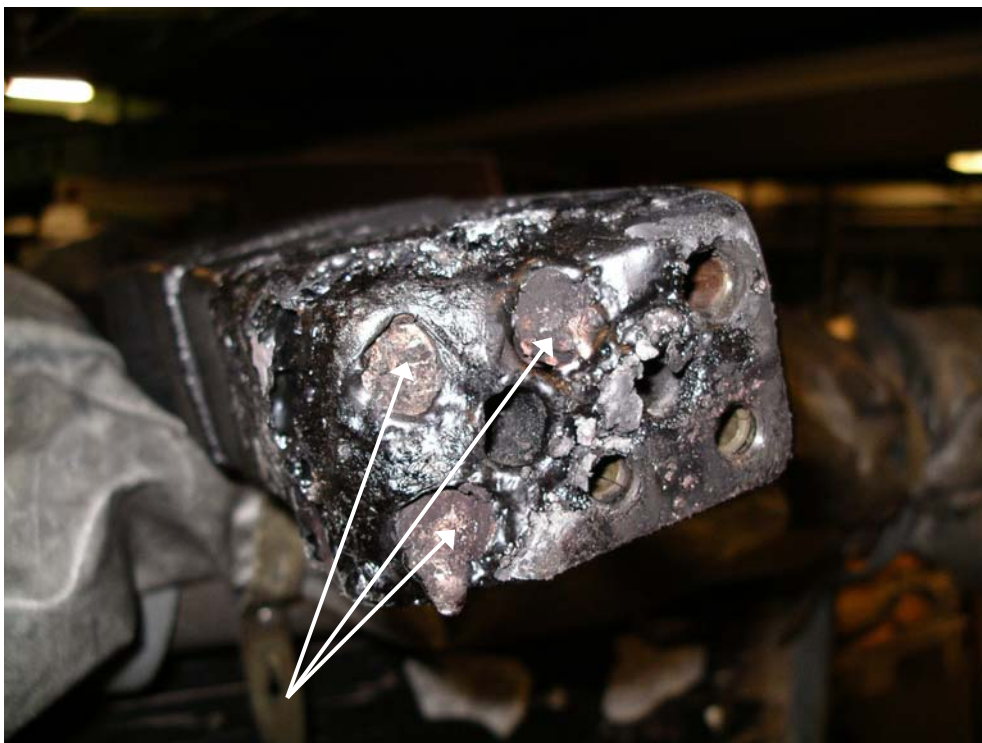
Annex 4: Destroyed dock-side plug

The very badly damaged plug was opened to determine whether de-icing fluid had penetrated it. Fluid residue was found in the jacket and in the plug itself (see Annex 7).

The three molten contact pins of the aircraft-side connector plate

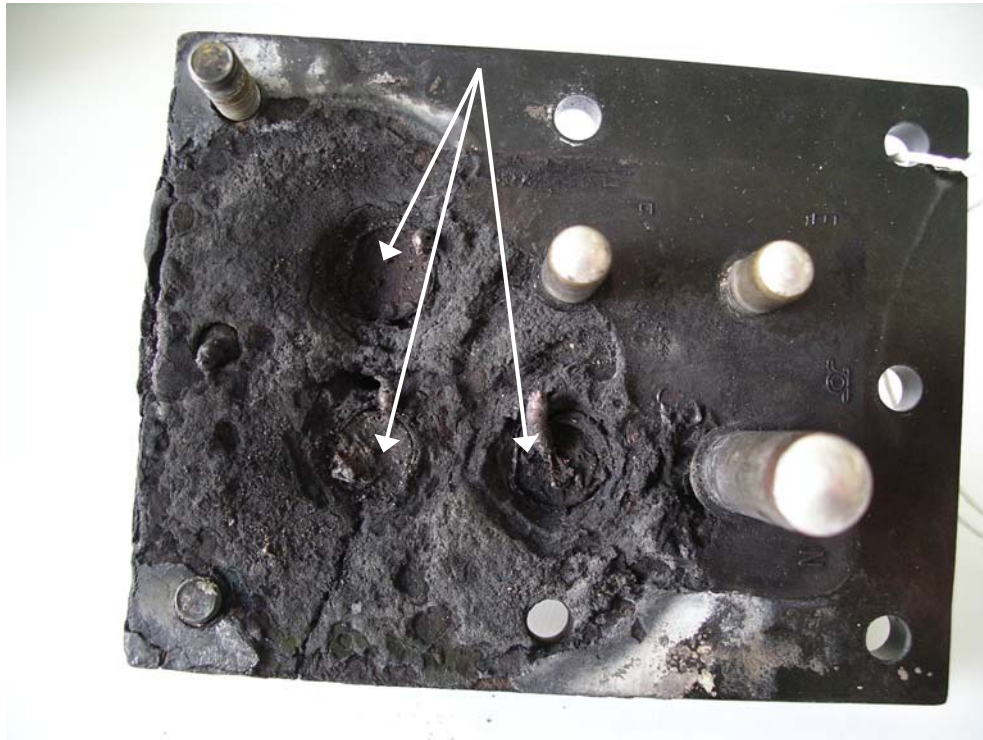
Annex 5: Contact pins on the aircraft-side connector plate

The three phase contact pins have melted away

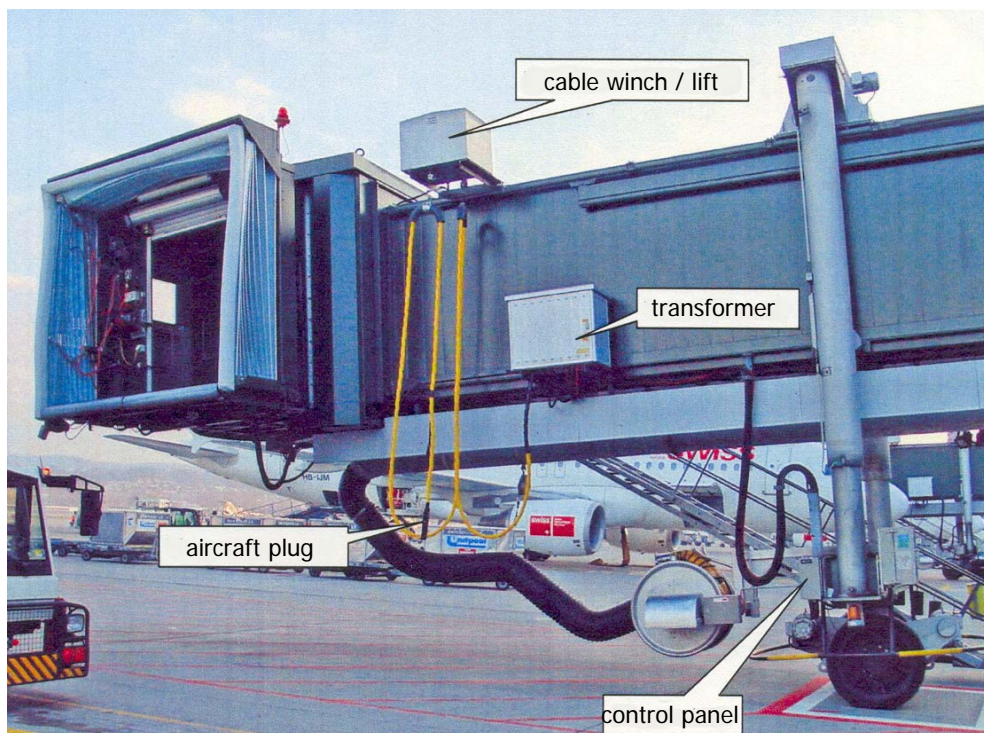
Annex 6: Cable lift up device

This causes the worker beginning to extend the cable, with the help of the cable lift up device, even before the aircraft comes to a standstill and to approach the expected position of the aircraft nose.

Immediately after the aircraft comes to a standstill, the worker opens the cover in the aircraft fuselage to obtain access to the aircraft-side connector. Since he generally needs two hands to do this, he may be unable to keep hold of the plug on the extended cable. He either places the cable over his shoulder or, as was observed as part of the investigation, places it on the ground.

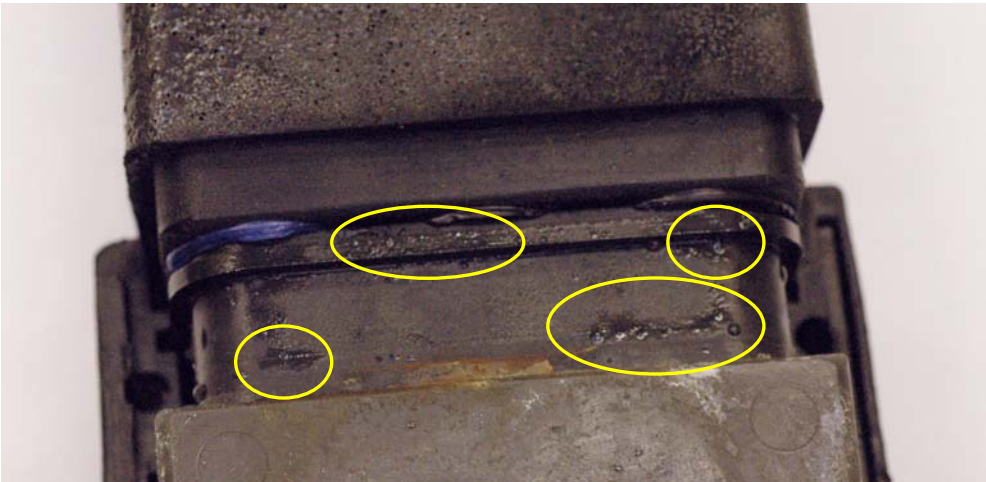
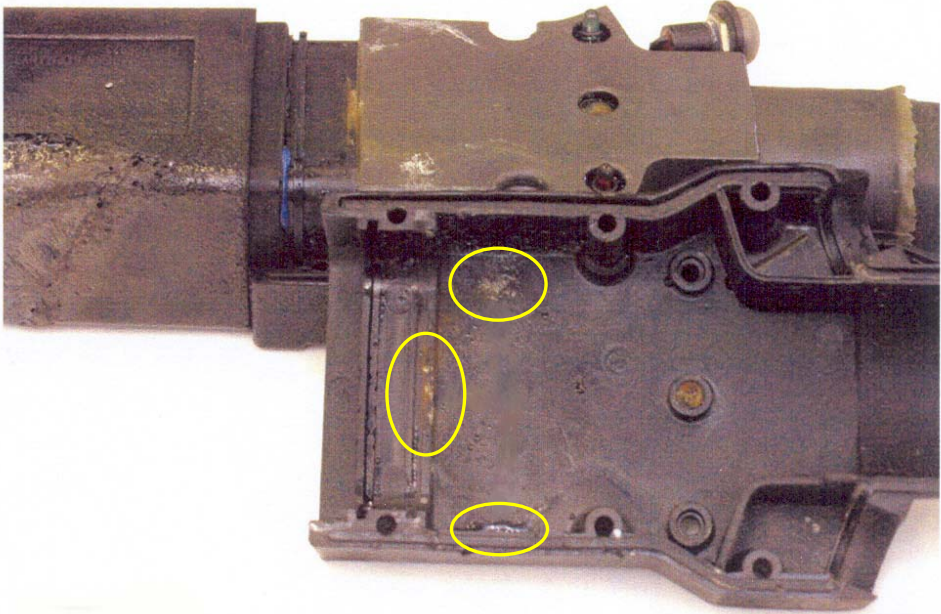
Annex 7: Fluid residues on the dock-side plug

In the scanning electron microscope high levels (>10%) of potassium, carbon, oxygen and silicon were found both in the de-icing fluid and in the fluid residues.

Moreover, considerable levels of copper and zinc were found in the fluid residues.

In the de-icing fluid, as well as in the fluid residues found inside the plug, indications of formates were found as a result of a qualitative chemical analysis. The evaporation residues of both fluids had practically identical elemental compositions.

The fluid residues inside the plug analysed in the course of the investigation exhibited practically identical elemental composition as the de-icing fluid. On the basis of the chemico-physical analysis it can be assumed that the short-circuit was caused by de-icing fluid which had penetrated the plug.

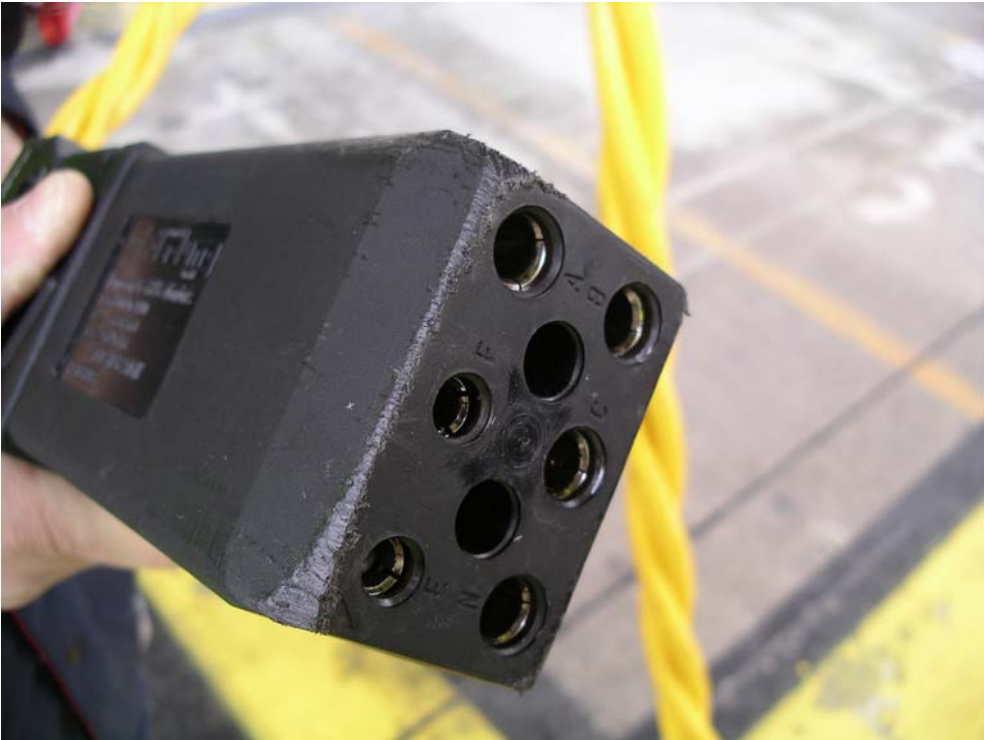
Annex 9: Abrasion marks on the two-day old plug

Two days after the serious incident, the investigation team inspected stand A-57 and observed the cable connection procedure for the external power supply. An aircraft was towed to the stand. The cable was pulled from the dock to the aircraft. In order to open the aircraft-side cover, the worker needed both hands and he therefore placed the cable on the ground. It must be assumed that this procedure was not an isolated case, as the new plug fitted after the incident already exhibited abrasion marks (Annex 9). This allows the conclusion that the cable is not only laid on the ground, but is also dragged around on the ground. If the ground is contaminated, this may cause contamination on the surface of the plug. This creates the conditions which prevailed in the serious incident.
