Final Report No. 1936 by the Aircraft Accident Investigation Bureau

concerning the accident
to the Cessna C172P aircraft, OK-HOS
on 23 August 2005
in Bärnetscha, municipality of Simplon-Dorf/VS,
approx. 65 km W of Locarno

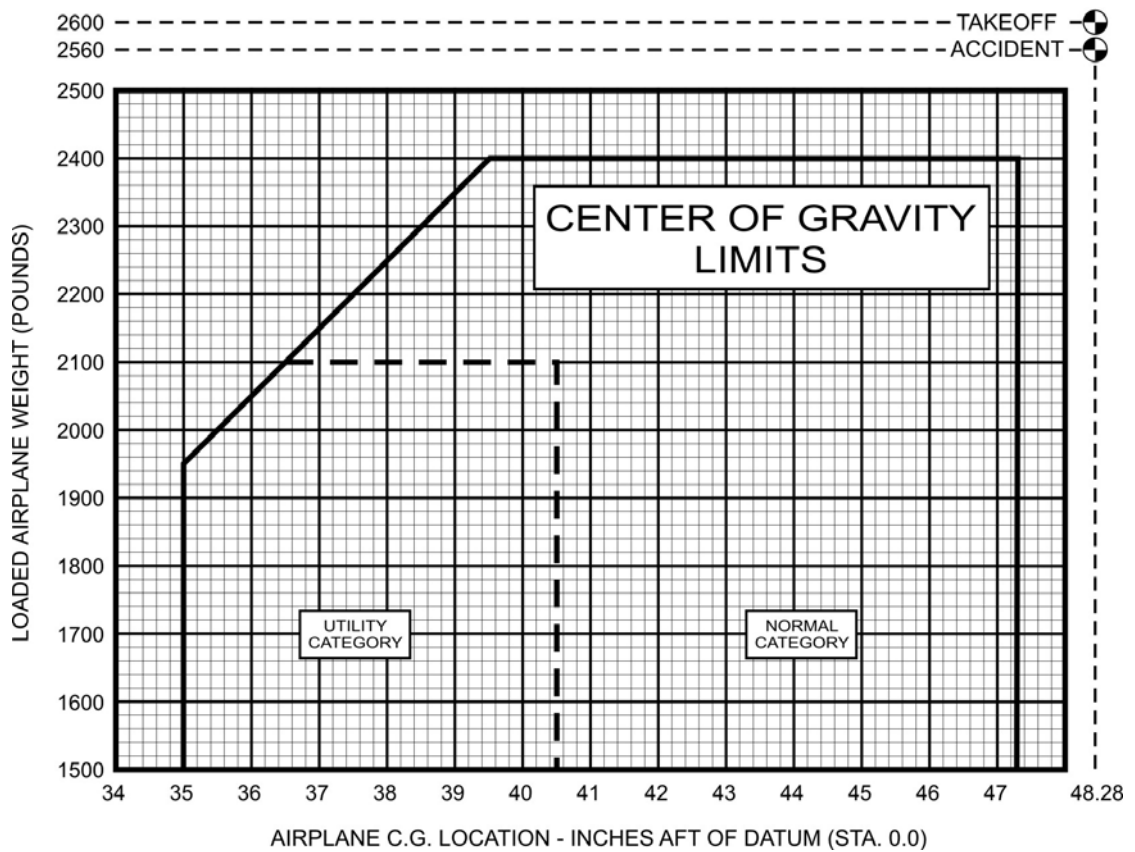
On take-off in Locarno OK-HOS was overloaded by 200 lb (91 kg).

The aircraft's aft centre of gravity limit was 47.3 inches according to AFM.

The centre of gravity was therefore approximately 1 inch outside the permitted range.

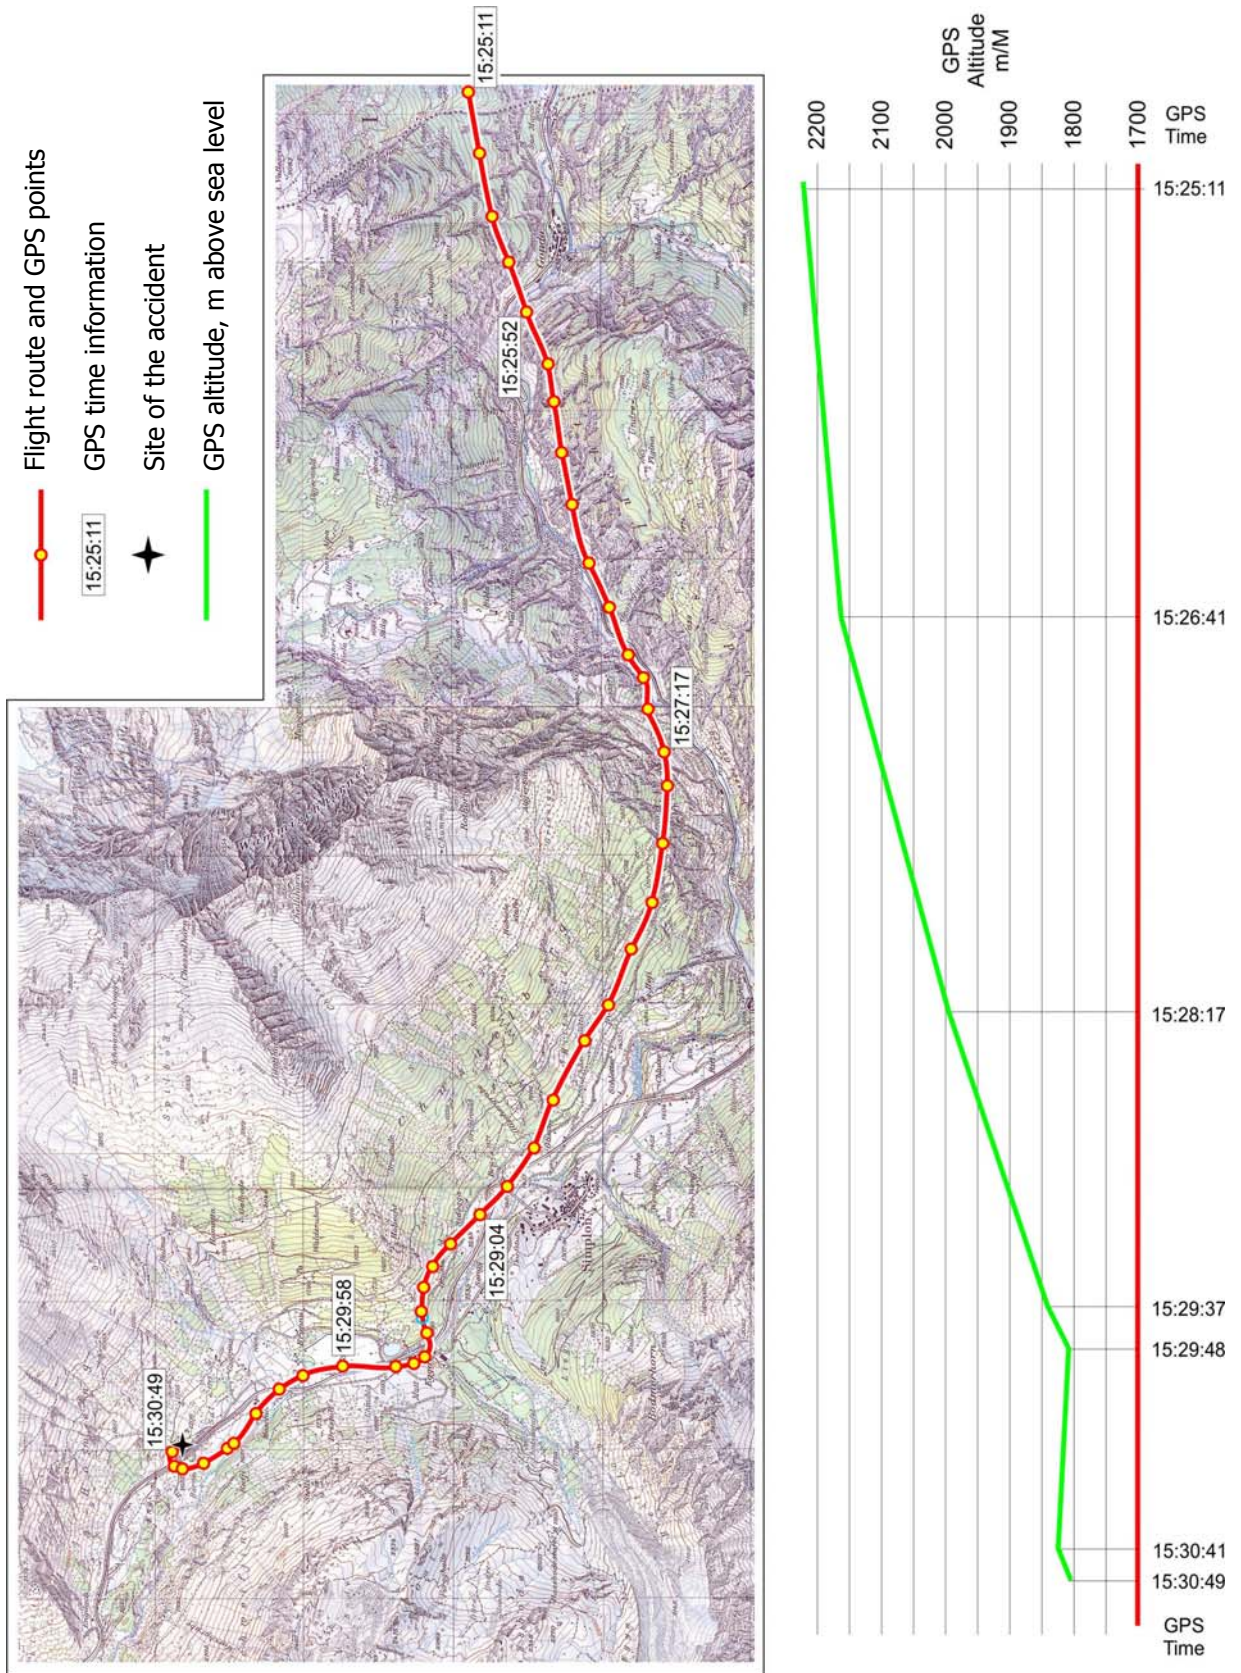
Flight route

It was therefore possible to reconstruct the flight route (see Annex 1).

Experience indicates that on the Locarno-Simplon route irregular up- and downdraughts are to be expected as far as the Domodossola region. From Domodossola to Varzo, updraughts generally prevail. From Varzo, especially in the centre of the valley, strong downdraughts are to be expected up to the Simplon Pass. The GPS recordings confirm the effect of these wind conditions (cf. Annex 1).

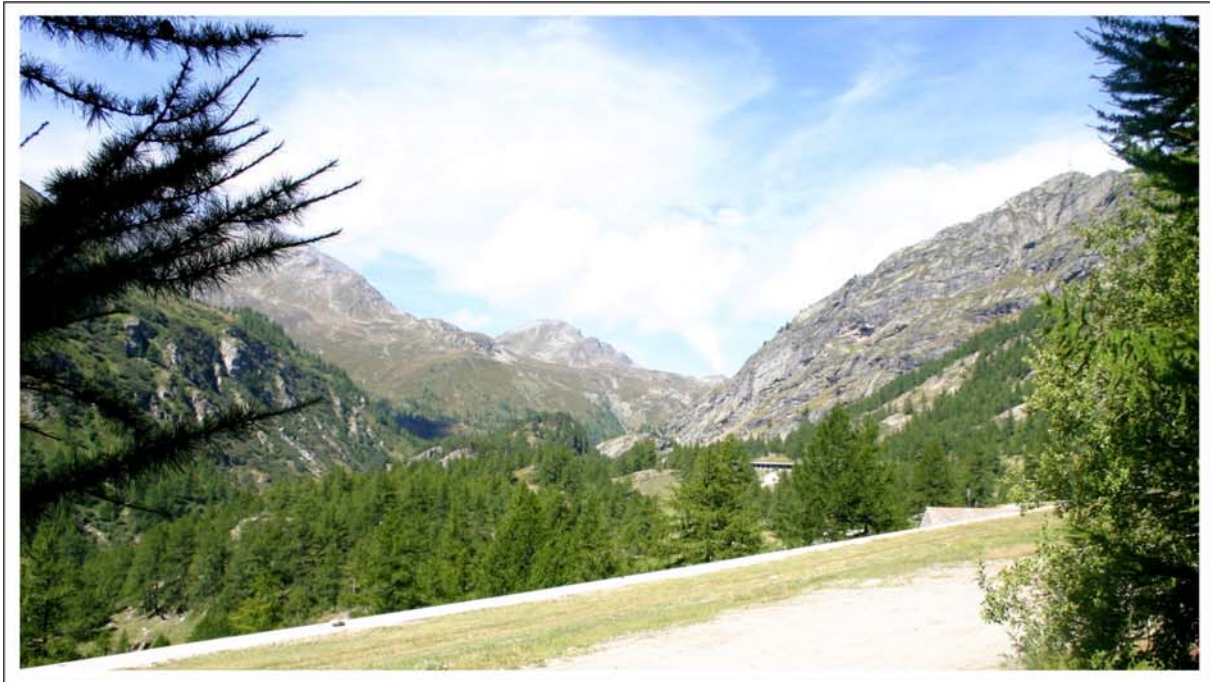
View towards the Simplon Pass from the site of the accident

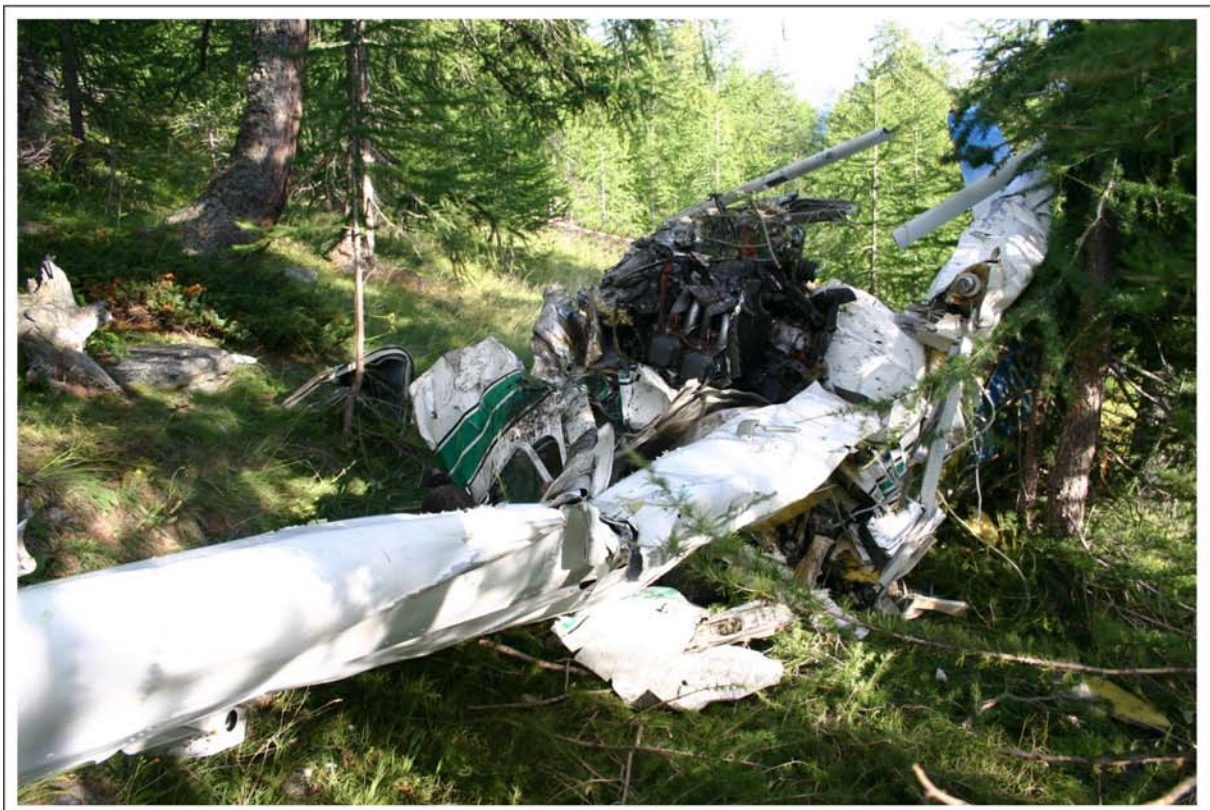
The aircraft crashed into the ground immediately in front of a small tarred private road and skidded over the road; the wreck came to a standstill in a small wood a few metres away (see Annex 2). A large quantity of fuel leaked from the ruptured tanks, causing crop damage.

The aircraft crashed into the ground with a near-vertical inclination. The engine lay on the cabin. Both wings were bent forward and the fuselage was angled forward at 180 degrees (see Annex 2).

Accident site and wreckage
