Final Report No. 1940 by the Aircraft Accident Investigation Bureau

concerning the serious incident
to the SAAB 2000 aircraft, HB-IZJ
operated by Swiss International Air Lines
under callsign SWR 1042
on 15 August 2003
at Zurich Airport

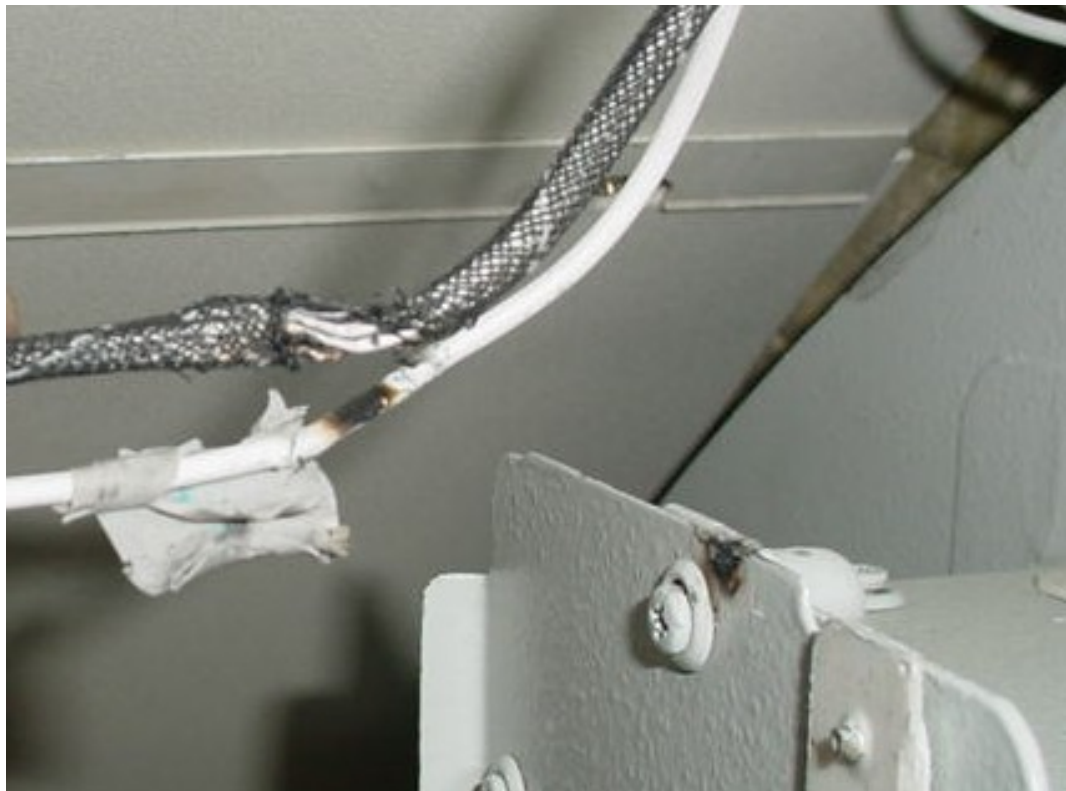
After the landing, it was found that the power supply cables for the working light in the forward galley were squashed between the structure of the galley and the frame of the door to the avionics compartment. The insulation of the cables had been damaged and arcing was able to occur between the cables and the metal structure of the aircraft.

Figure 1 – Damage behind the forward galley: the insulation of the cables is damaged. The heat marks on the cables and the aircraft structure show that arcing has occurred.

The forward galley is located in front of an area containing electronic equipment (avionics compartment). To allow access to the avionics compartment, the galley is mounted on rails and can be pulled out with little effort. The cables for lighting the work surface must therefore possess a degree of flexibility and must be of sufficient length to allow the galley to be moved. In the present case, when the galley was pushed back these cables were presumably squashed between its structure and the frame of the door to the avionics compartment. In the process, the insulation was damaged and arcing was able to occur between the cables and the metal structure of the aircraft. The resulting high temperatures then caused part of the plastic insulation of the cables to melt and evaporate; this could be perceived as the smell of a fire.

The serious incident is attributable to the fact that during the flight arcing occurred between two live cables and the structure of the aircraft, because the cable routing made it possible for its insulation to be damaged.

In view of the damaged cables which were discovered on aircraft HB-IZJ, all Swiss International Air Lines SAAB 2000 type aircraft were checked. On four out of 22 aircraft damage in the same location as on aircraft HB-IZJ was found on the corresponding power supply cable. This damage was repaired and the cable routing was improved.

As a result of the serious incident, on 18 December 2003 the manufacturer issued service bulletin (SB) 2000-25-092, which was sent to all operators of the SAAB 2000 aircraft type. The content of this service bulletin included a check and, if necessary, repair of the cabling in the area of the forward galley. The cable routing and protection were also improved.
