Final Report No. 1942 by the Aircraft Accident Investigation Bureau

concerning the accident

to the aircraft Zlin 143L, HB-TCD

on 8 August 2006

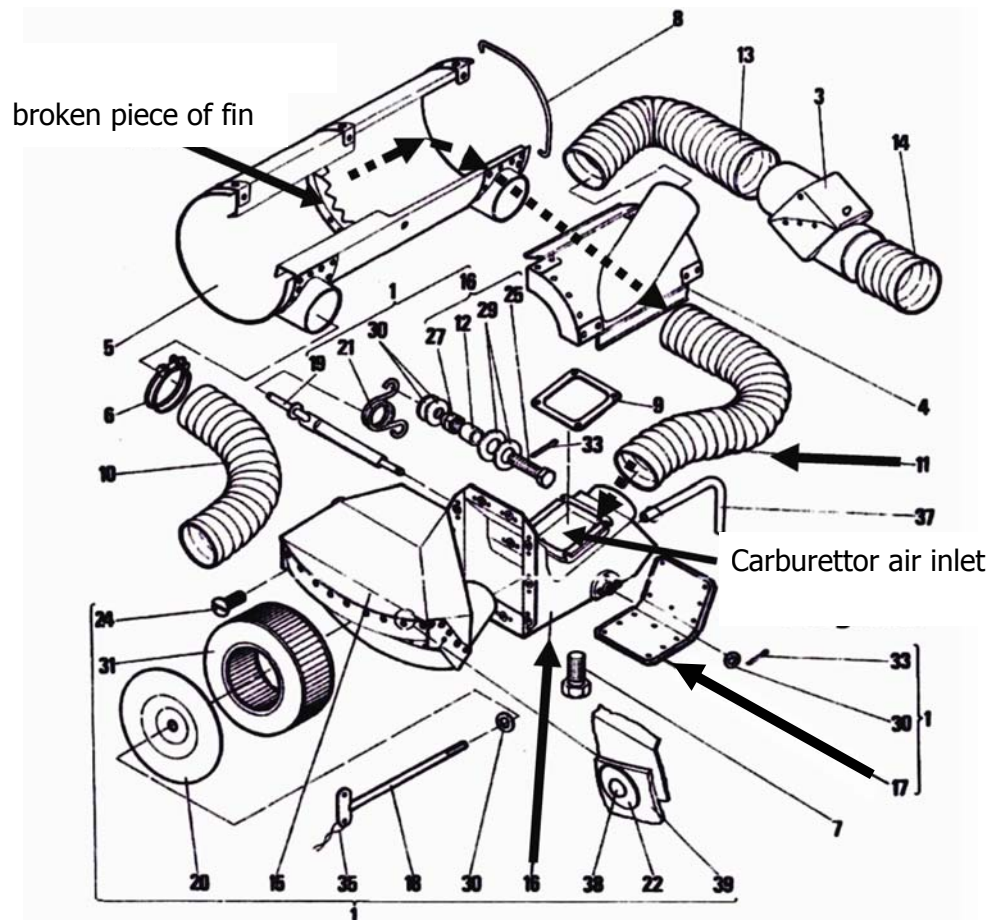
- Inside the right heat exchanger housing, the spot at which the piece of the fin had broken off could be identified. The remaining part of the fin exhibited a distinct fracture near a rivet hole.
- Inside the right heat exchanger housing, a second fin from which a piece had broken off was found. It was not possible to find this broken piece of the fin in the course of the investigation.
- On the outside of the panelling of both heat exchanger housings, distinct traces of chafing, originating from vibration, were found.

Fig. 1: Heat exchange system: On opening of the carburettor heating flap, item 17, the broken-off part of the fin was conveyed by the air current via the hose, item 11, and the air filter chamber, item 16, directly into the carburettor venturi channel. The broken-off part was caught in the venturi channel struts, got stuck between the petrol nozzle and the struts, and subsequently moved to a position which caused a massive deterioration in the air/petrol mixture. On approach, this prevented the desired increase in power from occurring and led to the observed spluttering and smoking of the engine.

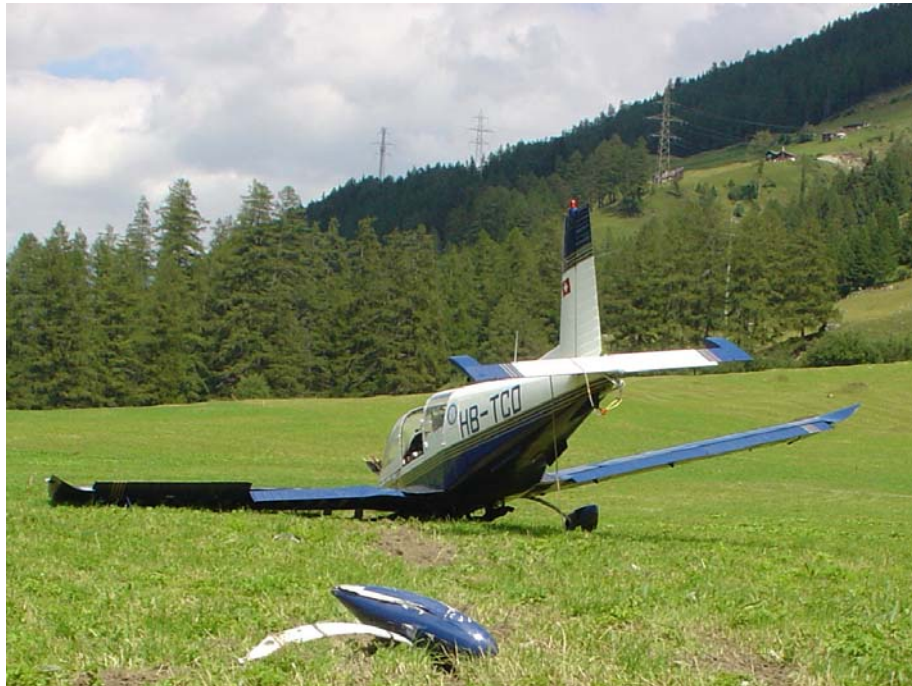
Fig. 2

The pilot then heard the stall warning sound. Shortly afterwards, the aircraft collided with the edge of the bank of a brook. In the process, the left landing gear was torn off. The aircraft skidded along the ground and came to a standstill after approximately 30 m. The pilot was seriously injured.

The impact occurred at a slight bank angle to the left, onto the upper edge of the bank of a brook. The aircraft then skidded over the meadow behind it and came to a standstill after approximately 30 m.

Accident site, HB-TCD, Münster/VS 08.08.2006

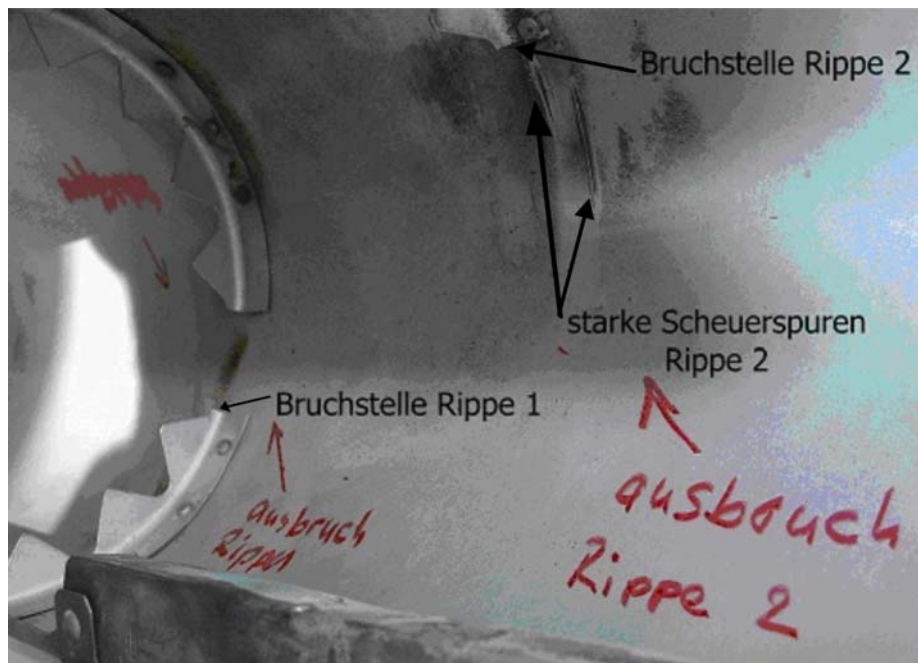
Fig. 3

On both sides of the two heat exchanger housings, near the pipe links to the exhaust flange, distinct traces of chafing were found, originating from vibration. In addition, the fixing holes of the retaining clamps for fitting and removing the housing were considerably worn and had been partly repaired by doubling up with sheet metal.

The fracture of rip No. 1 (cf. figure 3) occurred at some unknown point in time before the flight which was involved in the accident.

The inappropriate design of the heat exchanger contributed to the accident.

Heat exchanger lining with defective panelling ribs. The crack at rib 2 starts near the rivet hole

We consider necessary to issue a mandatory service bulletin that prescribes mandatory inspection of the vortex inserts inside the heat exchangers on each Z 143L aircraft from S/N 0001 to S/N 0044 (duraluminium inserts). In case a crack is found, the insert shall be immediately replaced with a new one made of stainless steel.

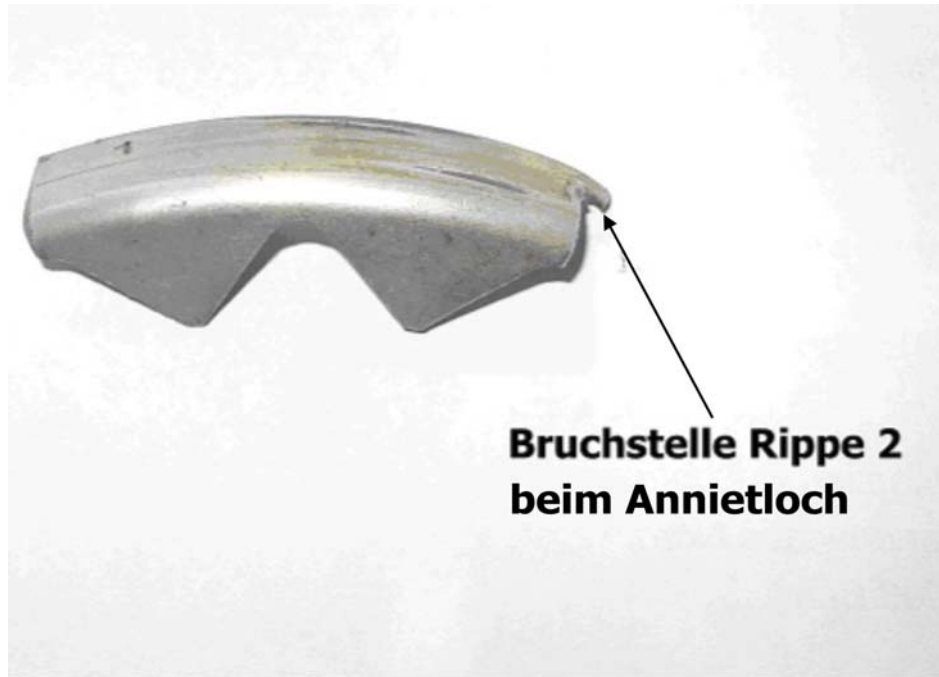
Fig. 4

During the examination of the carburettor, a broken-off piece of a fin was found in the venturi channel, originating from the inside of the right-hand heat exchanger housing.

The piece of the reinforcement rib which was caught in the carburettor's venturi channel

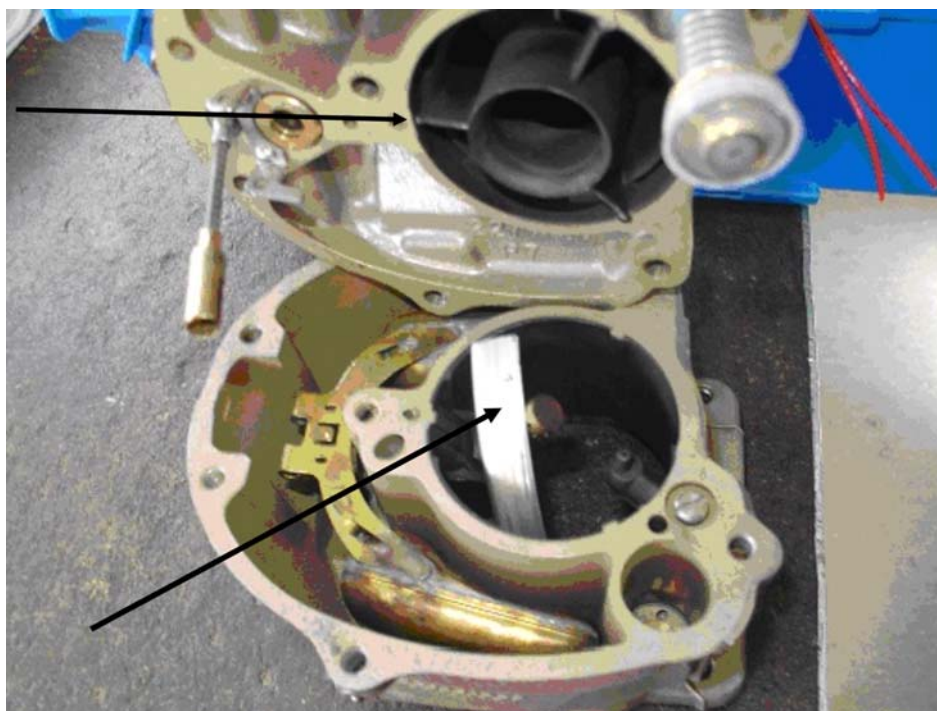
Fig. 5

The broken-off part remained caught in the venturi channel strut, got stuck between the petrol nozzle and the struts, and subsequently shifted to a position which caused a massive deterioration in the air/petrol mixture. On the approach, this prevented the desired increase in power from occurring and led to the observed spluttering and smoking of the engine.

Reconstruction of the piece of rib caught in the area of the fuel nozzle and the venturi channel. When the upper part of the carburettor casing was taken apart, rib 2 fell into the carburettor's float chamber.

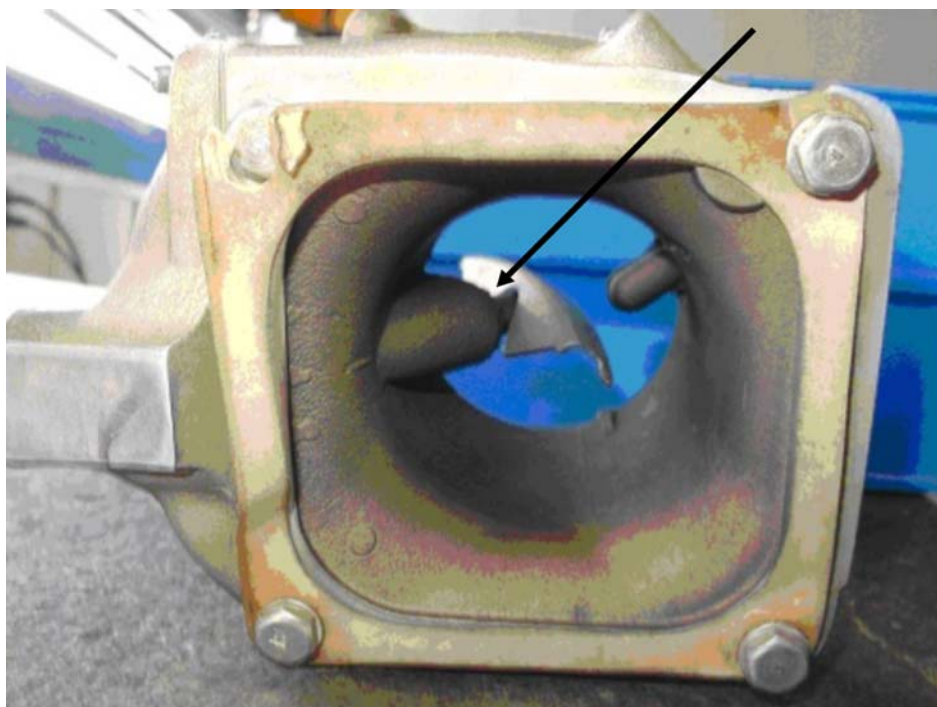
Fig. 6

View into the lower part of the venturi channel with a reconstruction of the piece of the rib that was caught.
