# **Final Report No. 1946 by the Aircraft Accident Investigation Bureau**

to the Pierre Robin DR 400/180 aircraft, D-ERAD

on 6 March 2005

in Val da Fain, Pontresina municipality/GR,

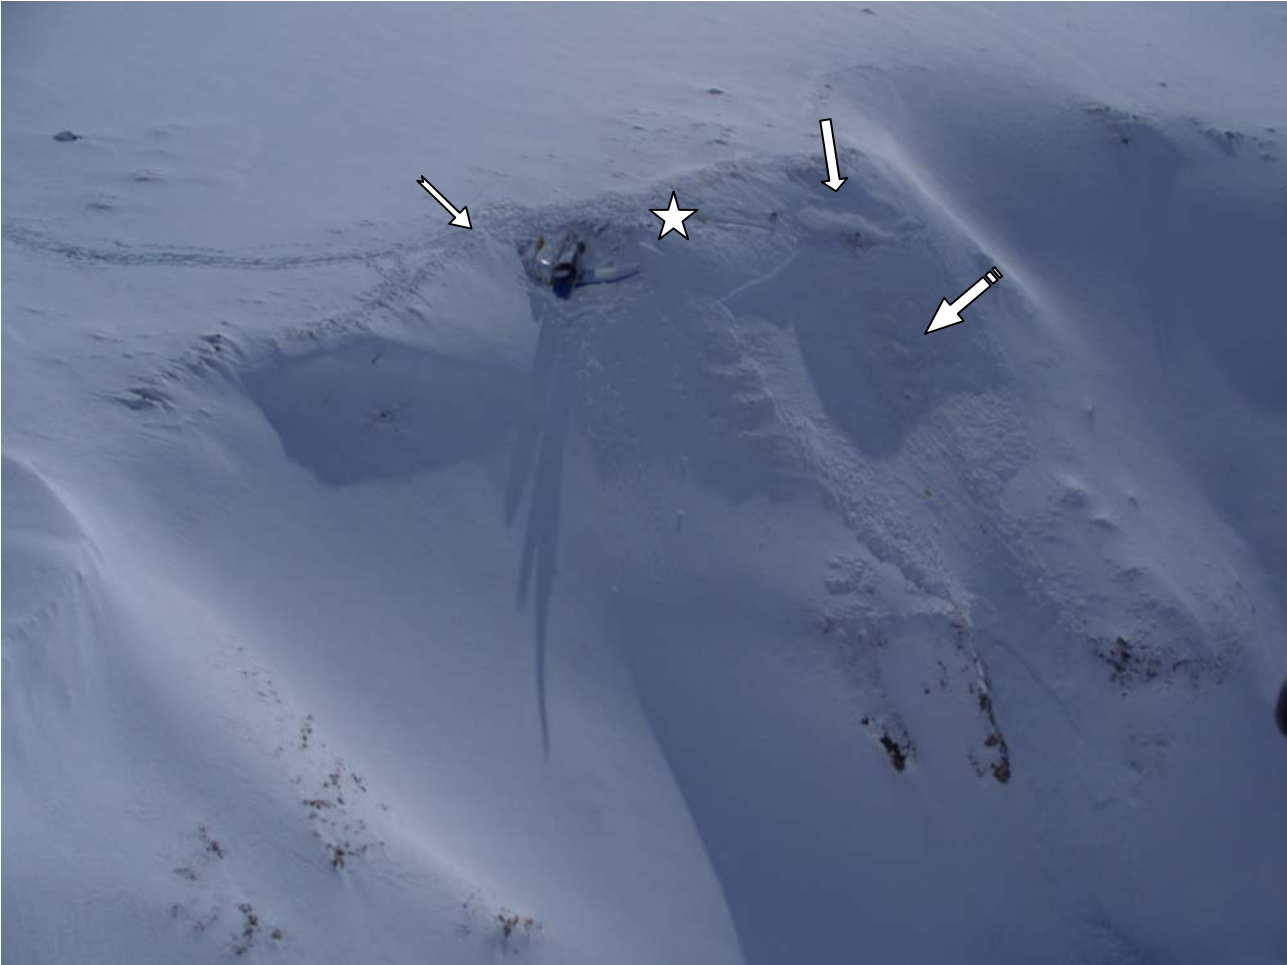
Wreck D-ERAD

The wreckage exhibited little external damage, but the wooden structure was substantially destroyed on impact. The right main landing gear remained in the snow at the point of first contact with the terrain. In the area of the second point of contact, wood and plastic debris were found within a 10 x 30 m rectangle.

The right wing was bent against the fuselage and destroyed. The wingtip and the leading edge were intact. The left wing and the left main landing gear were intact.

The fuselage was buckled to the left and the tail was separated at the connection point to the fuselage. The tail was intact and the control surfaces were free. The cabin was intact. The central fixing point of the rear abdominal seatbelts had been torn out. The front three-point belts withstood the loads. The engine components were damaged and the propeller was deformed.
