# **Final Report No. 1947 by the Aircraft Accident Investigation Bureau**

to the Cessna 172RG aircraft, registration HB-CLN

on 19 June 2005

on Dittingen airfield

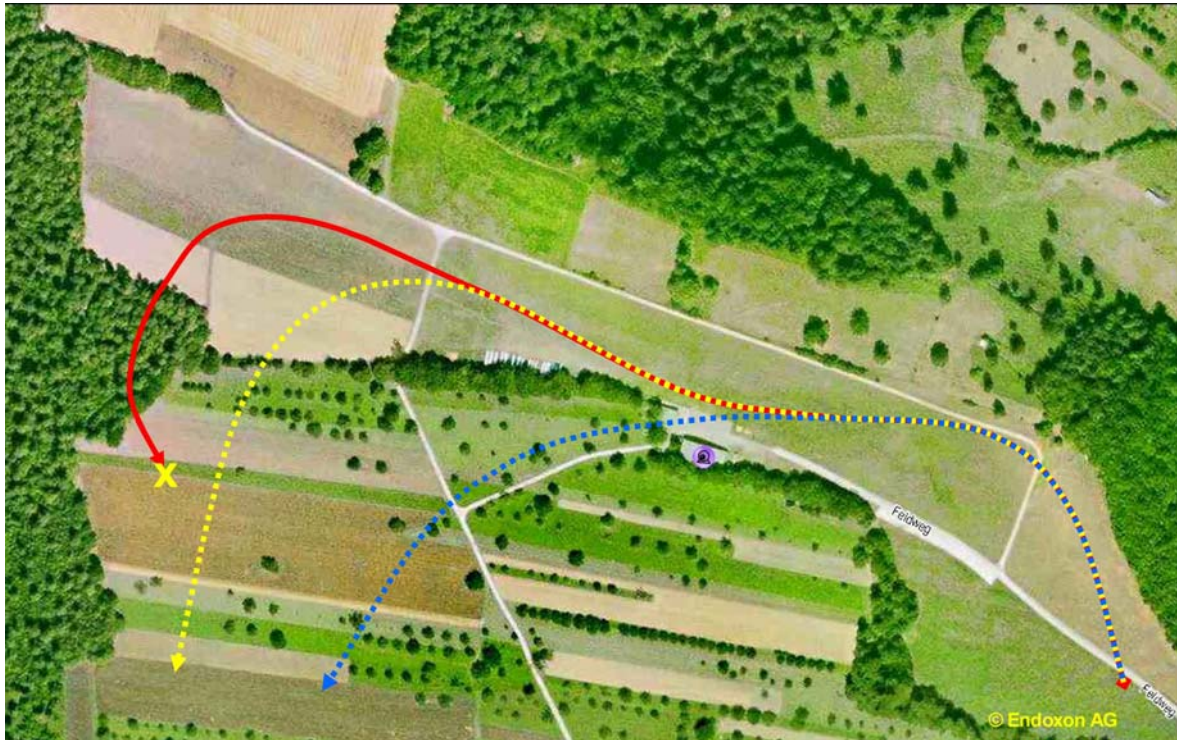
Ref. Figure 1.1 (copyright by © Endoxon AG):

The accident site is approximately 100 metres south of the western end of the runway (Annex 1, figure 1.1).

If the pilot had chosen this departure path, even the performance with the inappropriate configuration of the aircraft would certainly have been adequate (Annex 1, figure 1.1 and Annex 3, figure 3.3 Vertical profile).

Extract of chart with overview of the approximate flight path of the aircraft (red flight path) with the point of impact, with the "yellow" departure path for a go-around over the lowest obstacles and with the "blue" departure path over the restaurant.

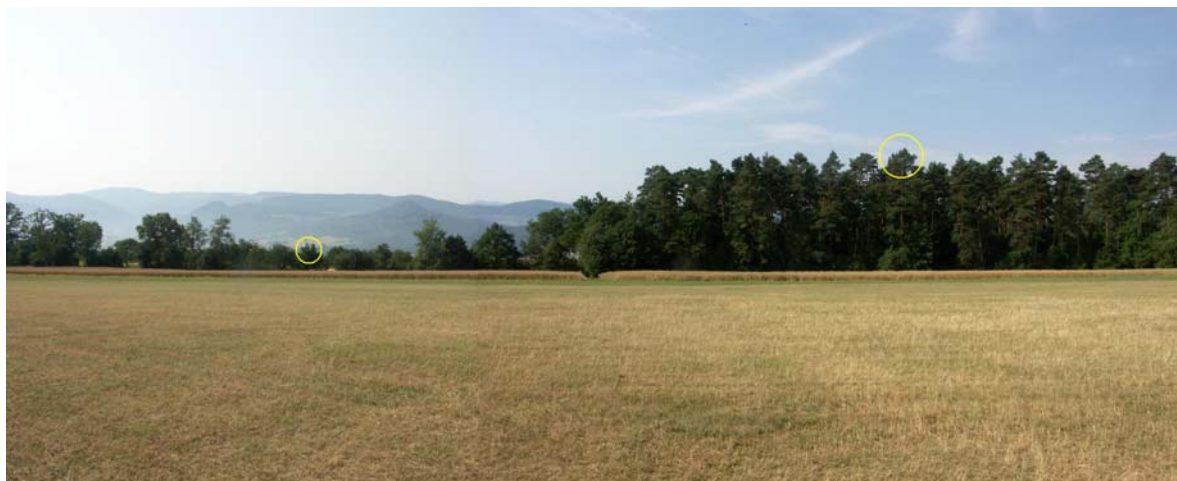
Ref. figure 1.2:

The pilot did not take the departure path in which he had been instructed for the go-around over the low obstacles (yellow circle on the left). He flew over the high trees (yellow circle on the right).

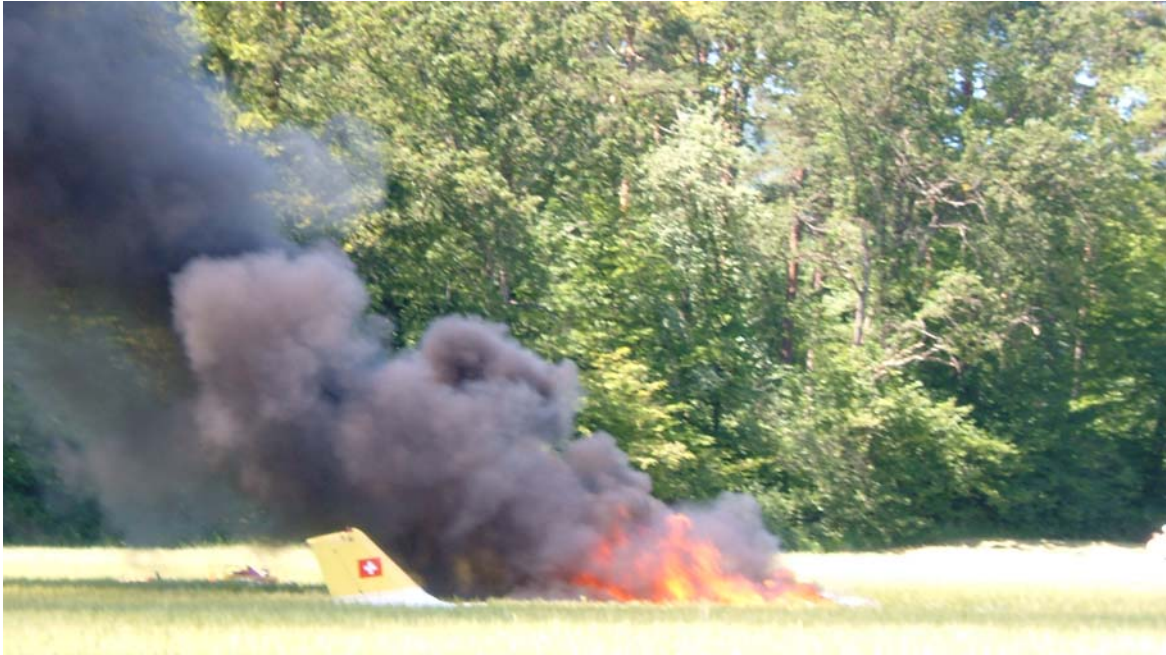
Ref. figure 1.3:

Shortly after the impact, fire broke out and the central section of the airframe burned out completely (Annex 1, figure 1.3 and figure 1.4).

The wreck caught fire shortly after impact. The plume of smoke indicates a strong wind.

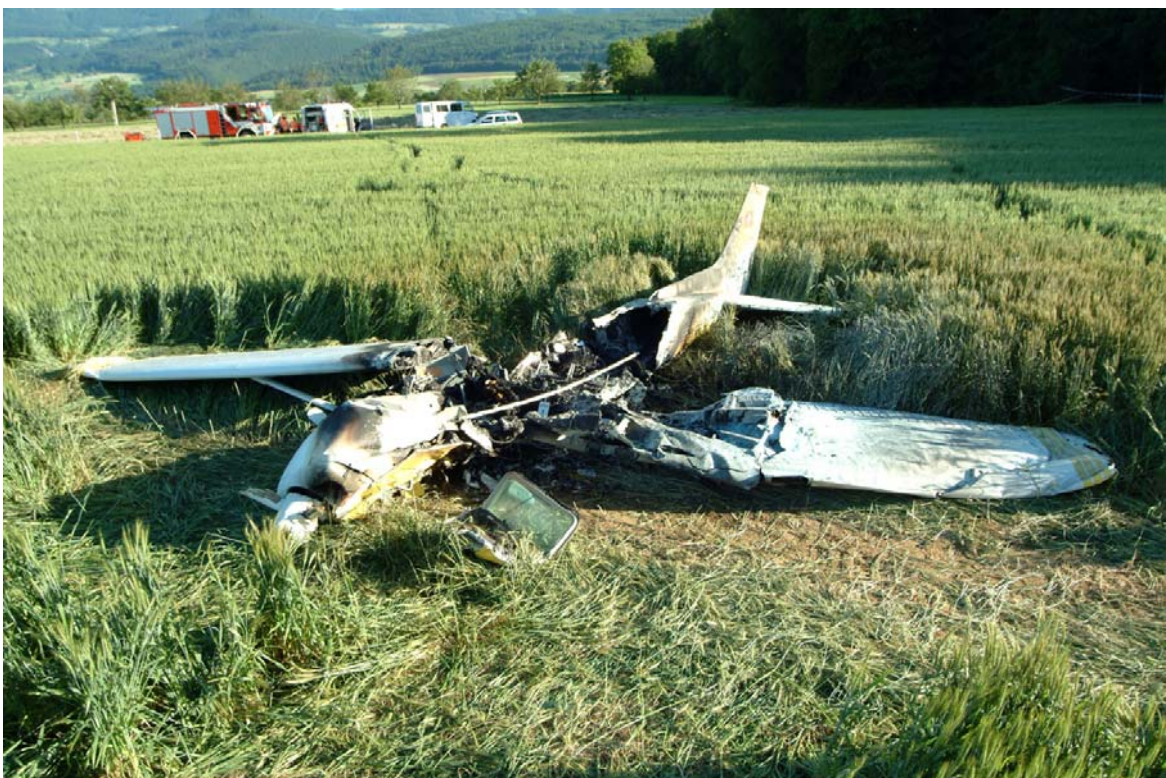
Ref. figure 1.4:

Overview of the condition of the wreck.

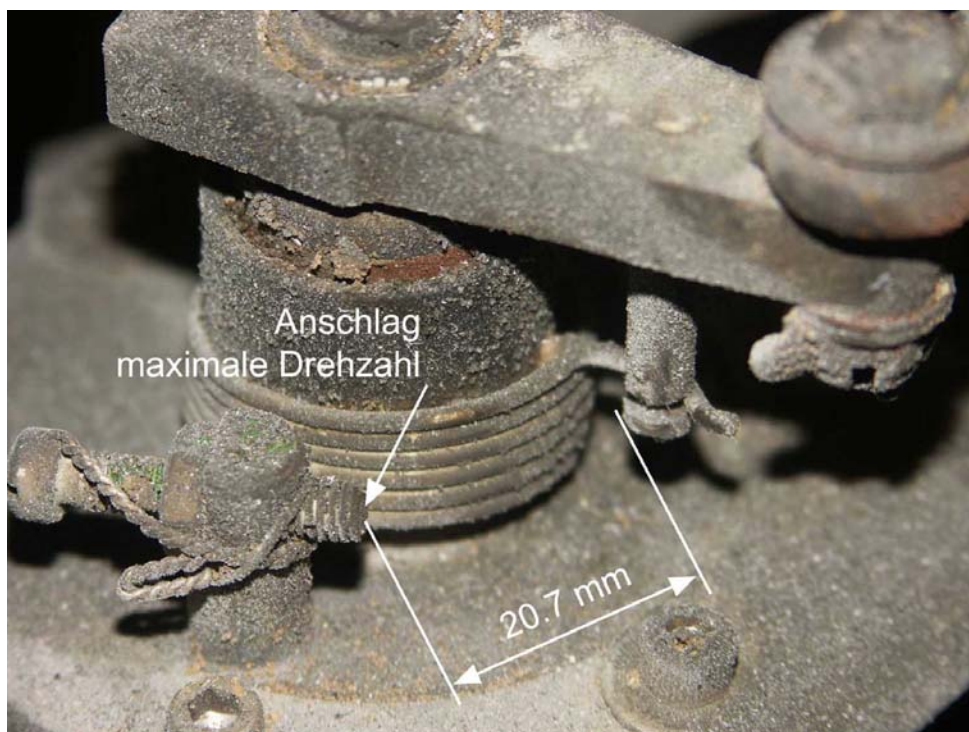
Ref. figure 2.2:

The propeller governor was 20.7 mm from the maximum speed stop and 12.7 mm from the minimum speed stop (see Annex 2, figure 2.1 and figure 2.2).

At full power, this corresponded to a propeller speed of approximately 1800 rpm.

It must be assumed that the governor was displaced somewhat as a result of the slightly asymmetrical impact of the aircraft with the ground, as the aircraft would hardly have been able to climb at a propeller speed of 1800 rpm.

The governor was 20.7 mm from the maximum speed stop, corresponding to a propeller speed of approximately 1800 rpm. It must be assumed that the governor was displaced somewhat by the slight asymmetrical impact.

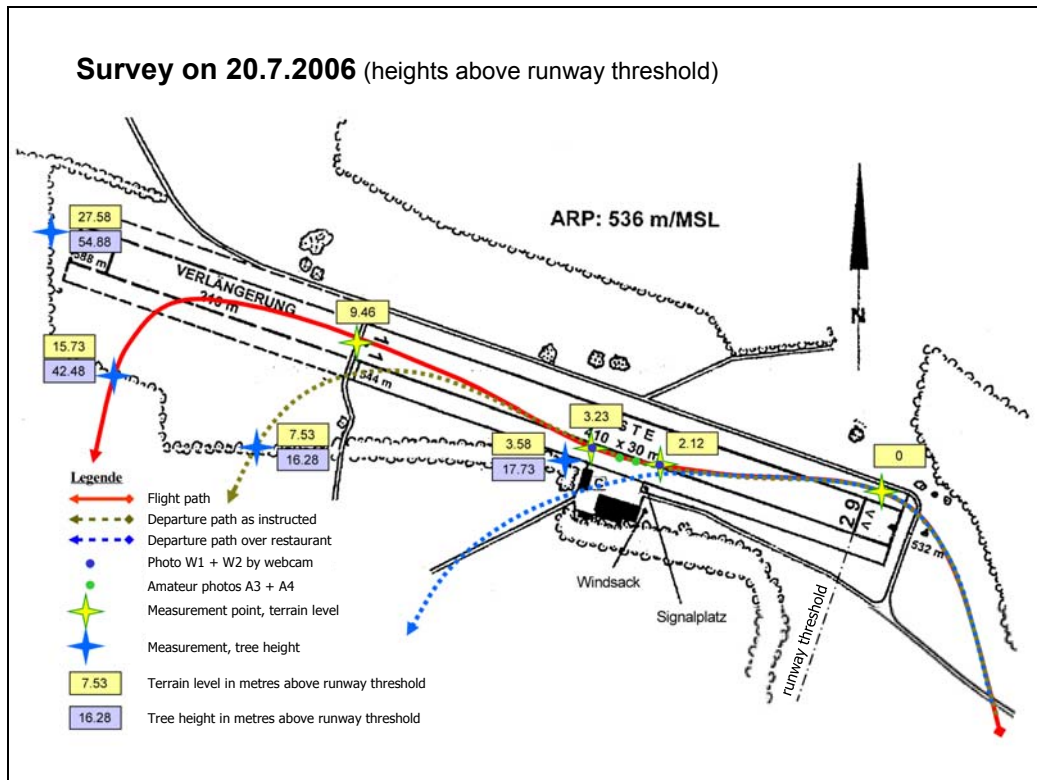
Ref. figure 3.1, terrain survey:

With help of the webcam photos and eyewitnesses, the flight path was reconstructed and points surveyed using a geometer.

The red flight path was the path involving the accident flight, the yellow flight path was the departure path for a go-around above the lowest obstacles and the blue flight path is the departure path over the restaurant.

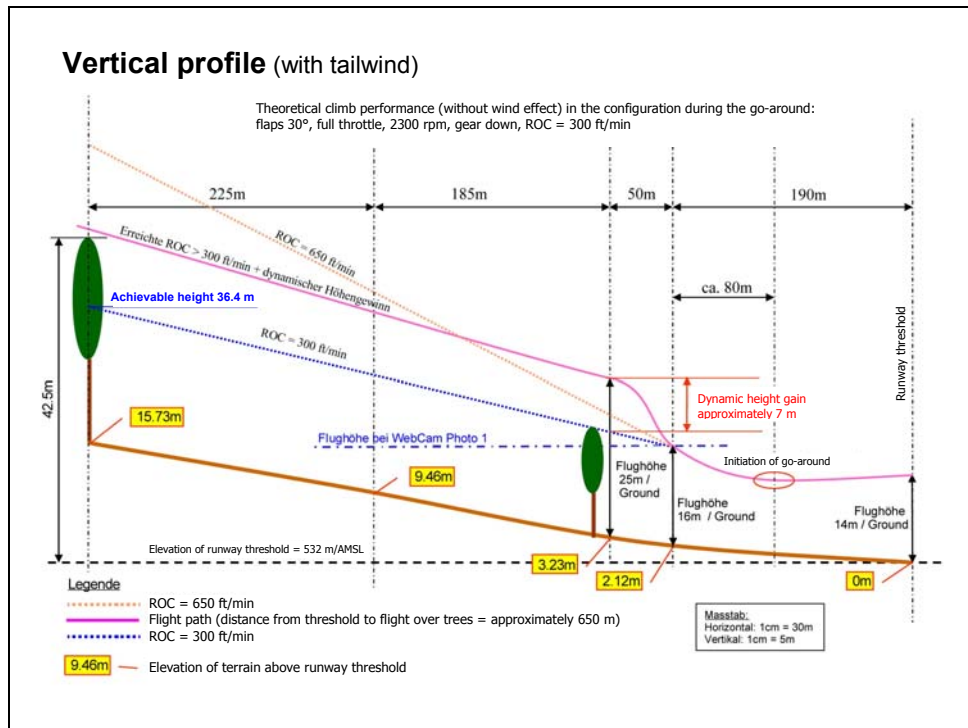
Ref. figure 3.2:

Analysis of the webcam pictures, other photos and calculations using the data from the flight manual, compared with the profile of the terrain (see Annex 3, figure 3.2 Vertical profile), produced the results summarised in the table below,.

This table shows that if the configuration of the aircraft had been correct, the high trees on the chosen flight path could certainly have been cleared at the 63 KIAS speed required for the go-around.

The vertical profile shows the accident flight path over the high trees with the average rate of climb of 300 ft/min (for the inappropriate configuration of the aircraft, pink line) and the flight path with the correct aircraft configuration (brown dotted line).

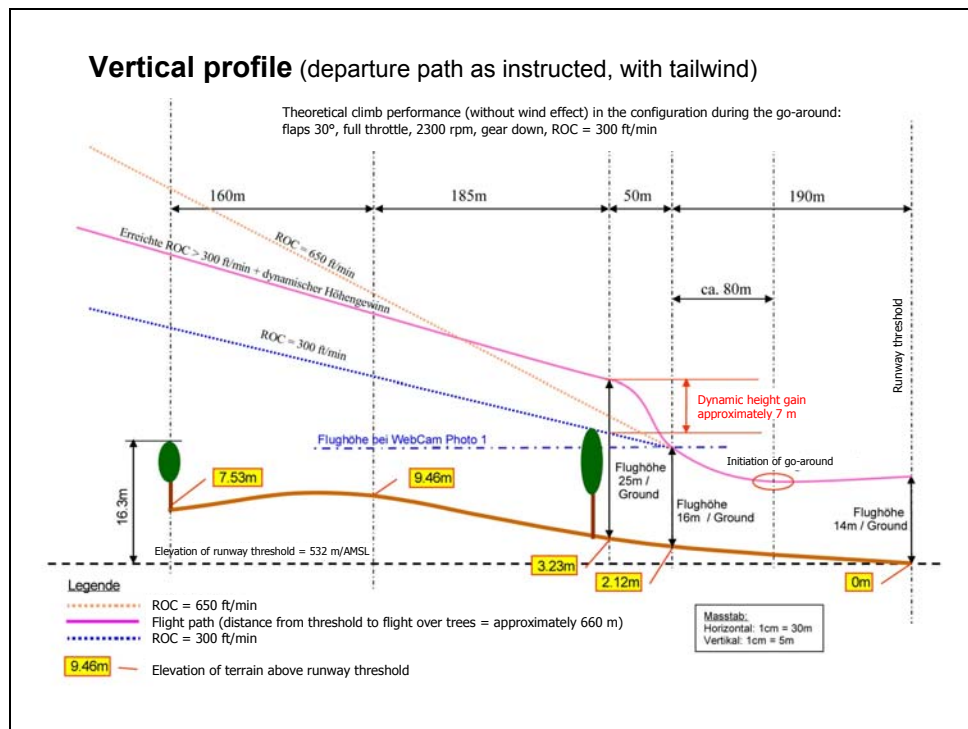
Ref. figure 3.3:

The vertical profile shows the departure path over the lowest obstacles for different rates of climb: the rate of climb of 300 ft/min as flown with the inappropriate configuration would still have sufficed by choosing this departure path.
