Final Report No. 1950 by the Federal Aircraft Accident Board

to the Boeing 737-33V aircraft, registration HB-III

of the EasyJet company, flight EZS 903

on 15 August 2003

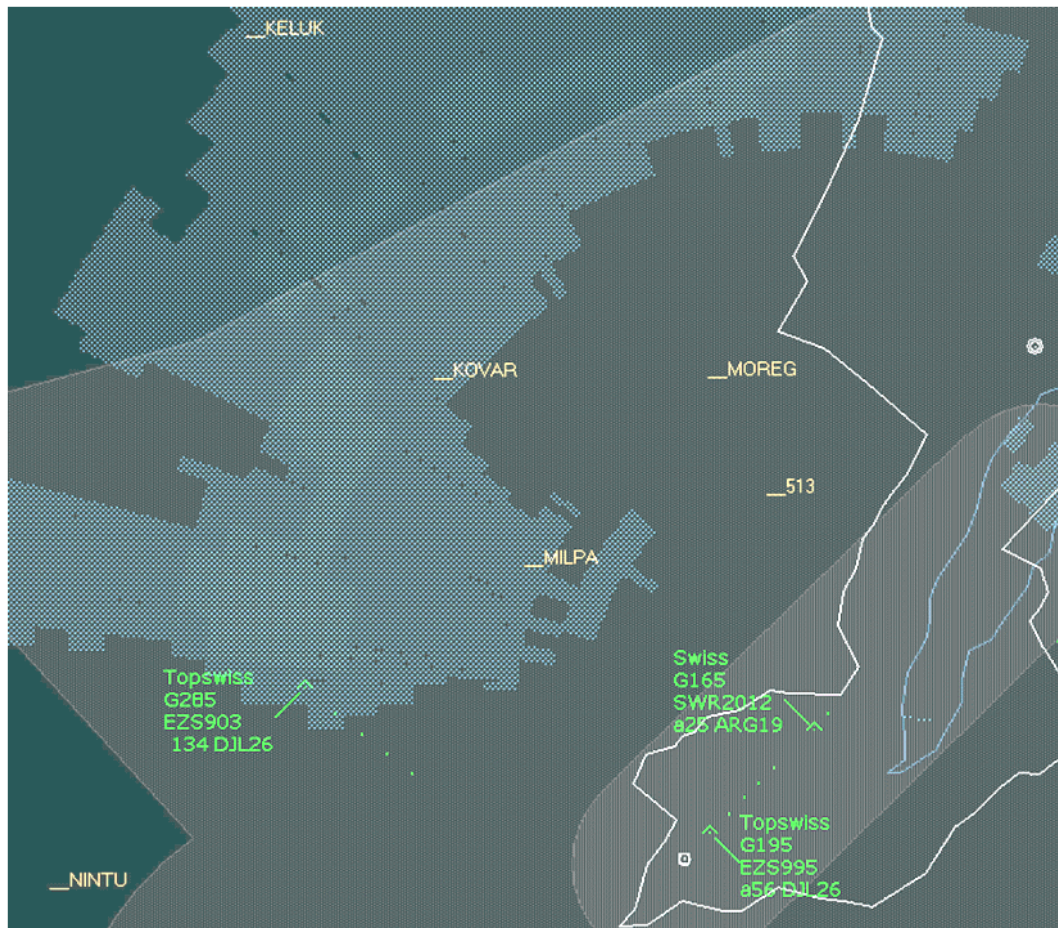
The part of the ICWS radar image represented in figure 4 shows the position of flight EZS 903 at 08:00:01 UTC, when it was entering a thunderstorm area with the highest intensity of precipitation.

Fig. 4 Representation of part of the ASR10SS radar image as it would have appeared on the ICWS console at 08:00:01 UTC.

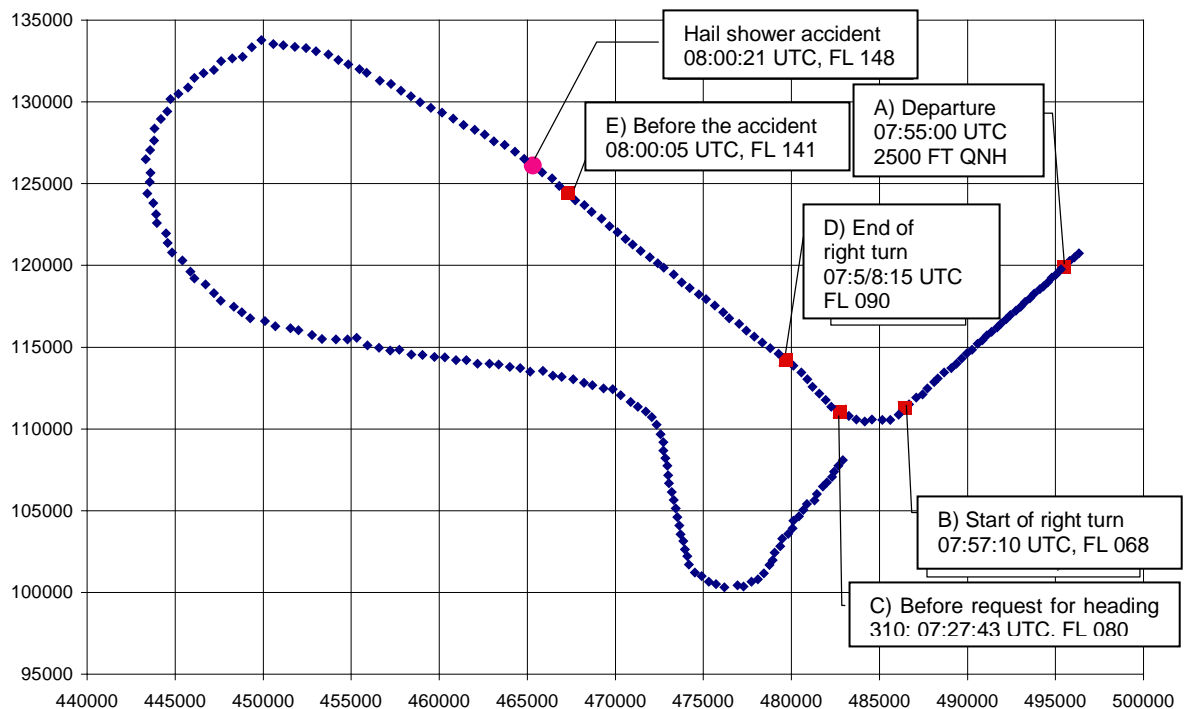
The accident sequence can be described by the events which took place at five significant points in time between the time of take-off and the time the aircraft entered the hail precipitation zone (figure 6).

Fig. 6 Route of the aircraft based on Geneva Approach sector radar recordings, with a 4 second refresh rate

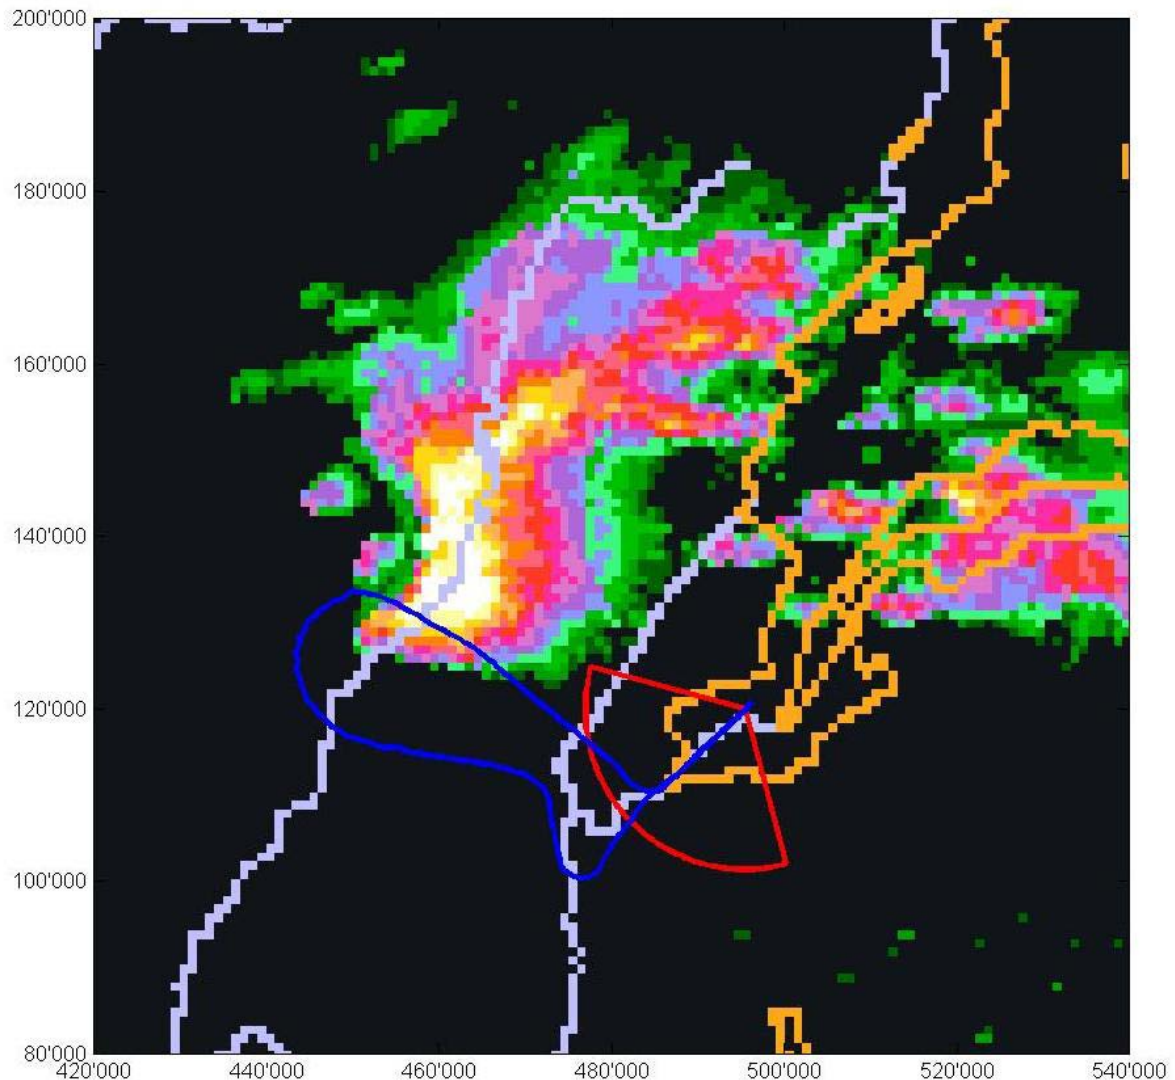
According to the crew's statements, the weather radar *tilt* was set to $+2^\circ$. At the range of 10 NM, the -1.3° line resulting from the *tilt* setting and the sensitive angle of the beam was 1300 ft below the flight altitude, i.e. at approximately 1200 ft. Since Geneva airport and the peaks of the Jura are at 1411 ft and 5700 ft altitude respectively, the radar was set to "*under scan*" and was mainly returning ground clutter.

Fig. 7 Superimposition of the route of the aircraft (blue) on the La Dôle weather radar image at 07:55:00 UTC. The sector shown in red is the one being scanned by the onboard radar at the time of take-off, for the range of 10 NM. Abscissa and ordinate are relative to the Swiss national kilometric grid CH 1903.

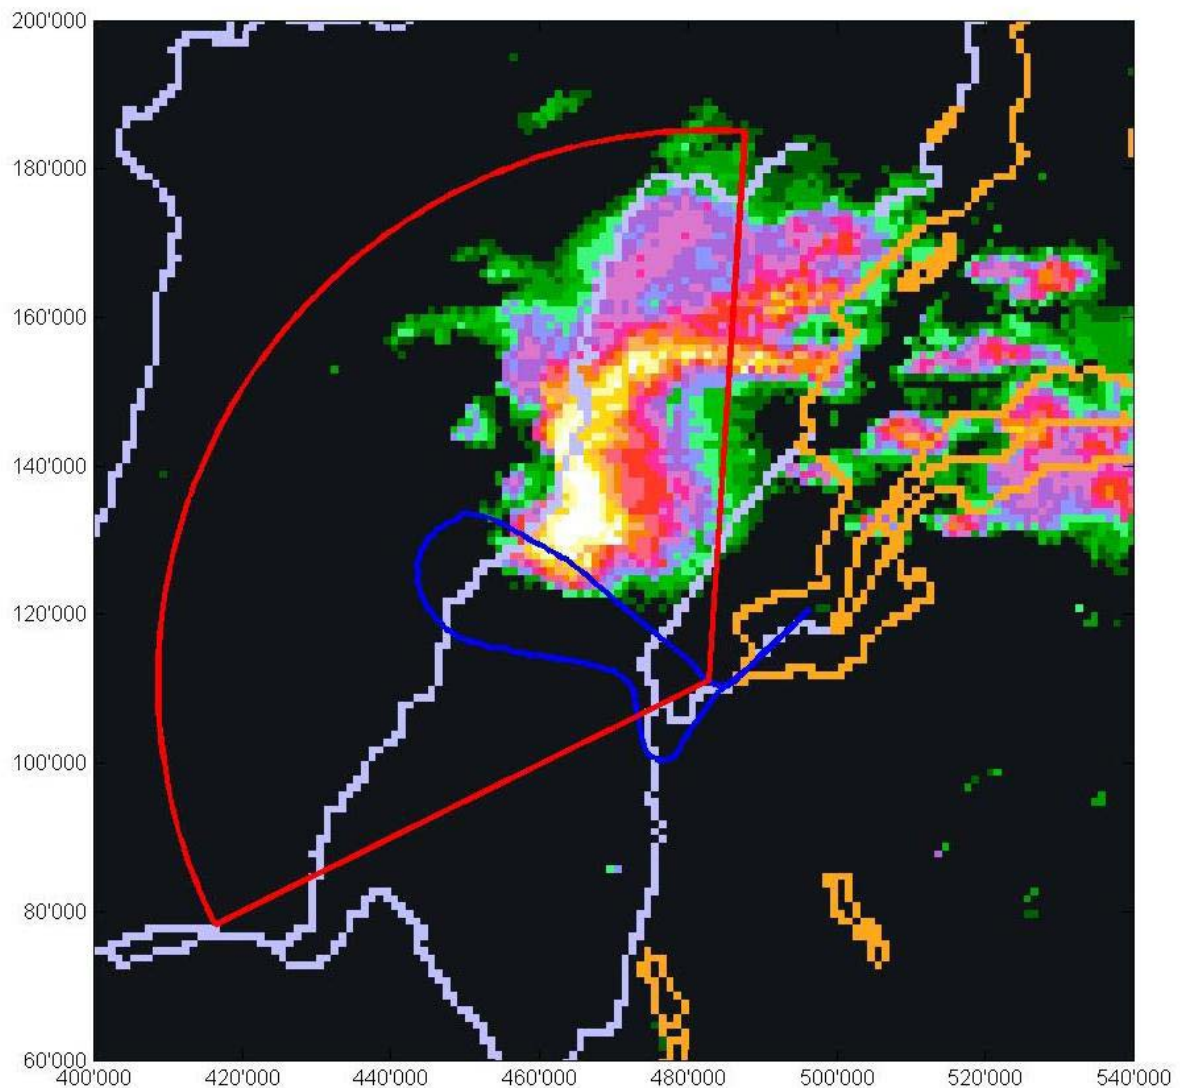
- The *tilt* settings of the onboard radar and the EHSI ranges set by the flight crew enabled the thunderstorm cell to be displayed;
- the radar cross sections (RCS) of the hail and rain permitted good detection in the X band of the onboard weather radar;
- the hail cell which caused the accident was part of a broad thunderstorm zone displayed with good resolution by the onboard weather radar;
- the hail cell which was traversed occupied a central position within the sector scanned by the onboard weather radar (figures 8 and 9).

Fig. 8 Superimposition of the route of the aircraft (in blue) on the La Dôle weather radar image at 08:00 UTC. The sector shown in red is the one being scanned by the onboard radar at the end of the right turn, for the range of 40 NM selected by the commander.

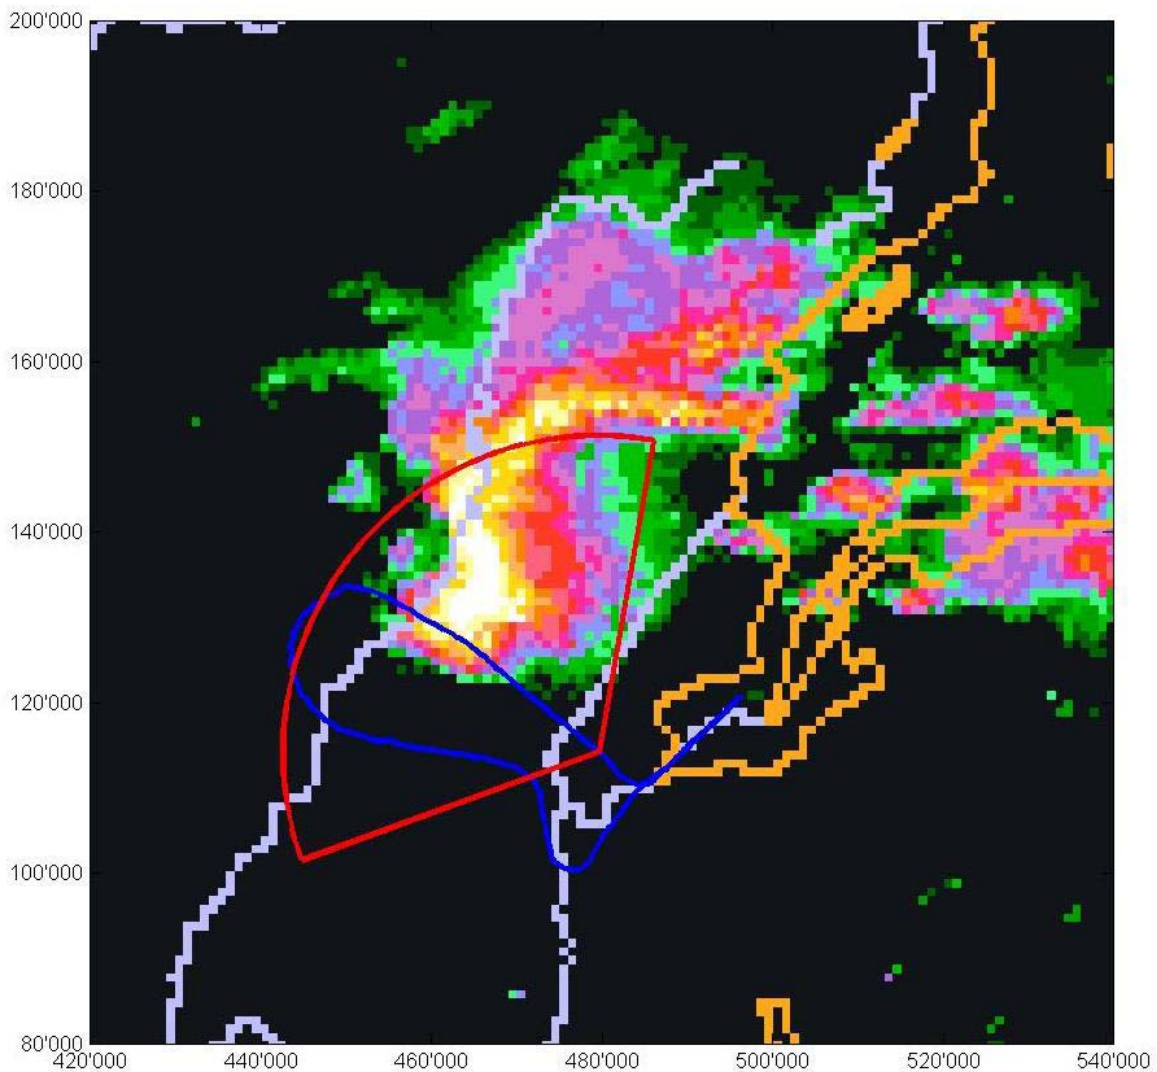
Fig. 9 Superimposition of the route of the aircraft (in blue) on the La Dôle weather radar image at 08:00 UTC. The sector shown in red is the one being scanned by the onboard radar at the end of the right turn, for the range of 20 NM selected by the copilot.

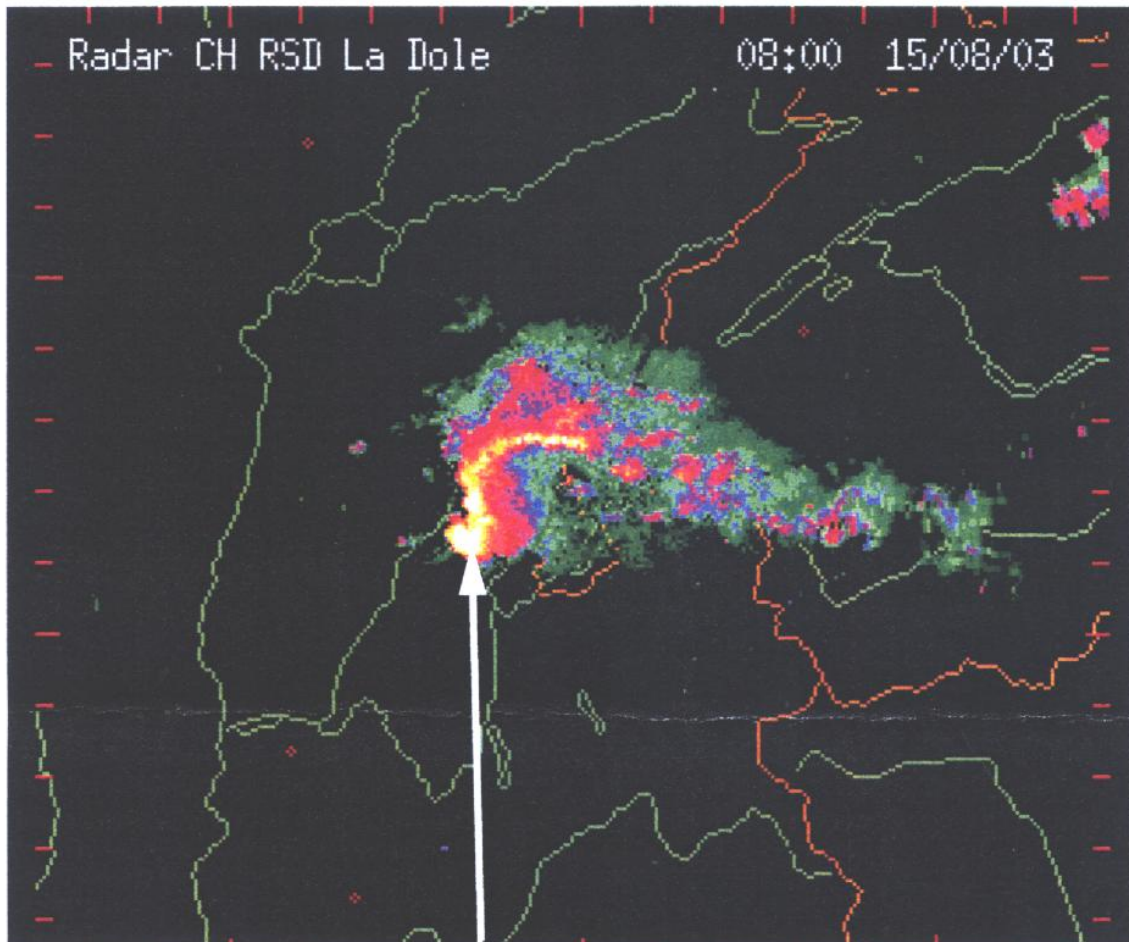
Echo de forte intensité
lié à la cellule orageuse
