Final Report No. 1956

concerning the serious incident

to the SAAB 2000 aircraft, HB-IZZ

on 17 November 2005

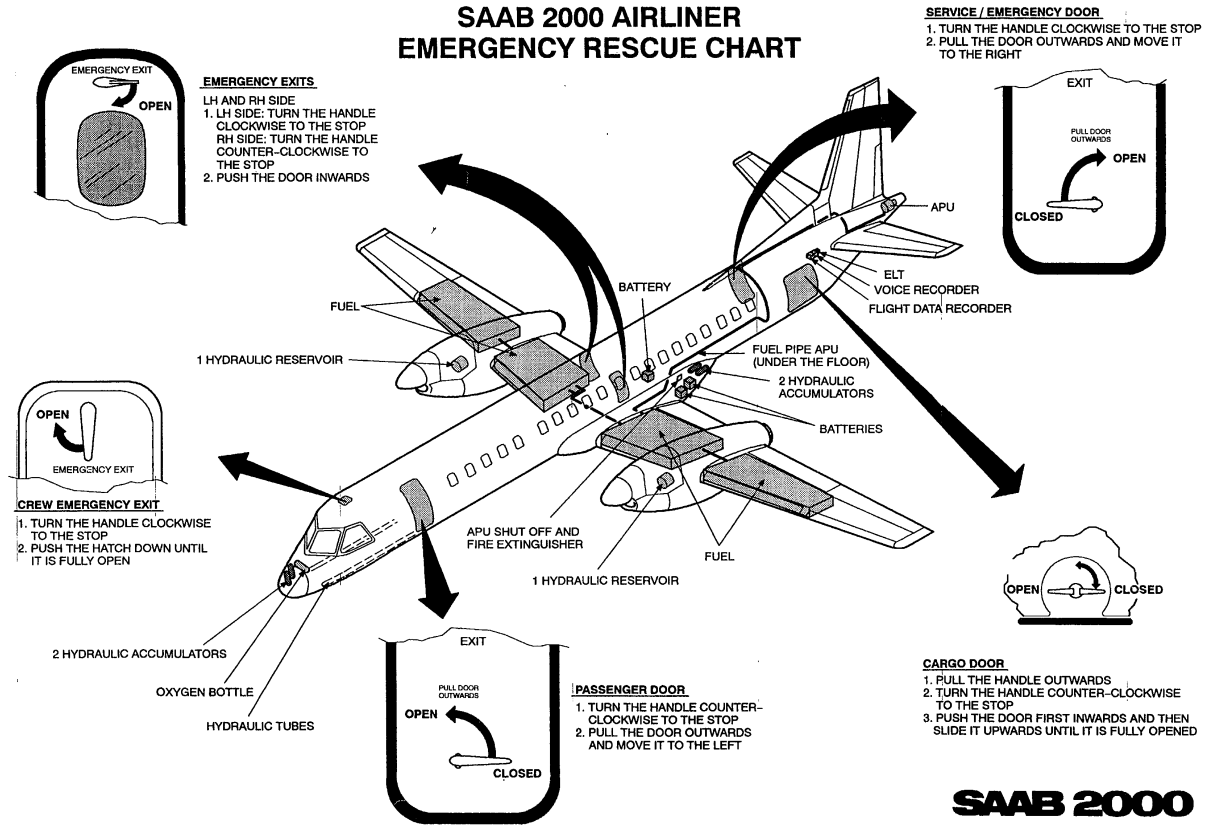
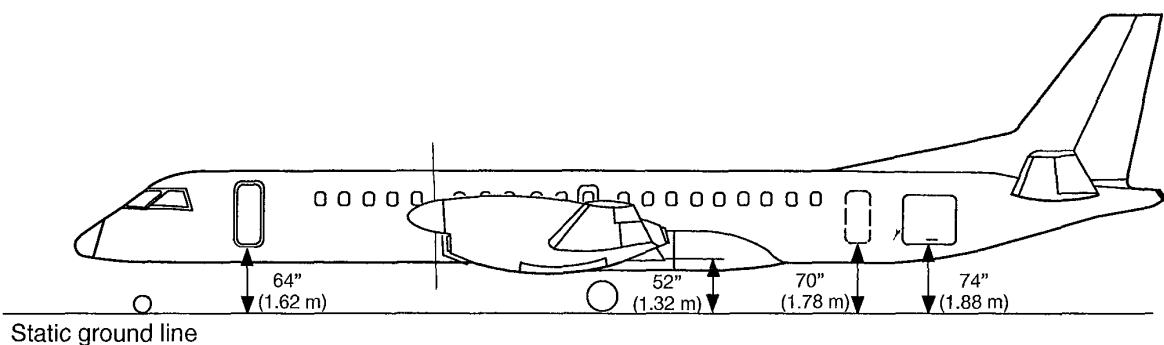
Annex 1: Emergency Exits

The Saab 2000 aircraft type has four emergency exits for passengers: in the front of the aircraft a passenger door to the left and in the rear of the aircraft a service/emergency door to the right. An emergency exit is installed over each wing (cf. Annex 1).

As can be seen in Annex 1, the threshold of the front passenger door is 1.62 m above the ground. The rear service/emergency door has a threshold height of 1.78 m.

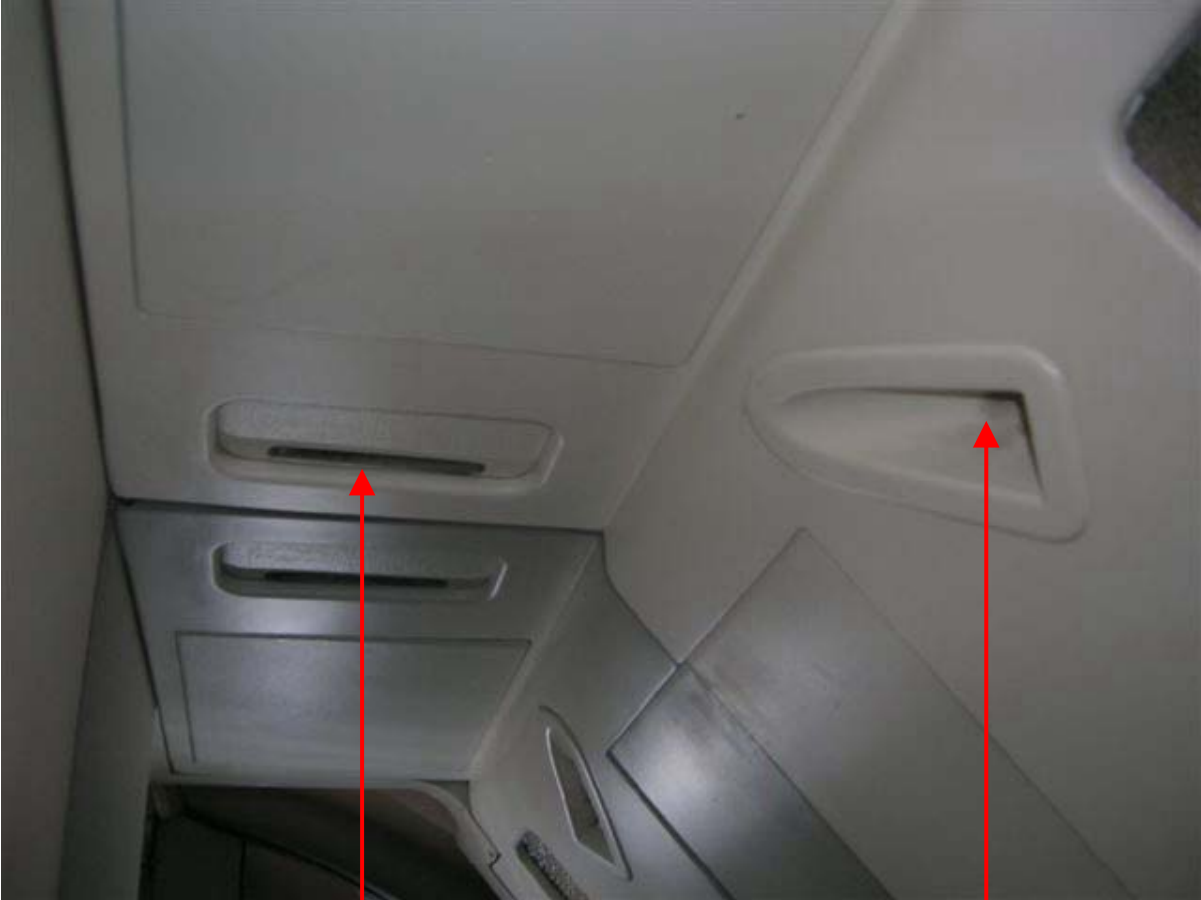
Annex 5: Position of smoke sensor and air nozzle in the lavatory

It must be assumed that this light smoke, as it was perceived in the cabin, was also responsible for briefly triggering the smoke alarm in the lavatory. The air-conditioning pack air nozzle is in the immediate vicinity of the smoke sensor (see Annex 5).

Smoke sensor

Fresh air nozzle
