# **Final Report No. 1958**

concerning the serious incident

involving the A330-243 Airbus aircraft, registration A6-EKU

the AVRO 146-RJ100 aircraft, registration HB-IXU

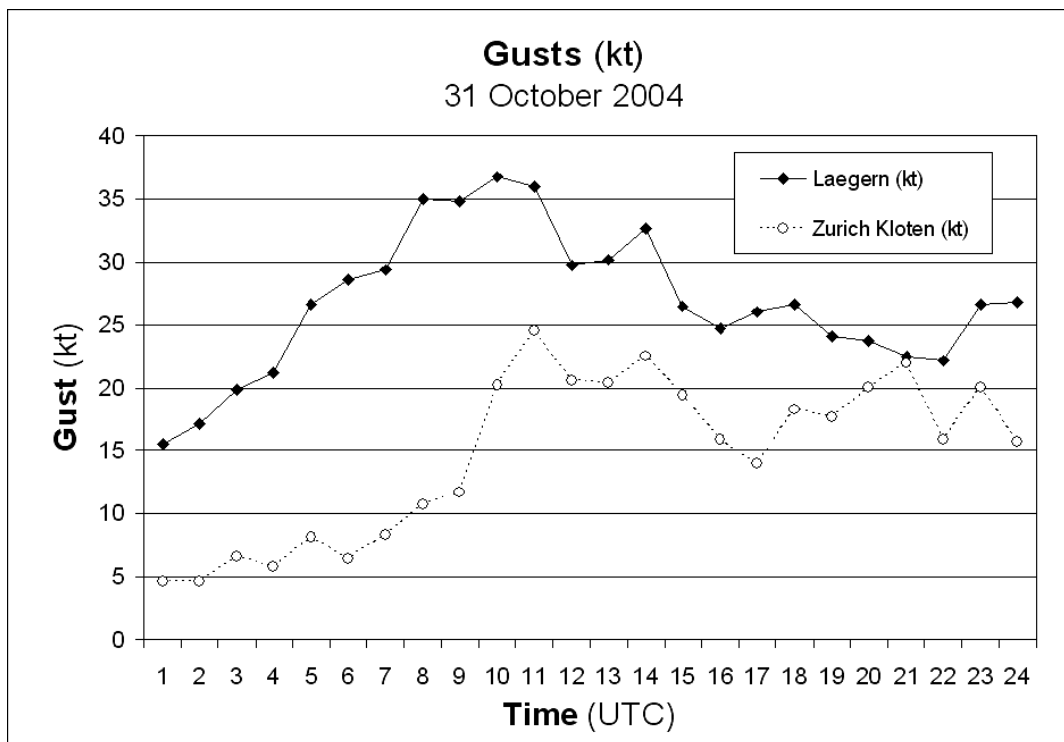
1.7.5 Record of gusts at Zurich airport and Lägern throughout the day (hill west of the airport, 2779 ft AMSL)

At the time of the serious incident, the following wind was recorded at the Lägern measurement station:

030 degrees 19 kt, gusting to 30 kt

At the Lägern measurement station, which is located on a hill to the west of the airport, gusts of max. 37 kt were recorded between 09:00 UTC and 12:00 UTC. With such peak wind values, moderate turbulence at least must be expected on approach to runway 14. The wind in the surface layer of the atmosphere is characterised by major fluctuations, making approach and landing on this runway a challenge. Under such conditions, the probability of a go-around is increased.

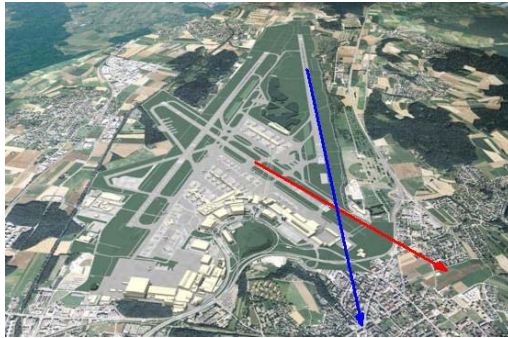
### 1.10.3 Standard procedure for departures from runway 10 and missed approaches on runway 14

Blue: Begin missed approach runway 14

Red: Begin departure route runway 10
