# **Final Report No. 1963**

concerning the accident  
to the Enstrom 480 helicopter, registration HB-XJQ  
on 19 March 2003  
Chilenfeld, municipality of Geltwil/AG  
30 km north of Lucerne

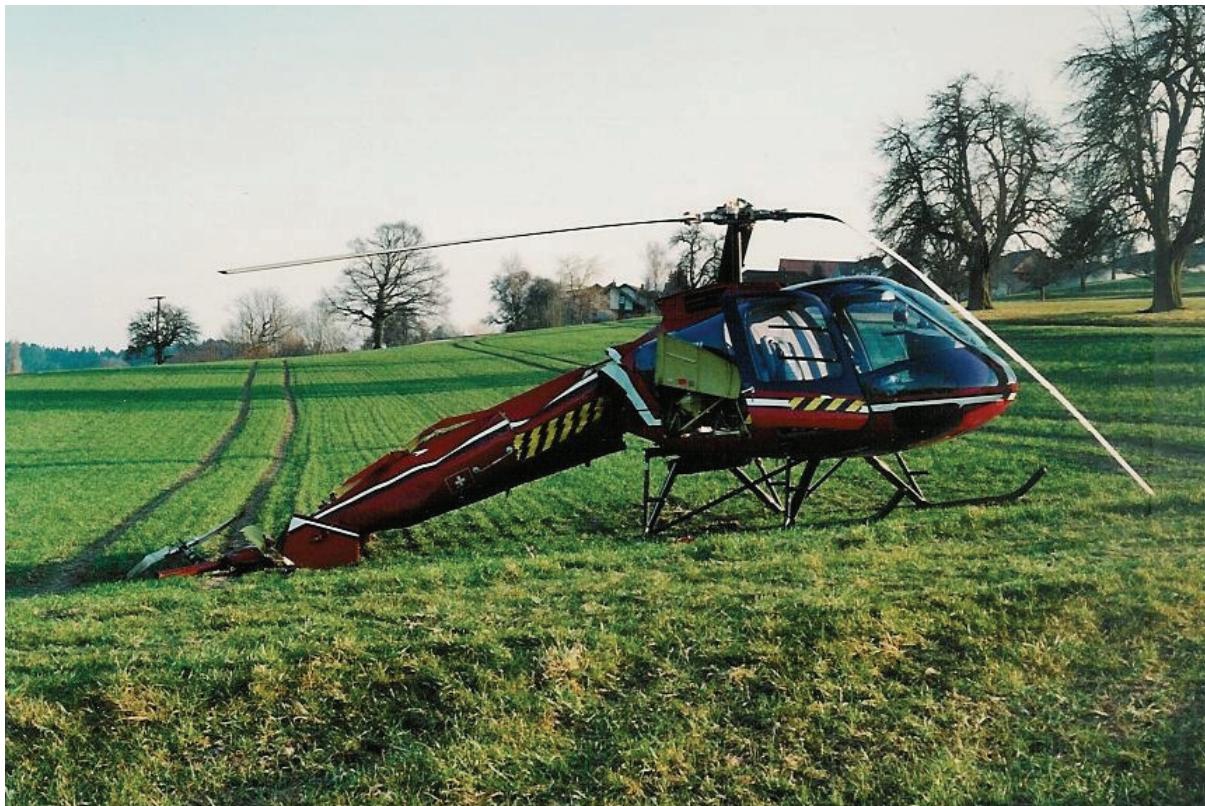
Since the terrain was uneven and rising in front of the helicopter, on touching the ground its deceleration was such that it pitched forward. As it did so, the main rotor struck the tail. The helicopter turned approximately 45° to the left.

View of accident site looking approximately direction south

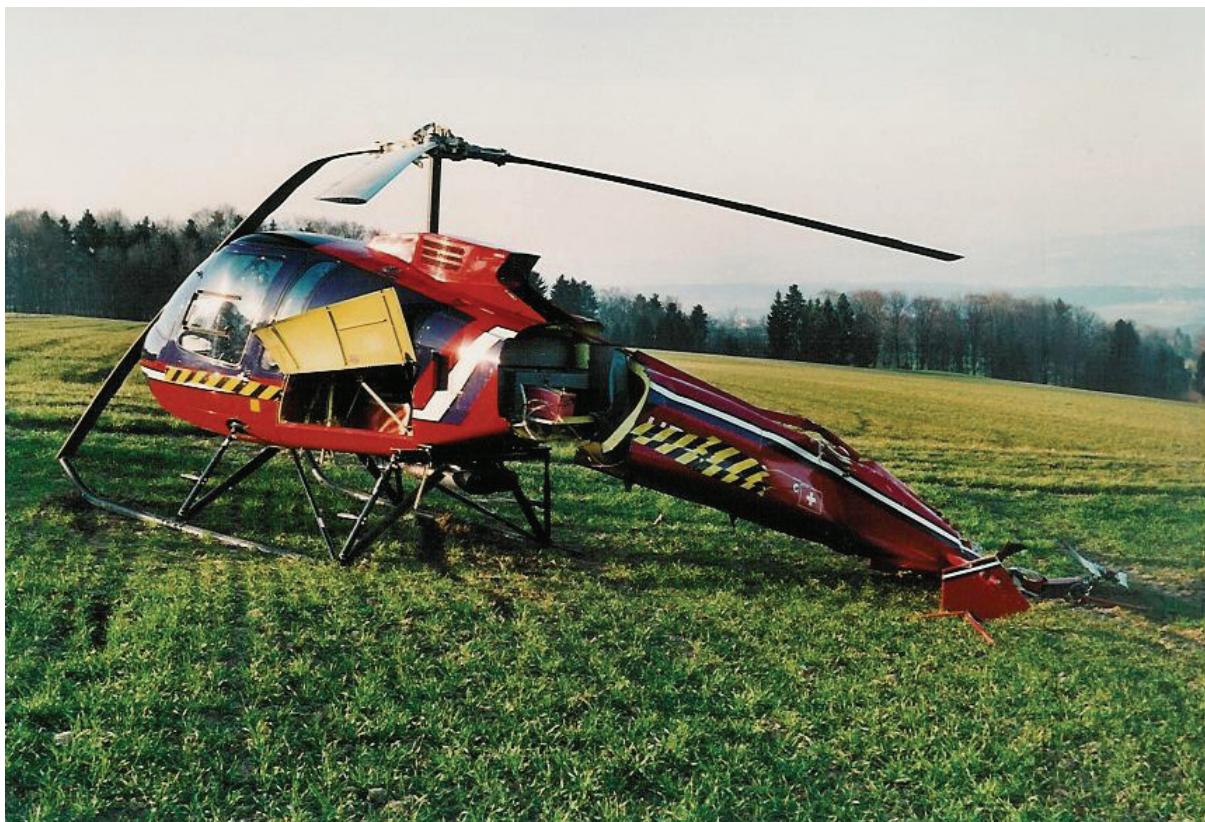
View of accident site looking approximately direction north

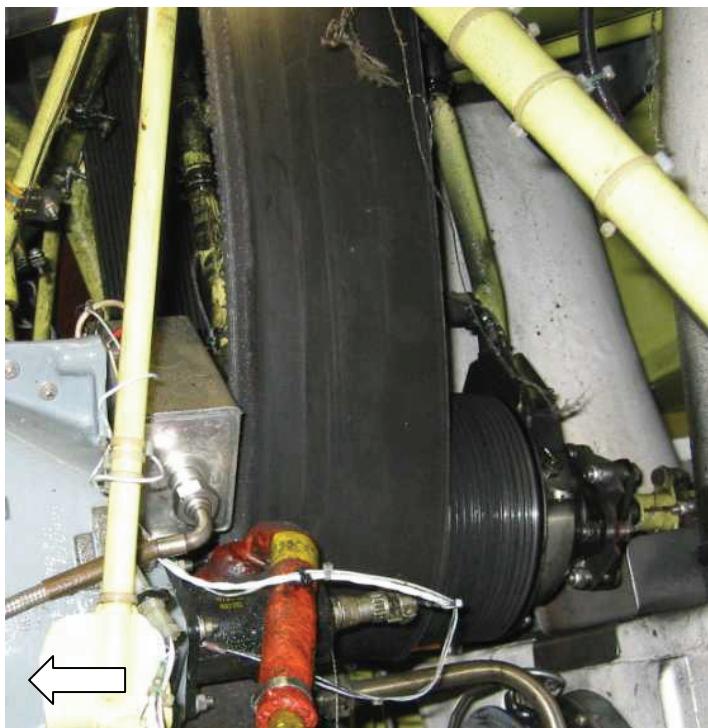
On detailed examination and disassembly of the drive transmission it was found that the H-strut responsible for maintaining the correct distance between the lower and upper pulley was broken (Annex 2). In addition, the ends of the two drag links, which were supposed to ensure the correct alignment of the lower pulley, were torn.

The belt was damaged on its front side. This damage was the result of the fact that the belt had been deflected forwards by the broken H-strut, where it grazed the main transmission housing causing it to be braked.

H-strut with belt deflected towards front in situ

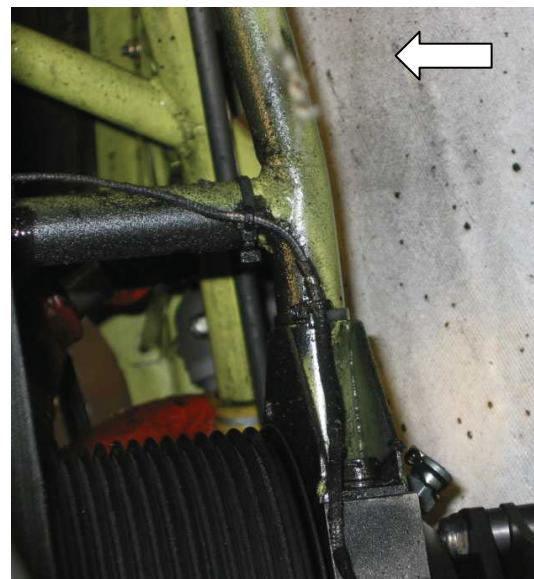
The defective H-strut was examined. The investigation showed that cracks had formed where the H-strut had been welded during manufacture. The macroscopically brittle fracture ran along the weld seam of the cross-member and then relatively straight in the radial direction of the tube.

The metallographic examination showed that on the H-strut both cracks ran through the heat-affected zone of the weld. The matrix of the heat-affected zone exhibited a martensitic formation. In addition, there was evidence of fine heat-treatment on the inner edge of the tube.

Rear Tube of the H-strut

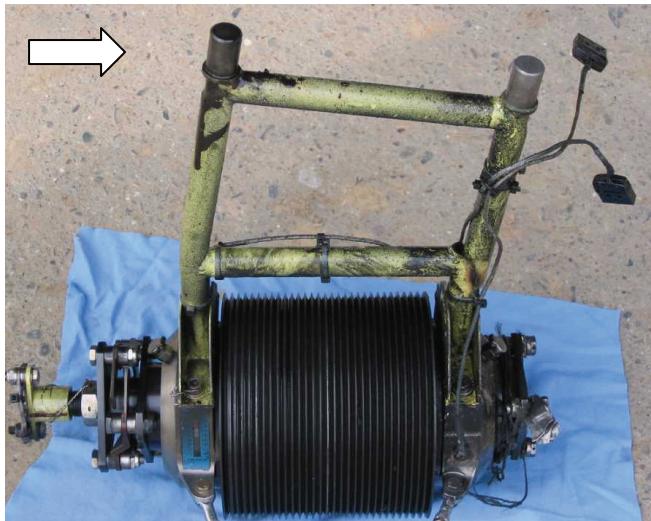
The investigation showed that the crack on the H-strut had started in the area of the weld. The material had been aged there by the welding process.

Broken forward tube of H-strut

The manufacturer has issued the service directive bulletin No. T-018 on 16 june 2003, in which a detailed procedure for the inspection of the welding seams is described. The inspection has to be carried out every 100 hours.

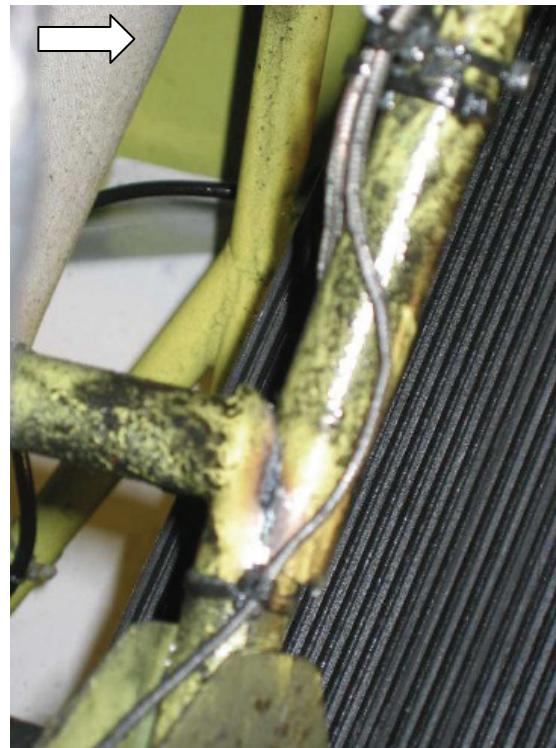
Lower pulley with H-strut

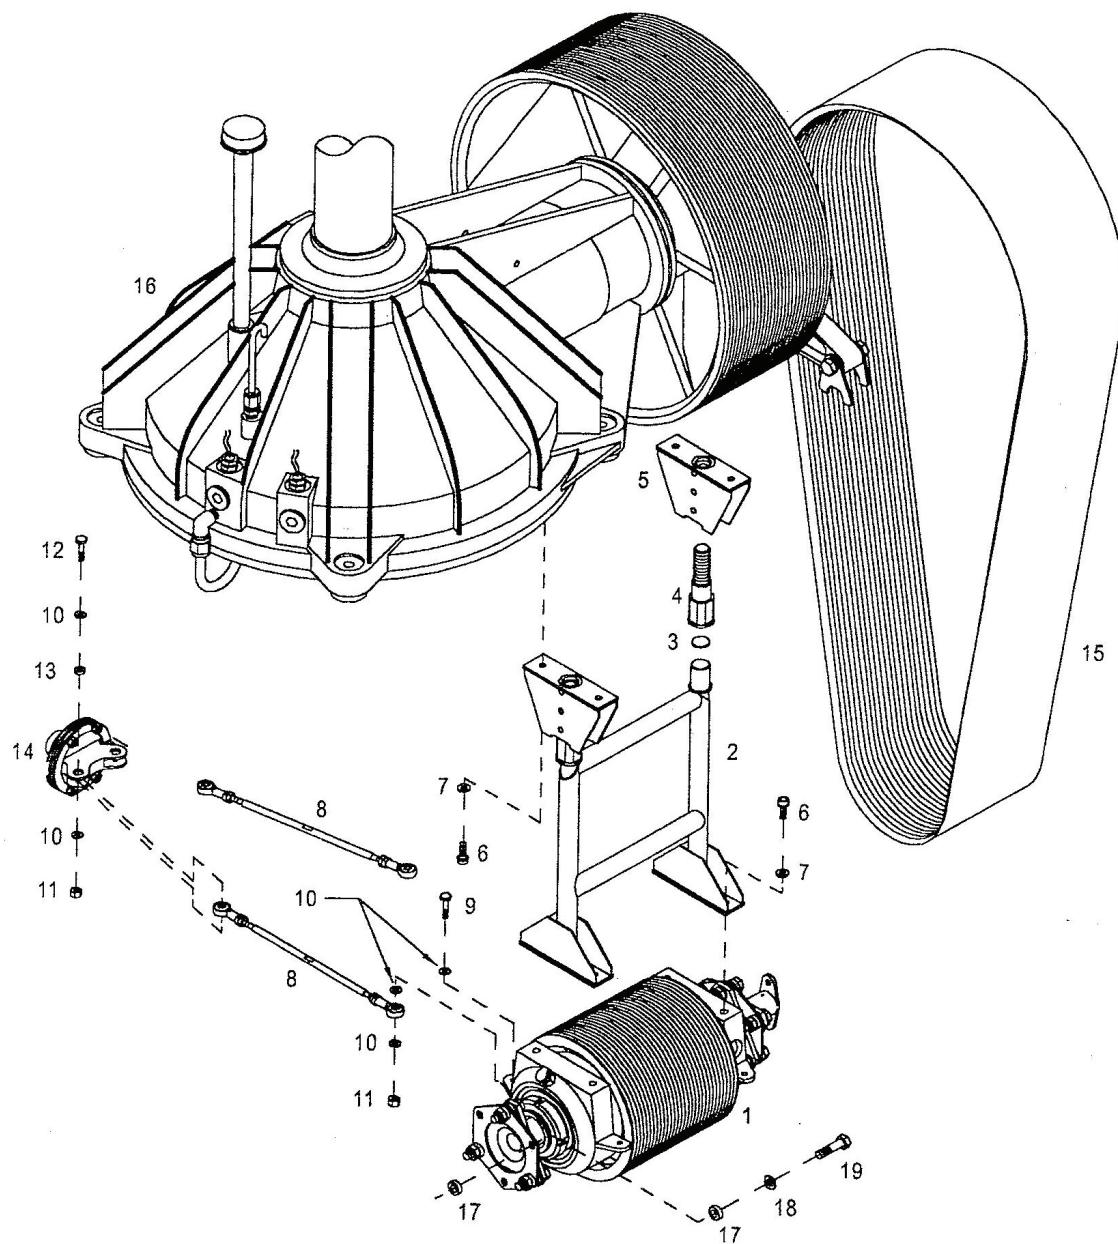
## Enstrom TH-28/480 Lower Pulley Drive System

The two pulleys are normally kept at a specified distance by an H-strut and aligned so that the belt runs straight on the parallel pulleys (Annex 3).
