# **Final Report No. 1964 by the Aircraft Accident Investigation Bureau**

to the Robinson R44 Raven helicopter, registration HB-ZCU

on 26 July 2003

Selzach, municipality of Grenchen/SO

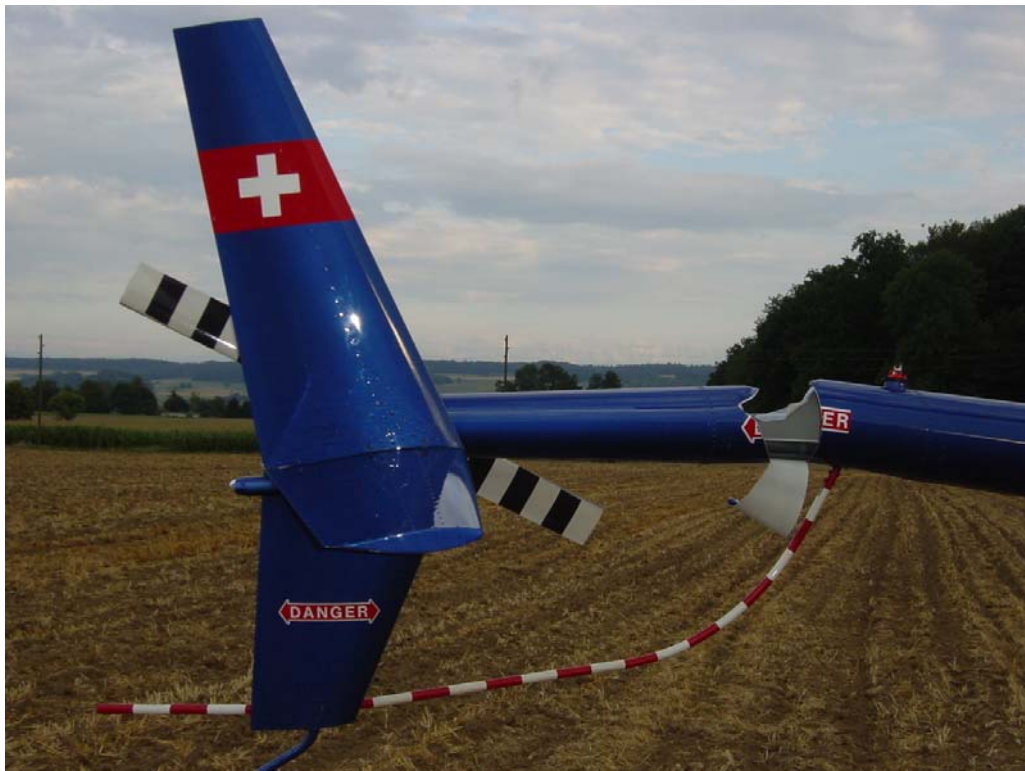
The helicopter was upright on the landing skid in a stubble field. The nose was pointing to the west. The helicopter had damage to the main rotor and tailboom, i.e. a main rotor blade had struck the tailboom. The rotor blades, cabin, engine housing and tailboom were contaminated with oil.

Tailboom with damage due to impact of a main rotor blade

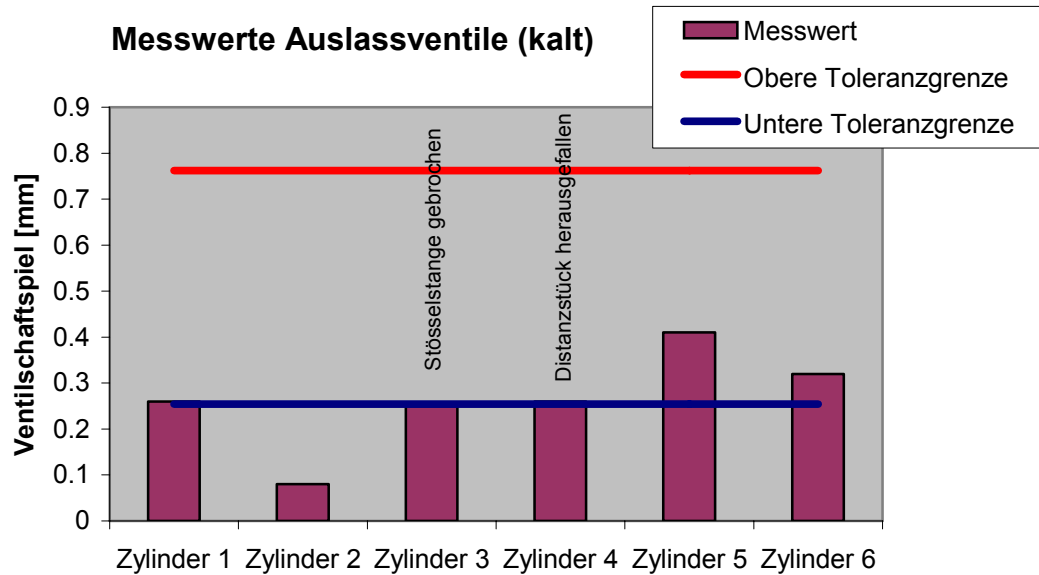
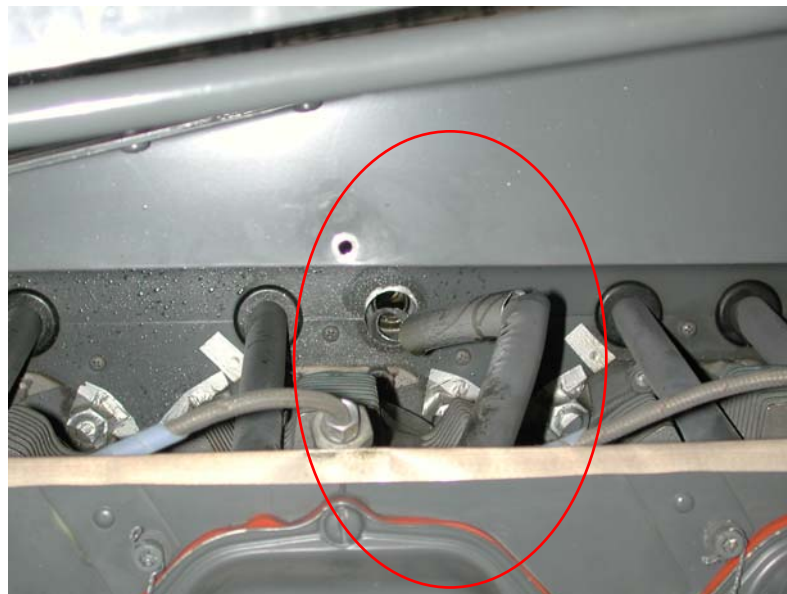
General findings	On cylinder No. 3, the pushrod of the exhaust valve and the corresponding protective tube were kinked and broken. An oil leak had occurred through the fractured pushrod tube.
Engine oil level	4 qt. The required minimum quantity is 7 qt.
Ignition	Both magnetos within tolerance.
Fuel	Fuel was present up to and including the carburettor.
Valves	<p>All valves were examined for the following points:</p> <ul style="list-style-type: none"> <li>• Damage</li> <li>• Loss of compression</li> <li>• Valve clearance</li> <li>• Valve stem clearance (measurement method according to SB 388B)</li> </ul> <p>Rated value:                      Minimum: 0.254 mm                      Maximum: 0.762 mm</p>

Cylinder No.	Valve stem clearance Exhaust valve	Tolerance situation	Comments
1	0.260 mm	within	
2	0.080 mm	outside	The valve may possibly have become blocked within a short time as a result of the low valve stem clearance.
3	0.250 mm	outside	
4	0.260 mm	within	The valve spacer was found loose in the valve cover.

The broken valve pushrod and the corresponding tappet sleeve on the cylinder No. 3 exhaust valve which was also broken clearly indicate that this valve must have stuck completely during operation. As a result, the pushrod buckled and failed. From this moment, cylinder No. 3 was no longer able to supply power.

The fracture of the cylinder No. 3 pushrod sleeve caused a major oil loss; this explains the low engine oil level.

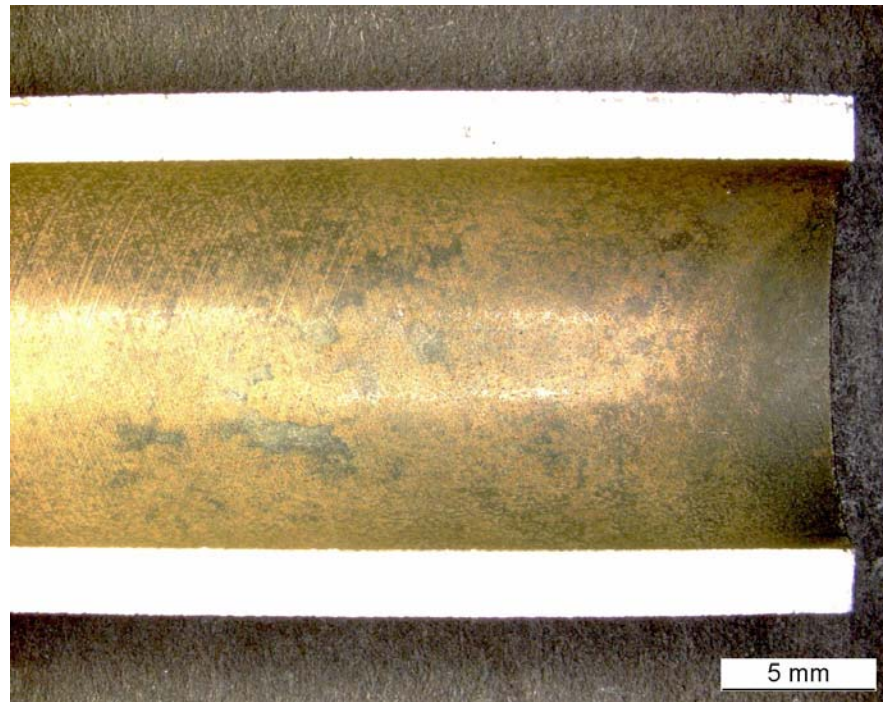
- Deposits of lead residue, predominantly in the lower half of the valve guide
- Aluminium and iron particles present on the surface
- No indications of sticking

Exhaust valve stem guide, inside. The dark deposits on the lower half of the valve guide (on the right in the photo) are predominantly lead residue.

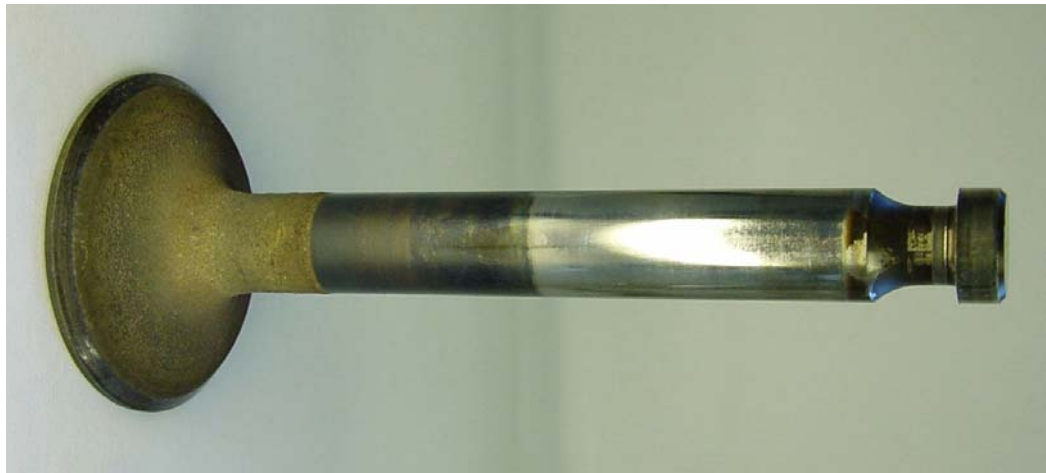
- Small scratches on the valve stem
- Lower half of the valve stem covered with paint-type carbon deposits
- Underneath, the layer of chrome on the valve stem is damaged in places; completely removed over a 3 mm wide area
- Large quantities of lead and bromine deposited on the surface of the valve stem
- Valve fit area predominantly covered with carbon residue

Cylinder No. 3 exhaust valve with deposits on the lower part of the valve stem

- The stem clearances of two other exhaust valves were also reduced.
- The reduced stem clearances and the consequent sticking of the exhaust valves were caused by deposits of carbon, lead and bromine on the valve stem and valve guide.

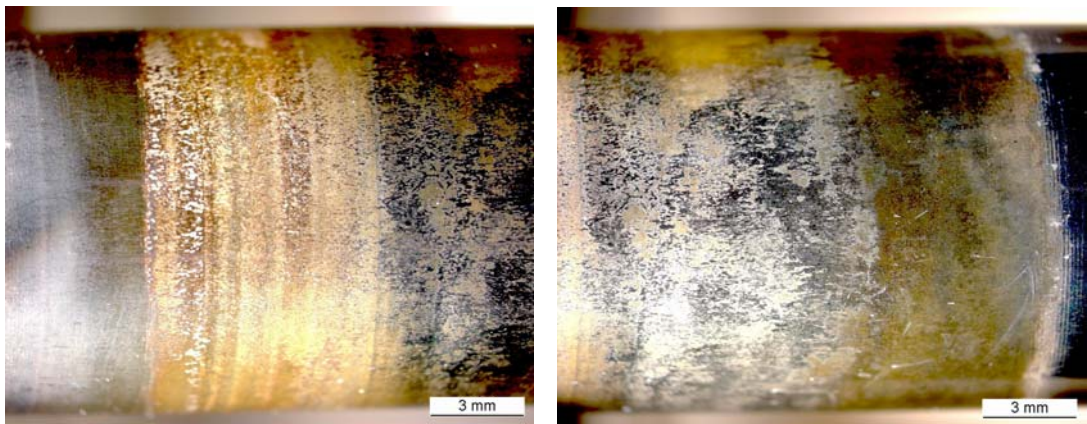
Microscopic photograph of deposits on the stem of cylinder no. 3 exhaust valve

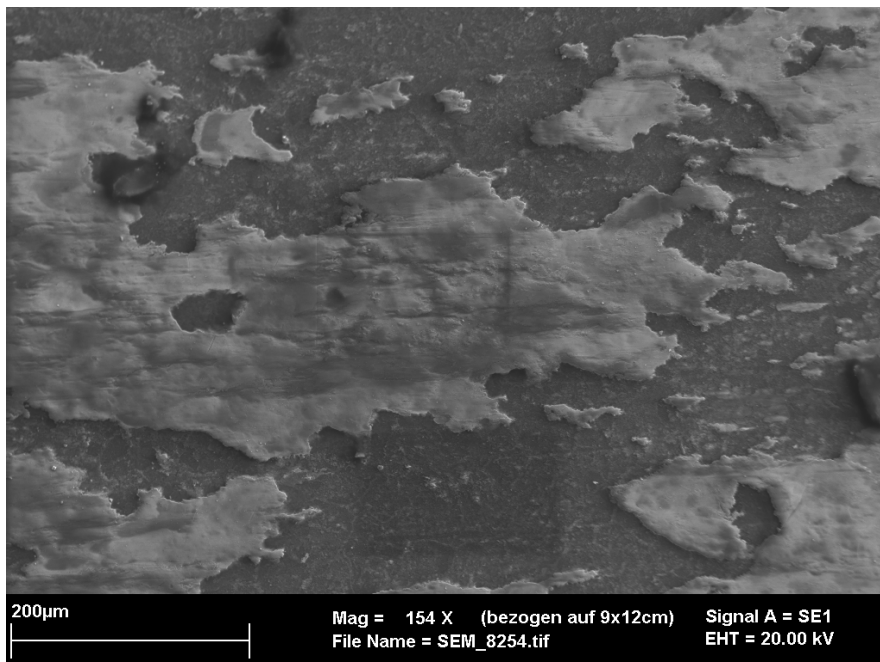
REM (Raster Electron Microscope) photograph of lead deposits on the surface of the valve stem of cylinder No. 3 exhaust valve

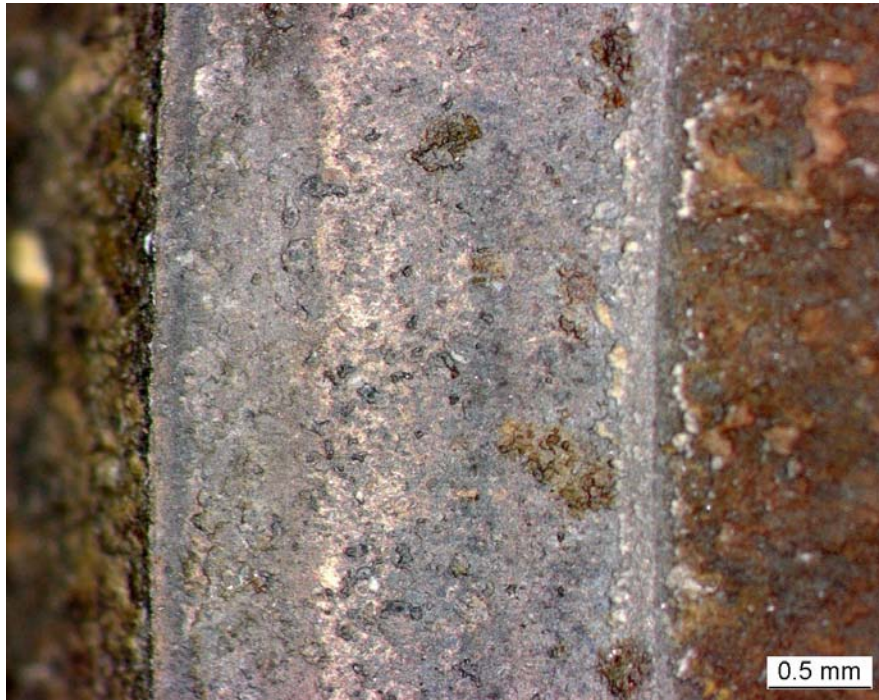
Carbon residue on the fit of cylinder No. 3 exhaust valve

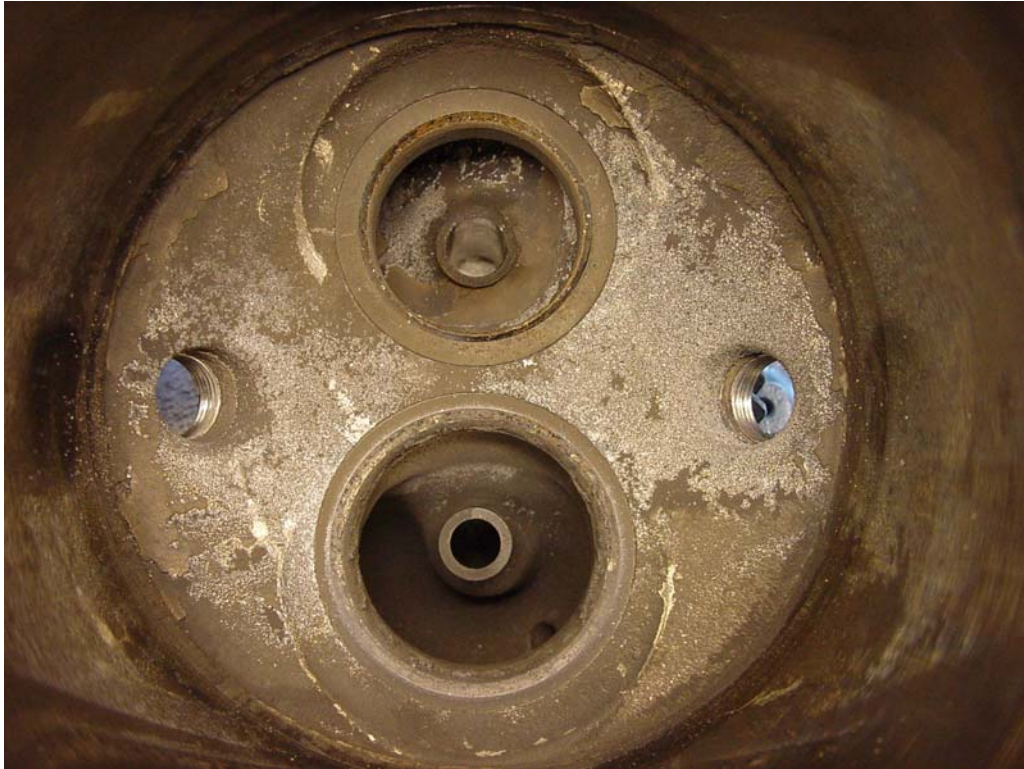
- Poor condition, i.e. the valve fits on both the inlet and exhaust valves were found to have rough surfaces; they were no longer capable of providing a complete seal.

Cylinder No. 3 combustion chamber. Rough surfaces of the valve fits clearly visible in the cylinder head, exhaust valve above, inlet valve below.
